Bulletin No. 2003-03

Cracked or Broken Brass Trim Pump Adapter Fittings

Models Affected

All Alpha and Bravo Trim Pumps for engines serial number 0M370777 through 0M641315 with Julian Date code 1612 through 0783

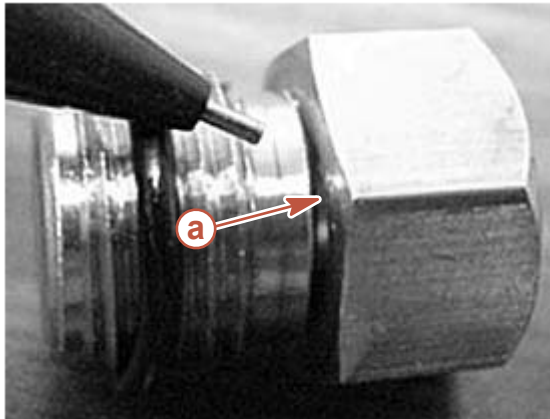
mc79452-1

Some of the brass fittings on the trim pump adapter are either cracked or broken causing the drive unit to drop when the oil leaks through the damaged fitting. The fittings on the gray and black trim lines may have been over tightened causing damage to the brass fittings.

The damage may have occurred as a result of an over torque between the trim line and the brass fitting due to inconsistencies between various service publications from the years past.

a - Area of crack

If either fitting is cracked or broken, replace both brass fittings on the trim pump adapter and torque the fitting and the trim lines to 9 Nm (80 lb-in.).

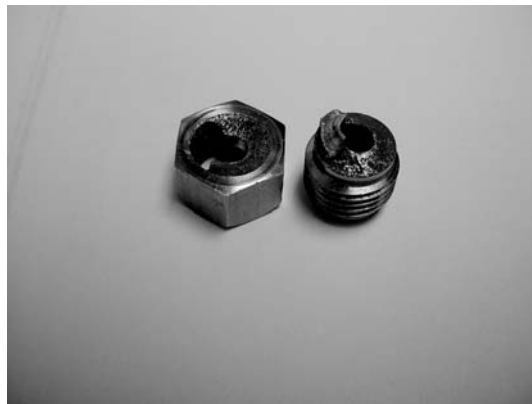
mc79453

Broken fitting

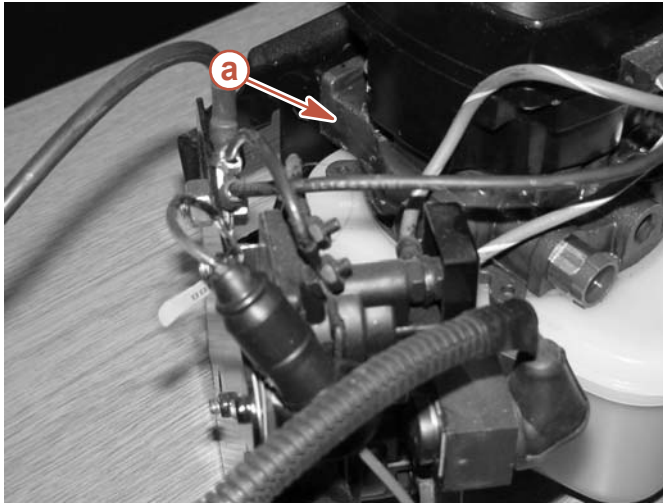
mc79454-1

a - Location of Julian date code on pump adapter
