4000 Series Panel Mount Control - Pistol Grip

Models Affected

Mercury Marine has identified a potential problem with the manufacturing of the 4000 series pistol grip panel mount remote controls. The amount of force required to move the shift handle out of the "NEUTRAL" detent lock position without depressing the release button, in a very small percentage of these controls, was found to be below specification.

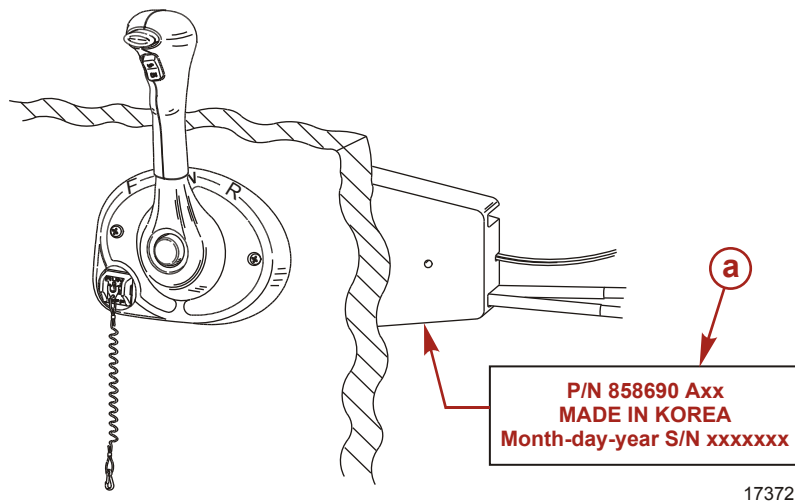
1. Have been installed in boats with the **last four digits** of the Hull Identification Numbers (HIN) between J000 (October, 2000) through F505 (June, 2005) are affected.
2. Have remote controls with dates of manufacture that are on the labels located as shown in the figure below between October, 2000 and May, 2005.

a - Label on bottom side of housing

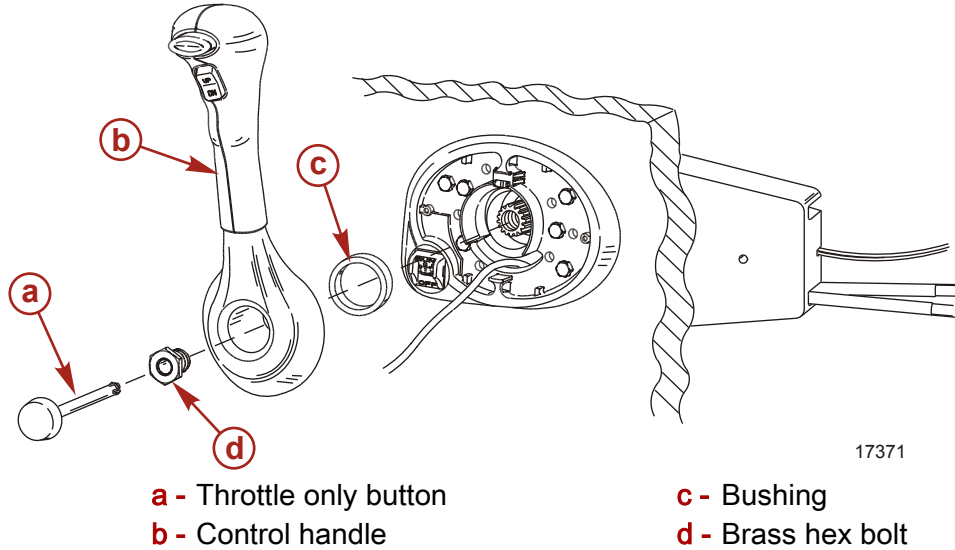
- e. If the handle lock functions properly, no further action is required.
4. If excessive free play is felt, it indicates that either the bolt that secures the handle to the control may not be fully seated or the bushing between the handle and bezel is missing. Either condition may allow the control handle to shift into gear without depressing the neutral release button while using minimal force. The excessive free play condition must be corrected before proceeding with any testing as described previously.

- a. Remove the throttle only button by:
 - Placing the control handle in the "NEUTRAL" position.
 - Push in the throttle only button.
 - Advance the handle forward to the first detent felt.

- Release the throttle only button and carefully pry it out. This exposes the hex head bolt in the bore of the handle.
 - b. Loosen the bolt approximately 1/4 turn. Then retighten the bolt and torque to specification. This should rectify the free play condition.

- c. If the free play still exists, remove the bolt. Remove the handle from the control and check to ensure the handle bushing is installed. If the handle bushing is not installed, purchase a new bushing (23-859016). Install the bushing and reinstall handle.
- d. Verify that the free play condition was rectified. Follow the procedures for the neutral lock test as described in Step 3. If the neutral lock functions properly, submit a warranty claim for **Inspection only**.

Description	Nm	lb. in.	lb. ft.
Hex head bolt	17	150

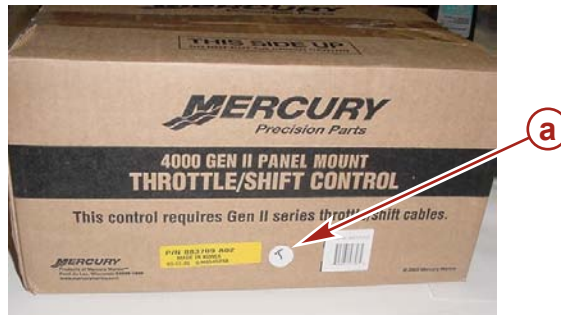
17483

Remote controls in the parts inventory must be checked for the part numbers as listed on the first page of this bulletin. All remote controls in the original unopened carton WITHOUT a white round sticker with a purple colored "T" on the part number label must be returned to Mercury Marine for credit. The purple colored "T" in the white round sticker indicates that the control was inspected and is able to be sold.

a - White dot with purple "T"

All controls that are in opened cartons should be inspected for the purple dot or two white dots on both the control handle and the bezel. If it is determined that they do not have the purple dot or two white dots, the handle and bezel should be replaced.
