## Transom Exhaust Bellows and Clamp Improperly Assembled

Model	Transom Serial Number Range
Alpha One Gen II transom and Bravo standard transom	0W777431–0W779891 and 1A100383–1A100788

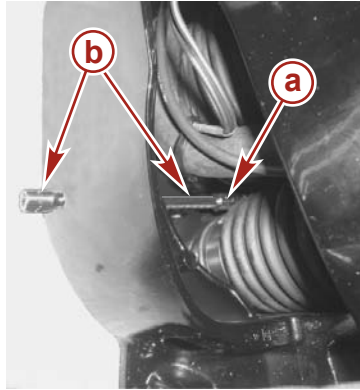
28098

The clamp and the exhaust bellows on the gimbal housing exhaust flange may have been improperly assembled. As a result, the exhaust bellows could become detached from the exhaust flange of the gimbal housing. A detached exhaust bellows is not an immediate hazard to the vessel or operator but may result in louder than normal exhaust noise and a potentially elevated risk of exposure to carbon monoxide while the vessel is operating at speed or on plane.

2. Insert a 1/4 in. drive extension through the access hole in the gimbal housing and attach a 5/16 in. socket. Tighten the exhaust bellows clamp to specification.

Description	Nm	lb. in.	lb. ft.
Exhaust bellows clamp	4	35

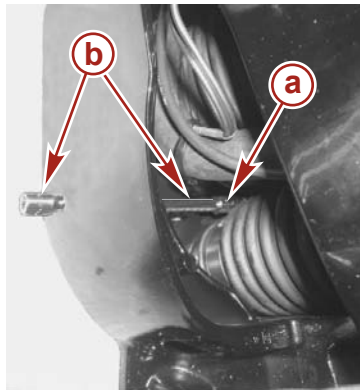
28098

If inspection reveals that the exhaust bellows has become detached from the gimbal housing, complete the following steps.

7. Insert a 1/4 in. drive extension through the access hole in the gimbal housing and attach a 5/16 in. socket. Tighten the exhaust bellows clamp to specification.

Description	Nm	lb. in.	lb. ft.
Exhaust bellows clamp	4	35
