Service Bulletin

Bulletin No. 2007-67
CMD 2007-07

Ground Strap on all Diesel Transoms

Model	Serial Number
All diesel Alpha and Bravo transoms	0W452481-1A410122

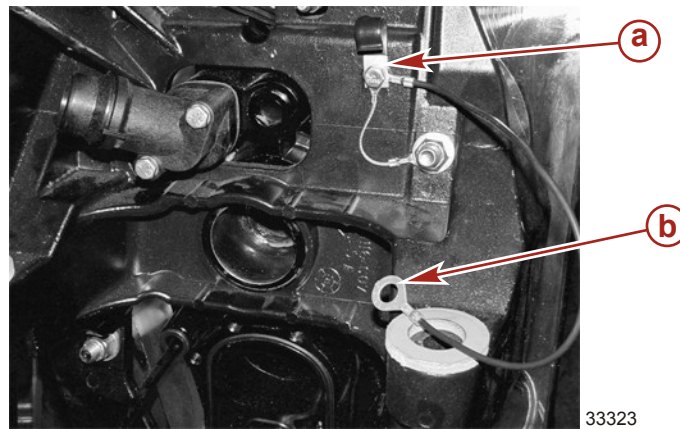
All transoms in the affected serial number range require an additional ground strap between the inner transom plate and the engine ground or battery ground to complete the continuity circuit.

- a** - Inner transom plate ground strap location
- b** - Attach to engine or battery ground

The ground strap is already included in the parts bag for all diesel transoms SN 1A410123 and above. For models affected (above), add a ground strap. Certain applications such as driveshaft extension kits may require a longer strap to complete the ground circuit.

Ground strap (P/N 62826A6) with a length of 33 cm (13 in.). If constructing a new strap, use at least 14 gauge wire and appropriately sized ring eye connectors.
