Power Steering Fluid Leaks—Mercury Diesel Sterndrive Engines Models Affected

Description	Serial Number Or Year
Mercury Diesel Sterndrive engines—2.0L I4, 2.8L I4, 4.2L I6, 3.0L V6 TDI, 4.2L V8 TDI	2015 and earlier

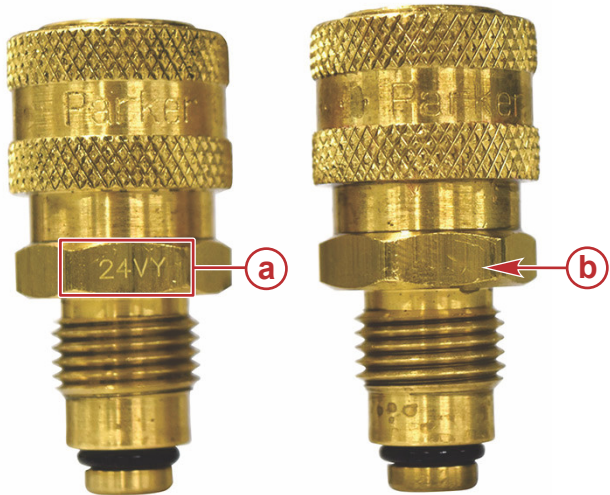
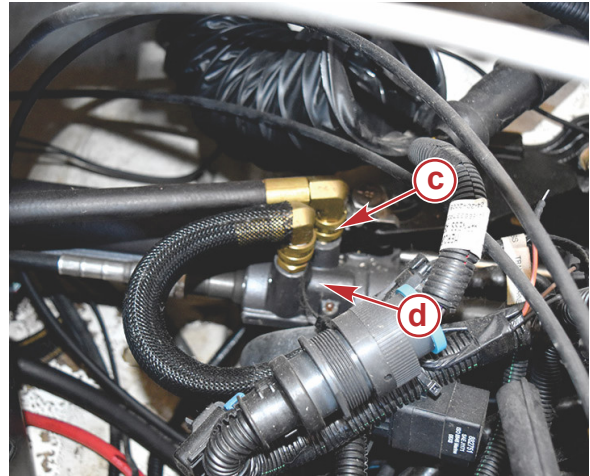
62455

Mercury Diesel has identified a potential issue with the power steering quick-connect return fitting that can cause slow leakage of power steering fluid on certain Sterndrive applications. Power steering pump failure, engine overheat, and engine fires could result from operating with extremely low levels of power steering fluid.

NOTE: The date code is only visible on one flat of the fitting. Be sure to check all sides of the fitting while attempting to locate the date code.

- a** - Power steering quick-connect return fitting with date code
- b** - Power steering quick-connect return fitting without date code
- c** - Power steering quick-connect return fitting location
- d** - Power steering cylinder assembly

1. Inspect any inventory of power steering cylinder assembly kits for a power steering quick-connect return fitting without a date code. Refer to **Parts Affected** for the cylinder assembly part number. Follow the instructions in the **Warranty** section of this bulletin, and return kits that do not have a date code.
2. Inspect any loose inventory of power steering quick-connect return fittings for a date code. Refer to **Parts Affected** for the fitting part number. Follow the instructions in the **Warranty** section of this bulletin, and return any loose power steering quick-connect return fittings that do not have a date code.

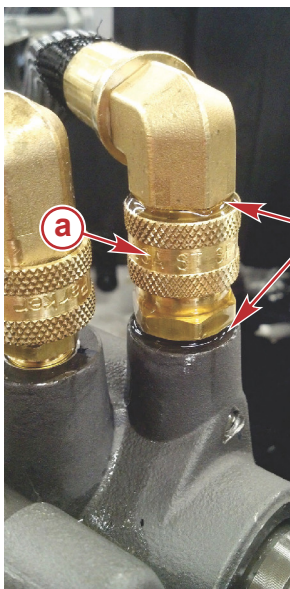
62454

3. Inspect the power steering quick-connect return fitting on systems mounted in vessels. Run the engine if necessary. The presence of residual fluid around the fitting indicates a leak. If residual fluid is found, replace the power steering quick-connect return fitting.

- a** - Power steering quick-connect return fitting
- b** - Power steering residual fluid
