# Service Bulletin

Bulletin No. 2016-71  
OEM No. 2016-71

## Official Recall Notification U.S. Federal Boat Safety Act

# Mercury Diesel 3.0L Tier 3 Turbocharger Oil Supply Line Sealing Washers

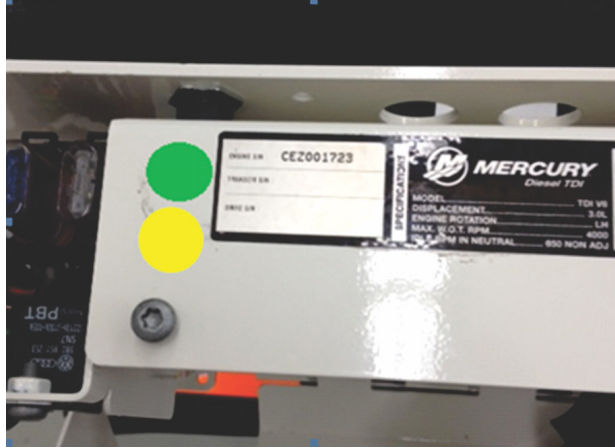
62628

Engines reworked by the factory or by an authorized dealer will have a mark indicating that the rework has been performed. With the engine removed from the shipping container, or installed in a boat the rework identification will be a yellow dot placed to the left of the serial number decal.

Dot location

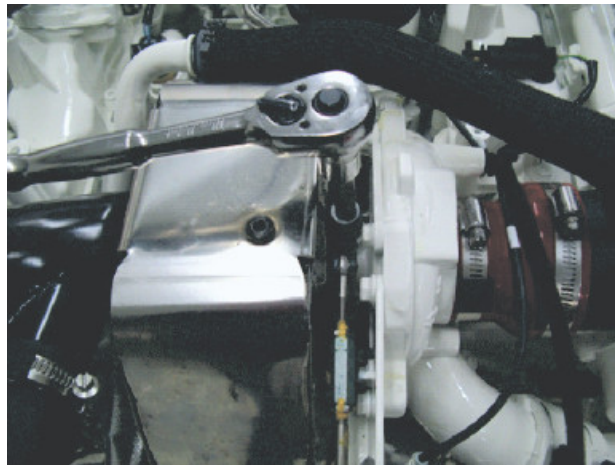
62629

Oil supply line hollow bolt

1. Remove the engine cover.
2. Remove the hollow bolt securing the oil supply line to the turbocharger.

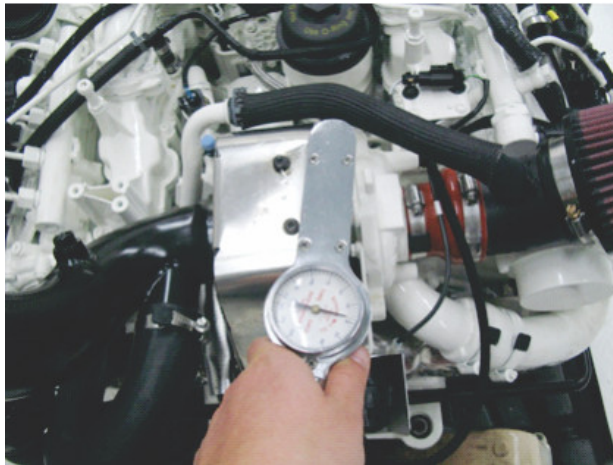
62631

Proper torque

5. Tighten the hollow bolt to the specified torque.

Description	Nm	lb-in.	lb-ft
Hollow bolt	20	177	–

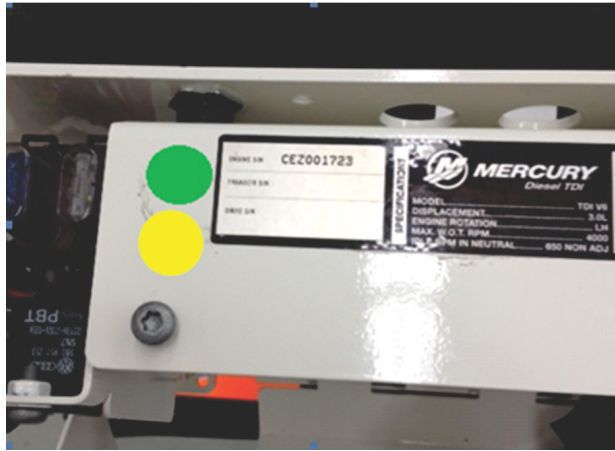
62628

Yellow dot location

6. Affix a yellow dot next to the serial number decal to indicate that the rework has been performed.
