Service Bulletin

Bulletin No. 2016-11
OEM No. 2016-08

Power Steering Fluid Leaks—MerCruiser Sterndrive Engines

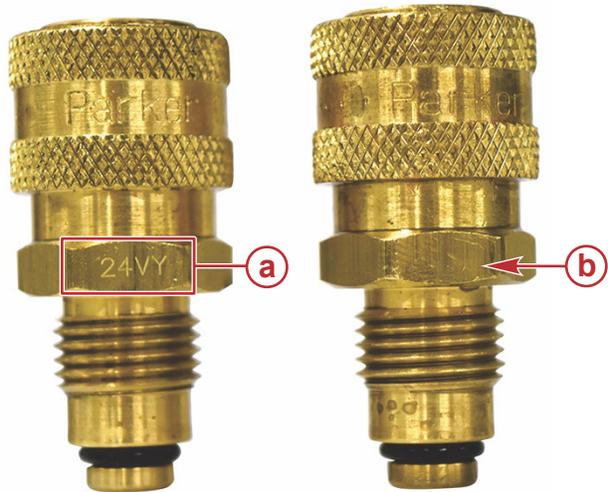
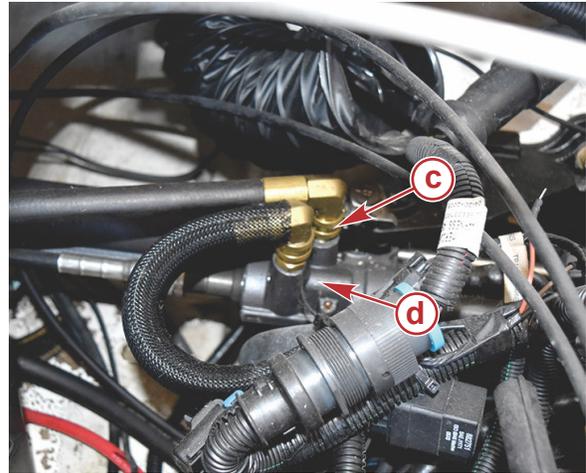
62455

NOTE: The date code is only visible on one flat of the fitting. Be sure to check all sides of the fitting while attempting to locate the date code.

- a** - Power steering quick-connect return fitting with date code
- b** - Power steering quick-connect return fitting without date code
- c** - Power steering quick-connect return fitting location
- d** - Power steering cylinder assembly

1. Inspect any inventory of power steering cylinder assembly kits for a power steering quick-connect return fitting without a date code. Refer to **Parts Affected** for the cylinder assembly part number. Follow the instructions in the **Warranty** section of this bulletin, and return kits that do not have a date code.
2. Inspect any loose inventory of power steering quick-connect return fittings for a date code. Refer to **Parts Affected** for the fitting part number. Follow the instructions in the **Warranty** section of this bulletin, and return any loose power steering quick-connect return fittings that do not have a date code.

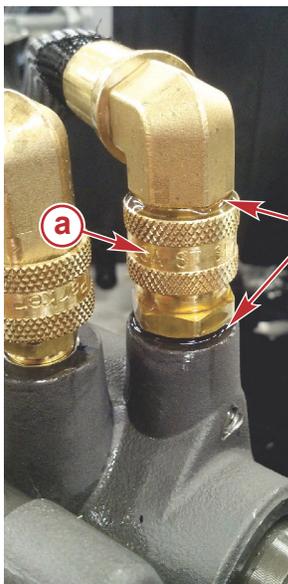
62454

- a** - Power steering quick-connect return fitting
- b** - Power steering residual fluid

3. Inspect the power steering quick-connect return fitting on systems mounted in vessels. Run the engine if necessary. The presence of residual fluid around the fitting indicates a leak. If residual fluid is found, replace the power steering quick-connect return fitting.
