# Service Bulletin

Bulletin No. 2010-73  
CMD 2010-13

## Official Recall Notification Under the U.S. Federal Boat Safety Act

## Replacement of the Core Wire of the Intermediate Shift Cable on Mercury MerCruiser Alpha and Bravo Sterndrives

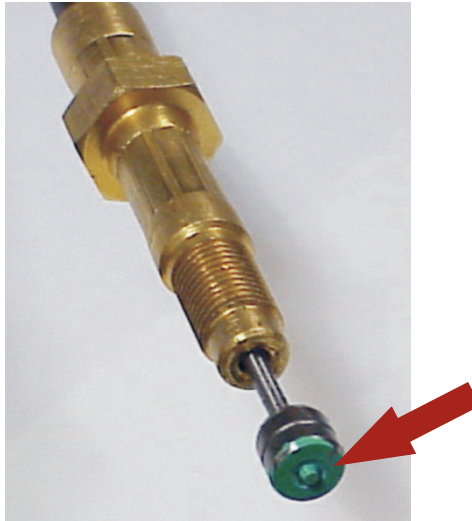
45159

Cables in transoms within the affected serial number range or cables within the date codes have been repaired if they are marked with a green or blue paint dot on the cable end. Corrected cables are now being marked with a green paint stripe on the barrel of the cable jacket or a stripe of green tape around the outside of the cable housing at the engine end of the cable. If this green marking is present, core wire replacement is not necessary. Some cables did not receive the paint mark on the outer cable. If the paint dot is present on the core wire end but not on the outer cable, the cable is still good. Add a mark to the outer cable and submit a claim for inspection without replacement.

**Green or blue dot on the end of the core wire indicates a corrected core wire**

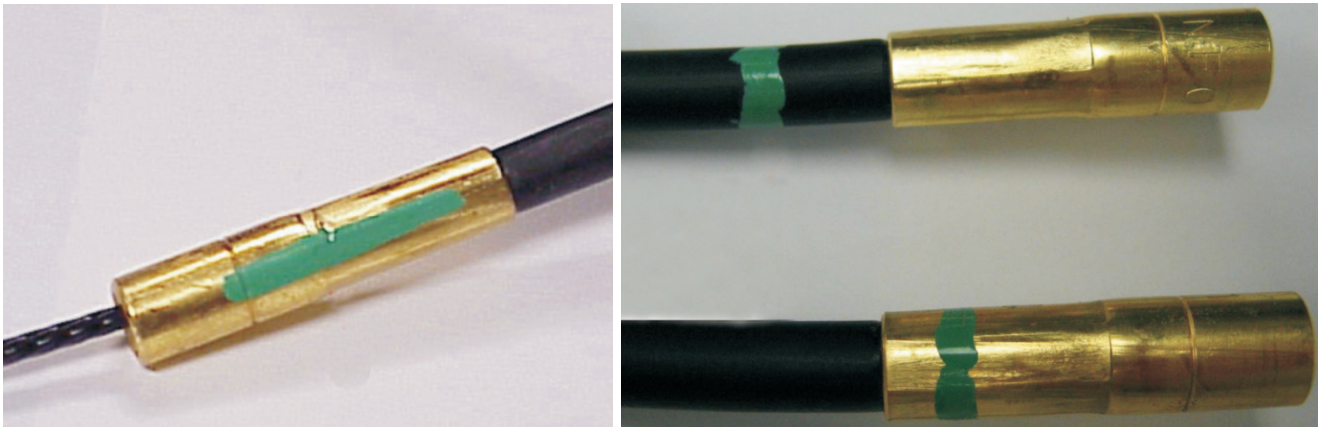
45171

Corrected cables have been marked on the outer housing at the engine end to signify that the inner core wire has been changed.

**Various markings to indicate a corrected cable**

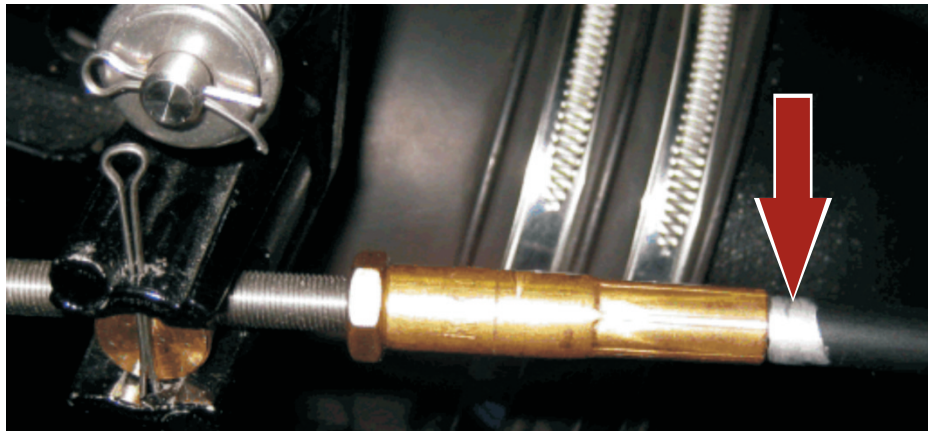
45170

Boat builders have been painting a silver stripe around the cable behind the brass ferrule at the engine end of the cable to signify that the inner core wire has been changed. Regardless of the color used on the outer cable housing, the inner core wire is identified with a green or blue paint dot on the end.
