## Official Recall Notification Under the U.S. Federal Boat Safety Act

# Replacement of the Core Wire of the Intermediate Shift Cable on Mercury MerCruiser Alpha and Bravo Sterndrives

Revised May 2012. This bulletin supersedes the previous bulletin number 2010-11R1 August 2010.

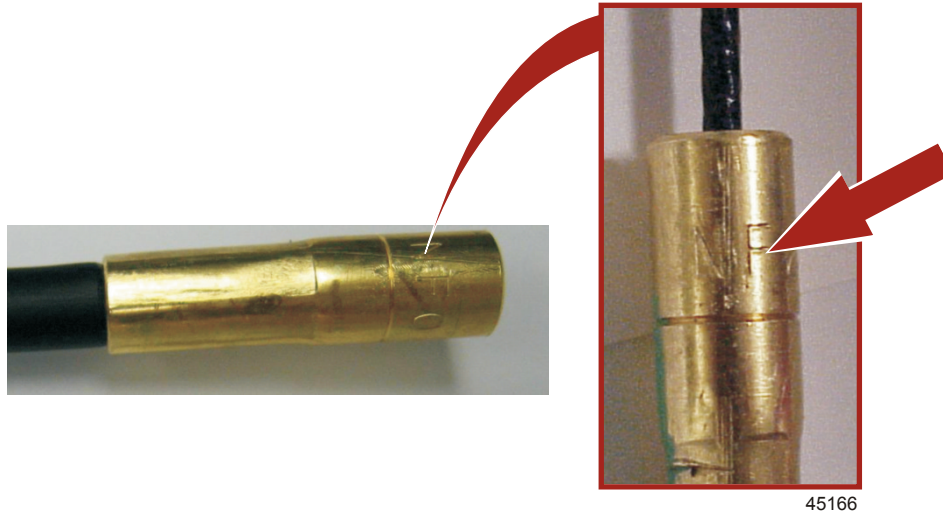
Date code stamp

To determine whether a replacement shift cable is affected by this recall, find the cable date code stamped on the barrel of the cable jacket on the shift-bracket end of the cable.

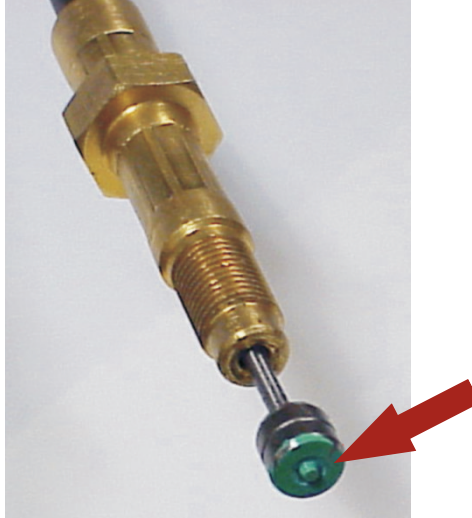
45159

**Green or blue dot on the end of the core wire indicates a corrected core wire**

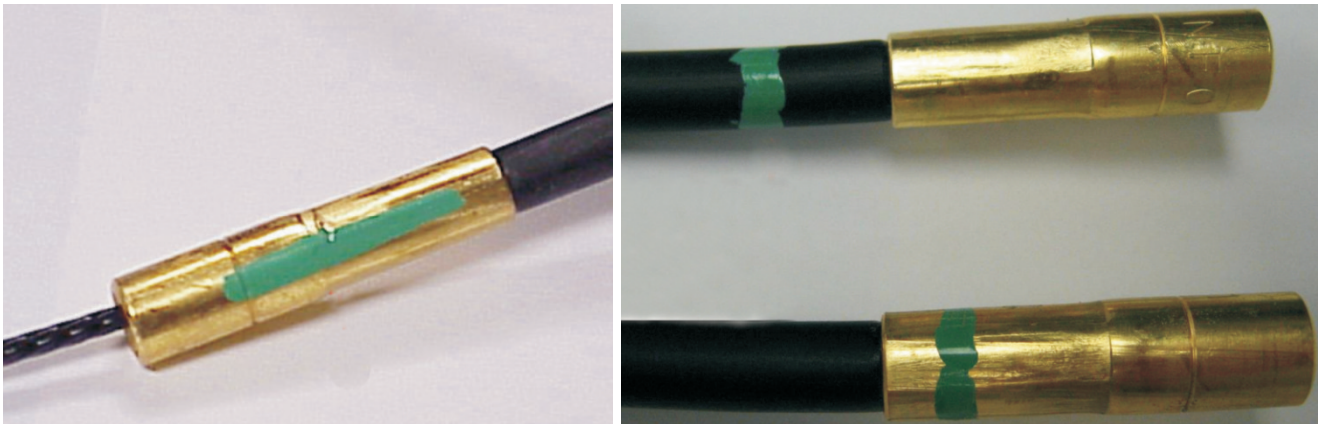
45171

Corrected cables have been marked on the outer housing at the engine end to signify that the inner core wire has been changed.

**Various markings to indicate a corrected cable**

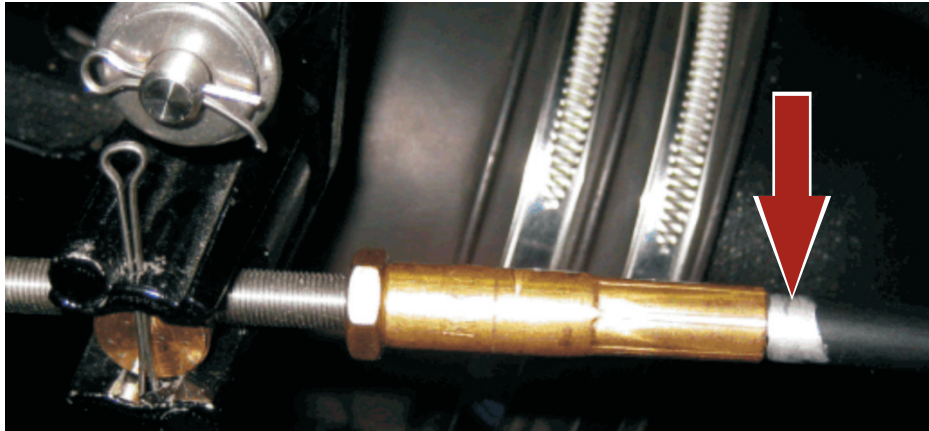
45170

Boat builders have been painting a silver stripe around the cable behind the brass ferrule at the engine end of the cable to signify that the inner core wire has been changed. Regardless of the color used on the outer cable housing, the inner core wire is identified with a green or blue paint dot on the end.
