Official Recall Notification: U.S. Federal Boat Safety Act

Possible Incorrect Routing Causing Pinched or Chafed Wires on 3.0 MPI Engine Harness

Models Covered	Serial Numbers
3.0 MPI Models	1A072812-1A650359

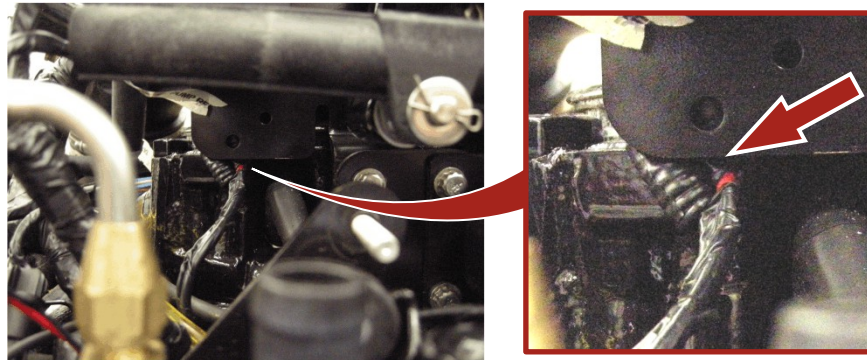
48253

2. Inspect the harness below the shift plate mounting bracket for incorrect routing.

Incorrect routing of harness—behind bracket

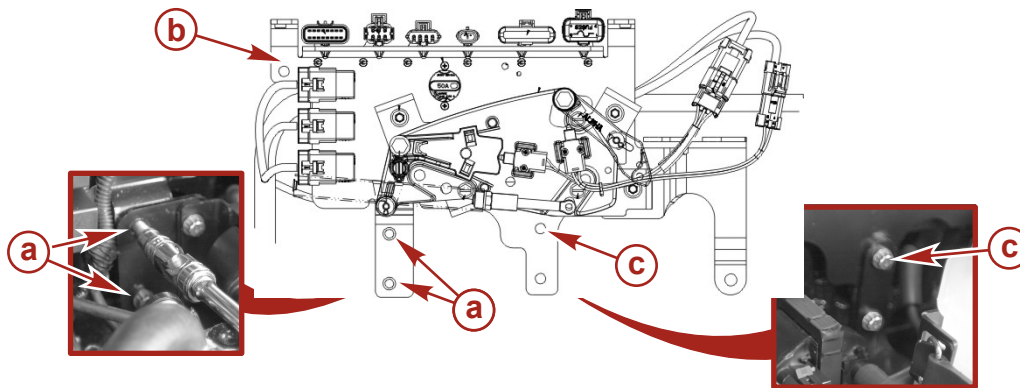
48289

Bracket shown removed for clarity

- a - Rear mounting screws (2)
- b - Rear upper mounting screw (1)
- c - Front lower mounting screw (1)

3. If the harness is routed incorrectly and pinched behind the shift plate mounting bracket, loosen the mounting bracket screws identified below.

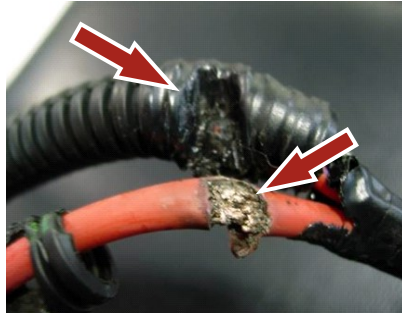
48288

7. If the harness was pinched and the insulation is damaged or revealing bare copper wire:

Example of damaged insulation and bare wire

- a. Replace the complete engine wiring harness. Order the part number listed in **Replacement Parts**.
 - b. Route the wiring harness to match the routing of the harness in step 8.
8. For a harness that shows no damage, prevent damage to the harness by ensuring that the harness is not routed behind the bracket where it could be pinched or chafed through the insulation.

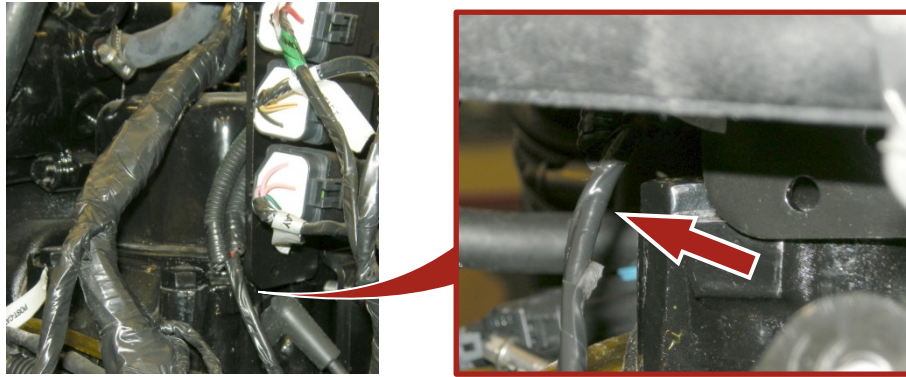
48257

Correct routing of harness—not behind bracket

9. Tighten the two mounting plate screws to specification.

Description	Nm	lb-in.	lb-ft
Mounting plate screws	11.3	100	–
