Crankshaft Position Sensor Connection

Worldwide

Models Covered	Serial Number
MCM 5.0L, 5.7L (350 MAG), and 6.2L (377 MAG) DTS ECT engines (including Axis)	1A300000–1A653330
MIE 5.7L and 6.2L DTS ECT engines	1A090000–1A092904

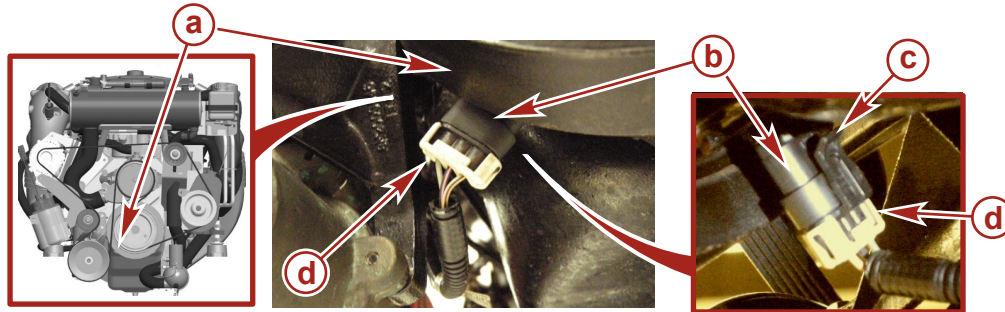
48709

2. Disconnect the engine wiring harness connector from the crankshaft position sensor (CPS) receptacle near the torsional damper.

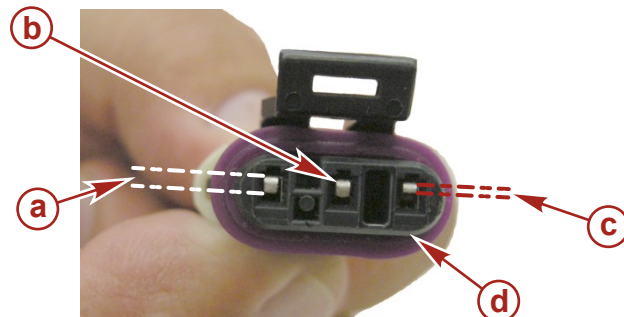
Comparing terminal ends

3. Inspect the three female terminals in the sockets of the engine wiring harness connector.
 - a. Turn the harness connector so you can see the mating end of the connector body.
 - b. Note the size of the female terminal ends visible in the opening of the connector's sockets—A, B, and C. The female terminal ends must nearly fill the socket opening and be the same size. Compare the properly formed (wide) female terminal ends (sockets A and B) with an improperly formed (narrow) terminal end socket C).

- a** - Properly formed (wide) terminal end—socket A
- b** - Properly formed (wide) terminal end—socket B
- c** - Improperly formed (narrow) terminal end—socket C
- d** - Harness connector

4. If one or more of the female terminals in the sockets appears smaller, disassemble and repair (bend) the terminal, or terminals, back into their correct shape or replace the connector using the CPS replacement connector and wire kit.
