## Field Campaign on 8.2 Sterndrive ECT Engines

Mercury Marine has determined that some 8.2 Sterndrive Emission Control engine models within the Models Affected serial number range may experience a hydraulic lock after hard running conditions and keying off. This situation may prevent the engine from restarting and could damage internal engine components.

An exhaust elbow inspection, and replacement when required, coupled with the installation of the vent valve assembly are corrections intended to prevent the hydraulic lock situation.

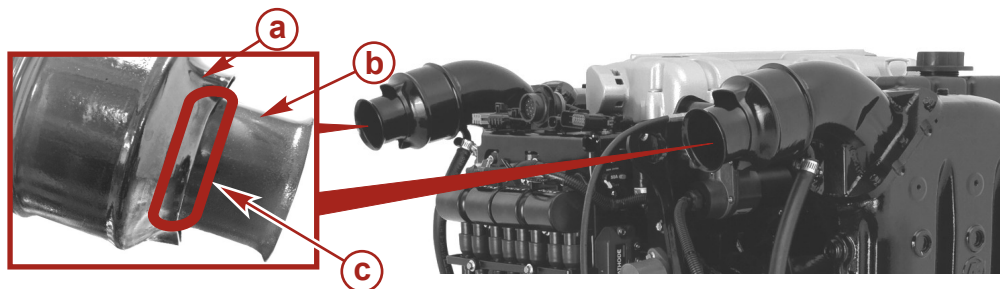
47849

**a** - Outer tube  
**b** - Inner tube  
**c** - Measurement area (both sides)

4. Attempt to insert a 0.020 in. (0.5 mm) feeler gauge between the inner tube to outer tube area.

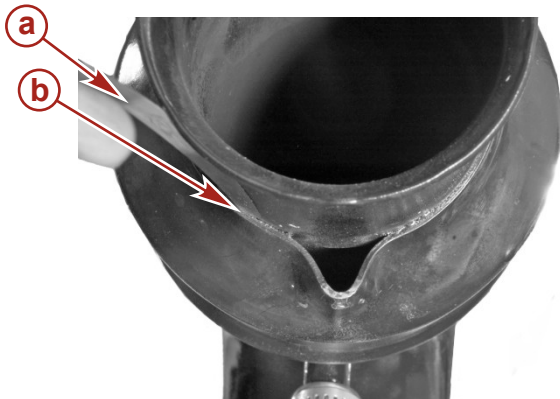
**Acceptable (no action)**

- **The exhaust elbow is acceptable:** If the feeler gauge does not go between the inner and outer tube of the exhaust elbow. Reassemble exhaust bellows and torque clamps.

- a - Feeler gauge 0.020 in. (0.5 mm)
- b - No gap (acceptable)
- c - Gap larger than feeler gauge (unacceptable)

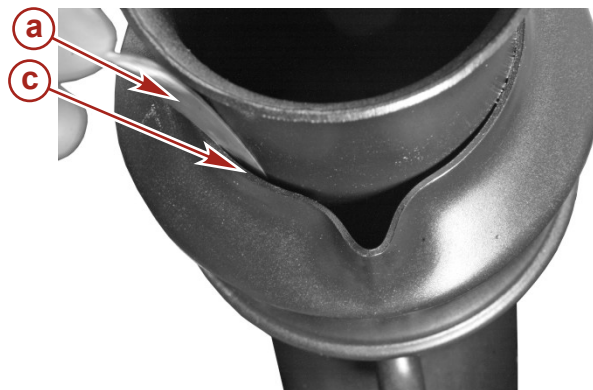
**Unacceptable (replace elbow)**

- **The exhaust elbow is unacceptable:** If the feeler gauge goes between the inner and outer tube. Replace the exhaust elbow.

Qty.	Description	Part Number
1 per elbow replacement	Exhaust Elbow 0" Riser	8M0058471
	Exhaust Elbow 2" Riser	8M0058472
	Exhaust Elbow 4" Riser	8M0058473
	Exhaust Elbow 6" Riser	8M0058474

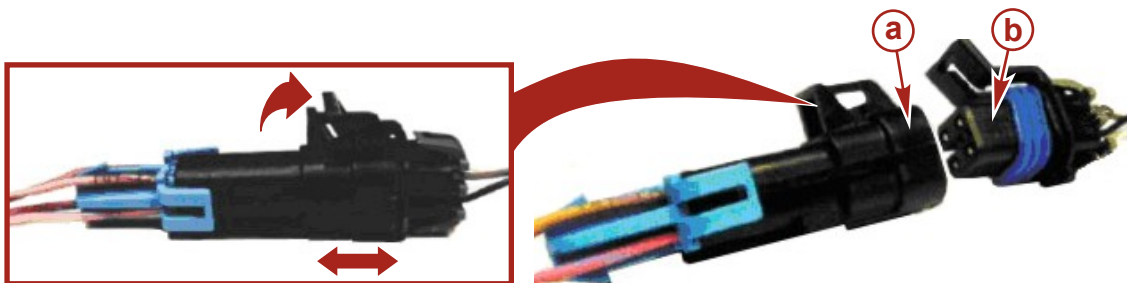
**Pre-exhaust and post-exhaust oxygen sensor**

2. Inspect each sensor and engine harness connector for evidence of condensation (moisture), corrosion, or damaged terminals and sockets. See image below.
3. If condensation is present, carefully use low-pressure compressed air to dry out both the male and female connectors.
4. Clean the pins and sockets using rubbing alcohol and a standard Q-tip (obtained locally) and then air dry.
5. Carefully inspect each pin and socket for corrosion or damage.
6. If damage is present, replace the sensor or harness as necessary.
7. If corrosion is present on any sensor pin, replace that oxygen sensor.
8. If light to moderate corrosion is present on any oxygen sensor connector, it can be removed as follows:
  - a. Locate the pink female terminal adapter (J-35616-5) from the CDS Terminal Adapter kit (SPX P/N MM-46523)

**IMPORTANT:** If light to moderate corrosion is present on any engine harness connector or sensor, and cannot be removed with the cleaning process. Replace the sensor or wiring harness as needed.

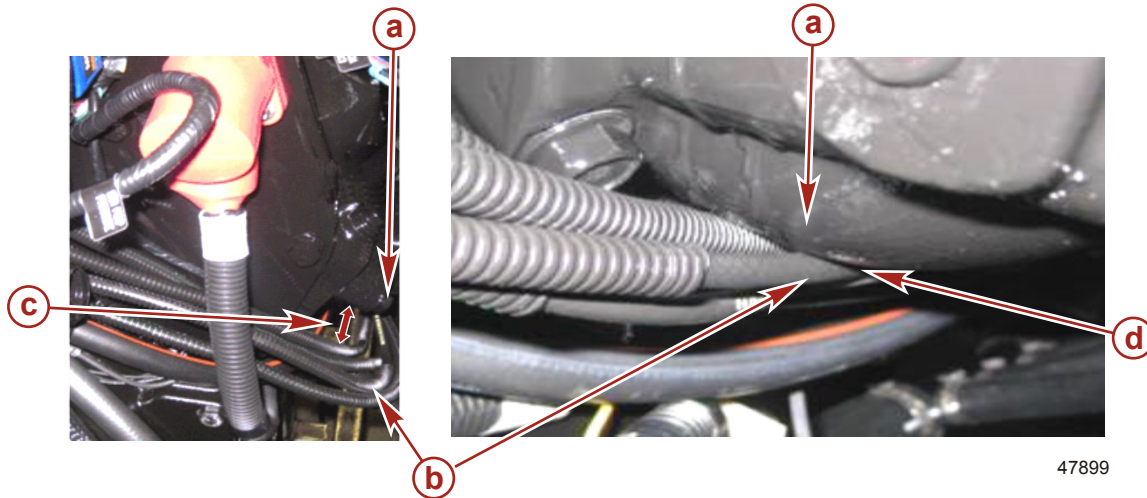
**Spark plug wires correct clearance**

2. If the spark plug wires contact the exhaust manifold, remove and inspect each wire for damage and replace as necessary.

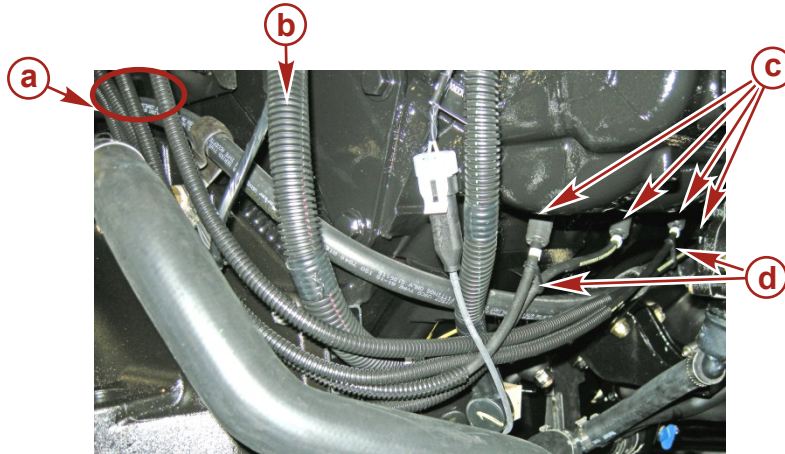
**Spark plug wires typical routing**

3. Route the spark plug wires to ensure an air gap exist between the exhaust manifold and wires.  
**IMPORTANT: The spark plug wires must have clearance from the exhaust manifold to prevent heat damage.**
