Power Steering Reservoir Hose Leak

Models Covered	Serial Number
All Sterndrive ECT 8.2 Liter Engines	2A041665–2A180547

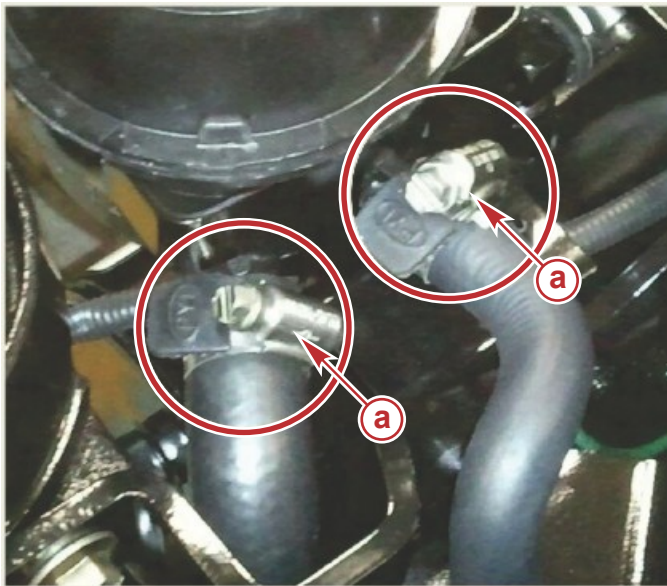
53564

Mercury MerCruiser has observed power steering fluid leaking from the return hose at the power steering reservoir on some engines. This is due to mispositioned or loose hose clamps.

a - Power steering reservoir clamps

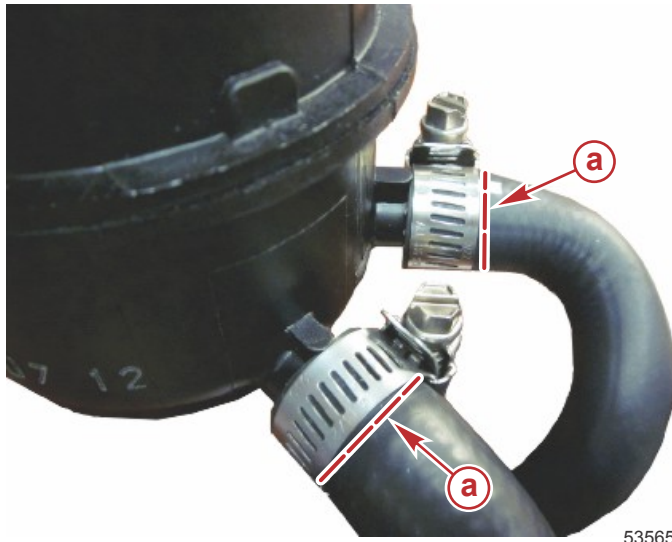
53565

a - Barb

Inspect the power steering reservoir hoses during predelivery inspection (PDI) or when servicing 8.2 ECT sterndrive engines within the above serial number range. The hose clamp position must be forward of the reservoir's barbed fitting, and the clamp must be torqued.

Description	Nm	lb-in.	lb-ft
Hose clamp	4	35	-
