Service Bulletin

Bulletin No. 2014-68 OEM No. 2014-66
Circulate to:	Sales Manager	Accounting	Service Manager	Technician	Parts Manager

Official Recall Notification United States Federal Boat Safety Act —Mercury Diesel 3.0L Tier III Turbocharger Oil Supply Line Update

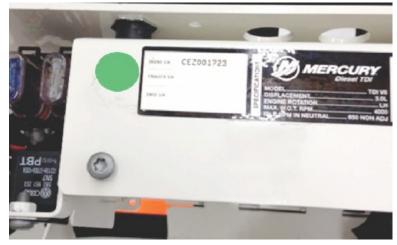
57251

Green dot showing that rework has been performed

Engines reworked by the factory or by an authorized dealer will have a mark indicating that the rework has been performed. With the engine removed from the shipping container, or installed in a boat the rework identification will be a green dot placed to the left of the serial number decal.

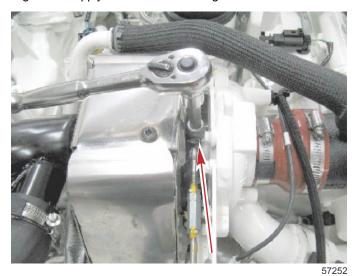
Banjo bolt being removed

4. Remove the banjo bolt securing the oil supply line to the turbocharger.

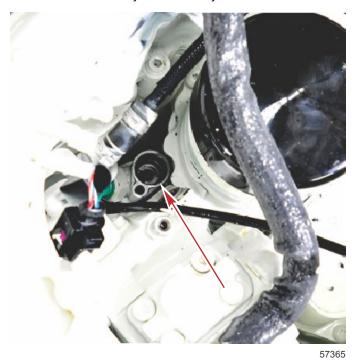
Oil line port with components removed for clarity

- 10. Remove the turbocharger oil supply line from the cylinder block.
 - a. To protect the engine from contamination by dirt or paint particles when installing the new line, a plug is included in the kit to close off the port. Using a flexible claw pickup tool, insert the supplied plug into the oil line port, as shown as soon as the oil line has been moved sufficiently out of the way.

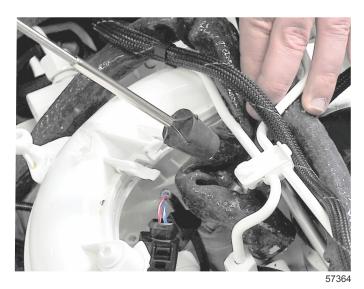
Plug being lowered

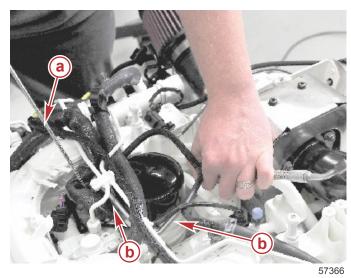
- a Mechanical fingers maintaining position of port plug while the oil line is being maneuvered
- **b** Turbocharger oil line being installed

13. Reinstall the oil supply line onto the engine. As with removal of the old line, it may be necessary to rotate the line during installation. Install the oil supply line from the engine by maneuvering the flange of the oil supply line between the oil filter canister, injection pump, and fuel supply lines.

IMPORTANT: Do not remove the oil port plug until it is necessary to attach the oil line. Contaminants may have been loosened while maneuvering the oil line.
