Service Bulletin

Bulletin No. 2015-06
OEM No. 2015-05

Official Recall Notification U.S. Federal Boat Safety Act: #6 Fuel Injector and Water-Separating Fuel Filter Require Inspections

4.5L Sterndrive Engines

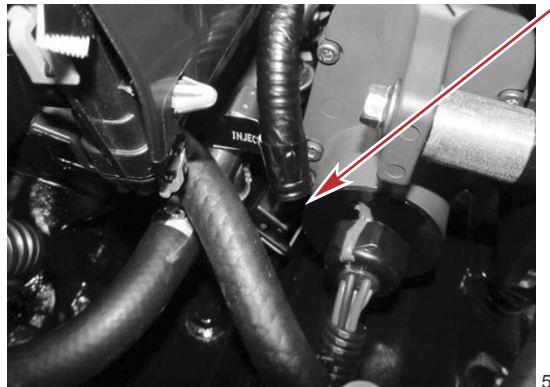
58802

1. Visually inspect DTS units to ensure that the injector connector is free and not bound by the actuator housing. The injector should rotate freely from the 6 o'clock position to the 8 o'clock position.

With the injector connector at the 6 o'clock position, it can bind against the actuator housing. Ensure that it is free to turn to the 8 o'clock position.

2. If the injector is found to be bound, loosen the shift bracket assembly from the exhaust manifold and reorient (rotate) the fuel injector to the 8 o'clock position.

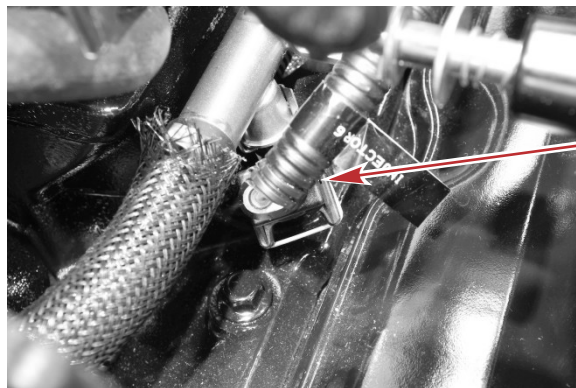
58803

Injector connector positioned at 8 o'clock

3. Tighten the fasteners for the shift bracket assembly to the specified torque.

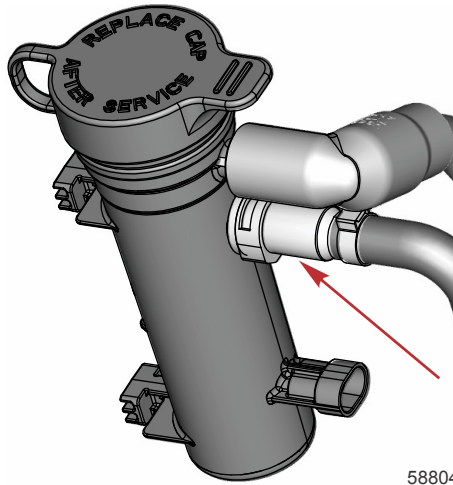
Inspect the water-separating fuel filter housing inlet fuel line connection for wetting or leaks. The fuel line is attached via a quick-connect fitting, which allows easy removal if further investigation is needed.

Fuel inlet with quick-connect fitting

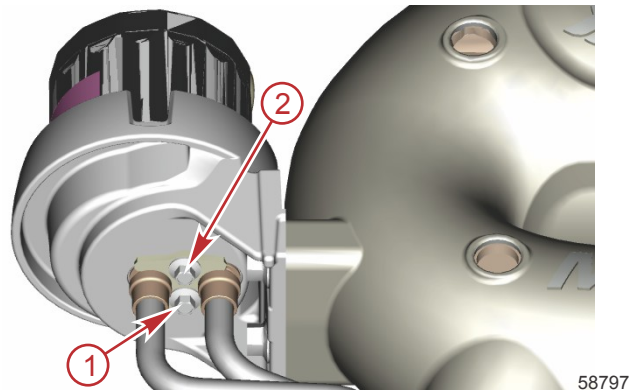
Torque sequence for oil line retainer fasteners at the oil filter

Tighten the fasteners on the oil line retainers at the remote filter base and cylinder block locations to the specified torque, following the indicated torque sequence.

Description		Nm	lb-in.	lb-ft
Oil line retainer fasteners	First Pass	13	115	–
	Final Pass	13	115	–

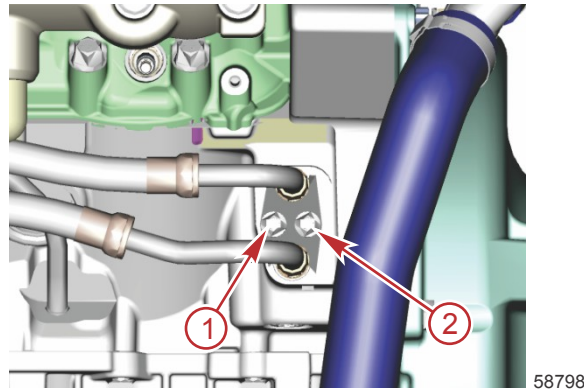
Torque sequence for oil line retainer fasteners at the block

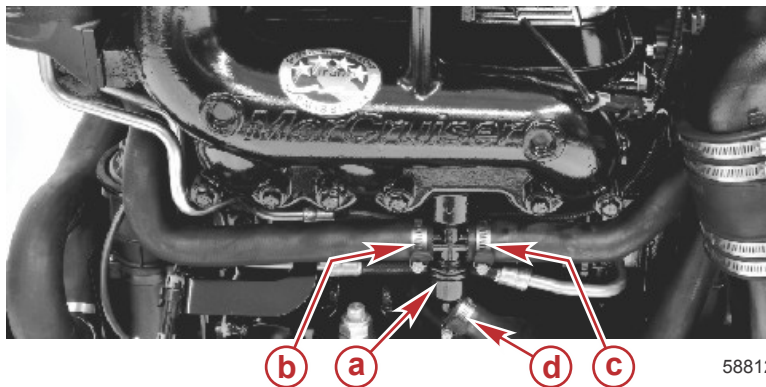
Port side shown, starboard similar

- a - Drain valve assembly
- b - Seawater cooling hose - disconnect
- c - Seawater cooling hose - disconnect
- d - Seawater drain hose - disconnect

3. Remove the drain valve assemblies from the exhaust manifolds. Discard the drain valve assemblies.
4. Install new drain valve assemblies into each manifold by turning them until they are hand-tight. Tighten the assemblies an additional 2-1/2 to 3-1/2 turns. The assemblies should be parallel to the manifold, and the drain (bottom plastic fitting) should angle toward the rear of the engine.
5. Attach the three hoses to each of the drain valve assemblies and secure them with hose clamps. Tighten the hose clamps to the specified torque. Install the retained hose clamp covers onto the hose clamps.

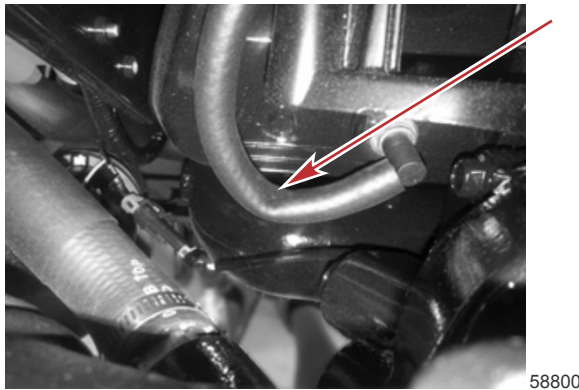
2. Inspect the PCV hose for kinks that restrict proper ventilation.

Kink in PCV hose

3. If a kink is found, remove the hose from the PCV valve, and reduce the length such that it reaches the valve but does not kink.
4. Reinstall the hose.
5. Install the outside engine cover.
