Service Bulletin

Bulletin No. 2015-08
OEM No. 2015-07

MCM 3.0L MPI EC Battery Cable Routing

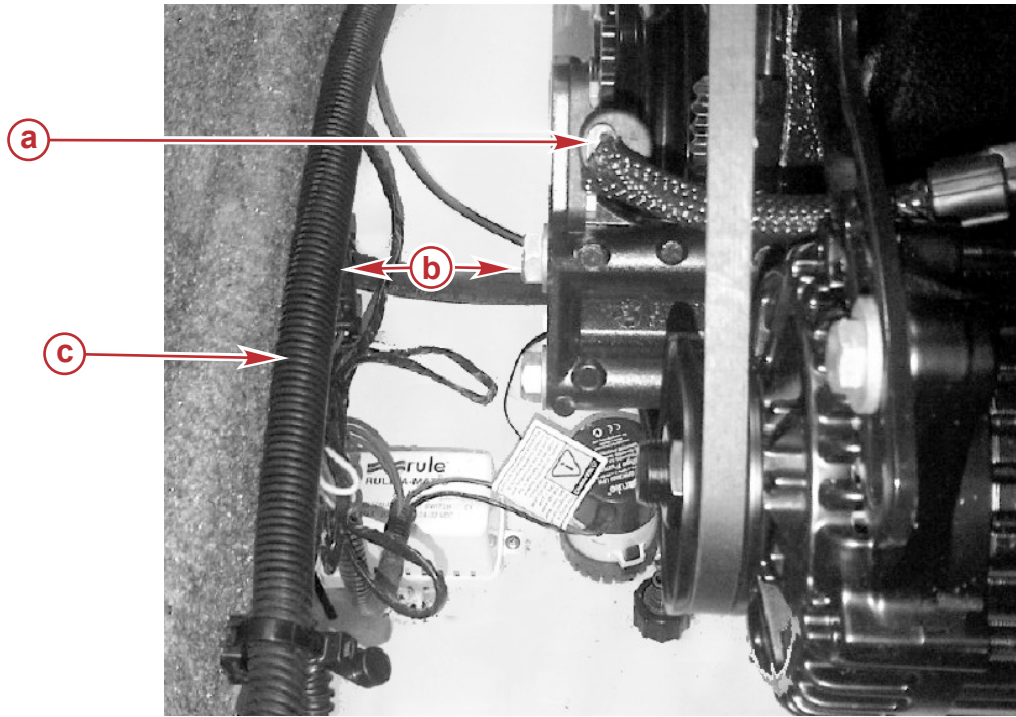
58773

An electromagnetic field is created when current passes through large-gauge current-carrying cables. If these cables are located too near the crankshaft position sensor, they will affect the sensor's signal and adversely affect engine performance. Therefore, engine battery cables and other large-gauge current-carrying cables must not be routed closer than 46 cm (18 in.) to the front of an MCM 3.0L MPI EC engine. Cables mounted closer than this to the crankshaft position sensor will result in engines failing to start, misfiring, or performing poorly.

Note that attaching a ground cable to the front of the engine will position it closer than the required minimum distance of 46 cm (18 in.) from the crankshaft position sensor, and will result in the engine failing to start, misfiring, and performing poorly.

- a** - Crankshaft position sensor
- b** - Required minimum distance between the front of the engine and the battery cable: 46 cm (18 in.)
- c** - Battery cable

When diagnosing a running issue on a MerCruiser 3.0L MPI EC engine with one of the symptoms listed above, ensure that both the positive and negative battery cables are at least 46 cm (18 in.) from the crankshaft position sensor or the front of the engine. Also, ensure that the battery ground cable is attached to the rear of the engine on the ground stud. Refer to the installation manual or service manual for identifying the proper location.

Additionally, the negative and positive battery cables should be routed together (paired) when possible to balance and reduce the disruptive effects of either cable's electromagnetic field.
