service bulletin

No. 98-1

Power Trim Piston/Rod Replacement P/N 43397A6

1998 150 - 225 HP Pro Max/Super Magnum 2.5L &
1998 300 Pro Max/Super Magnum 3.0L

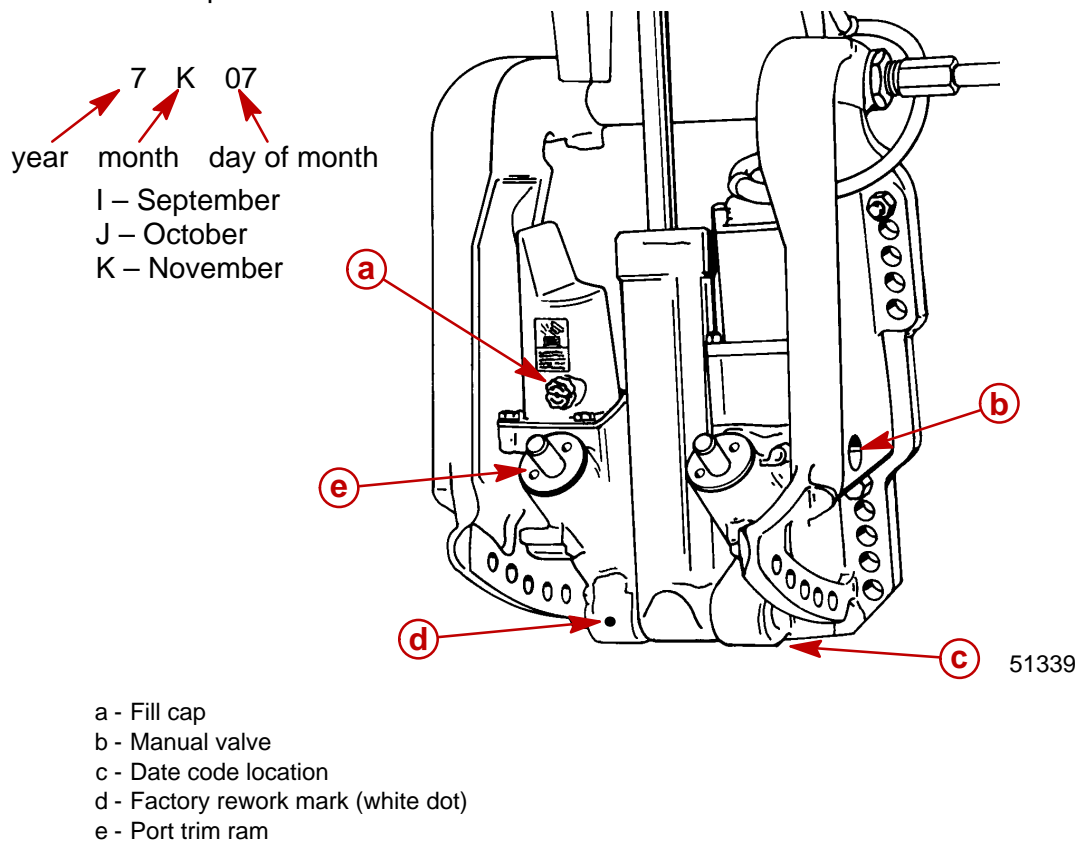
Date code explanation:

Any engine that **DOES NOT** have the factory rework marking, should have the anode assembly removed from the power trim, to inspect for affected date codes. Affected date codes are 7I02 thru 7K07. Power trims with date codes that are not in the affected range do not require trim piston/rod replacement.

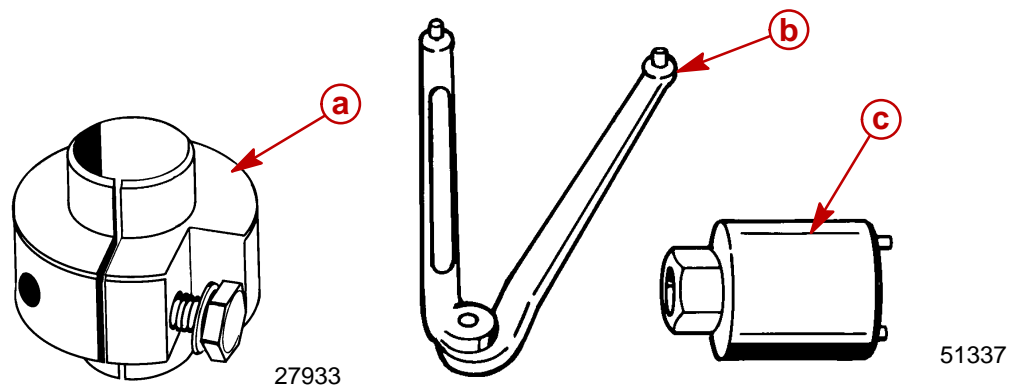
- a - Trim rod removal tool (91-44486A1)
- b - Spanner Wrench (91-74951)
- c - Cap removal tool (91-44487A1)

Loosen the port side trim rod cylinder cap using spanner wrench (91-74951), or cap removal tool (91-44487A1) . Before removing , clean any dirt or loose paint chips from around cap area.

Install trim rod removal tool (91-44486A1) and pull trim piston/rod assembly from cylinder.
