## TPI LOOSENING DURING ENGINE OPERATION

All Mercury Hi-Performance 300 Pro Max/Super Magnum engines.

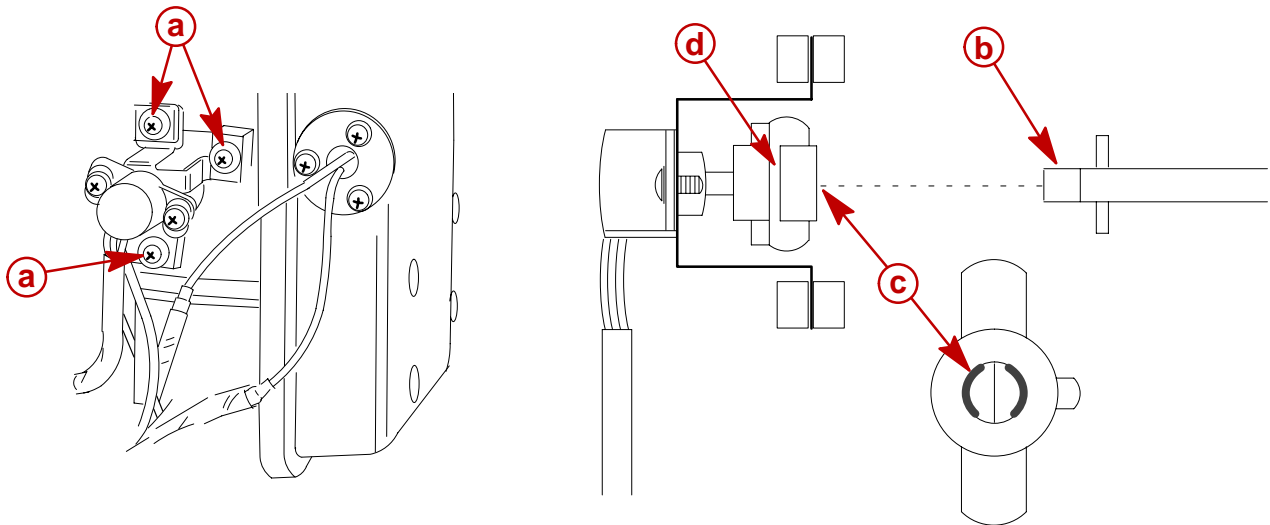
TPI setting may change during operation causing a rich or lean condition to occur.

1. Remove TPI assembly from fuel management system secured by (3) screws (a).
2. Clean throttle shaft (b) and inside of coupler (c) with a commercial cleaning solvent.
3. Apply Loctite #404 quickset to inside of coupler (c).
4. Slide coupler (c) over throttle shaft (b) and wipe off any excess Loctite.

**IMPORTANT:** When inserting coupler onto throttle shaft make sure the center portion of the coupler (d) does not glue together.
