Fleet Master Gear Case Change For 300 Pro Max

All 1999 1/2 model year 300 Pro Max engines with the model code ending in **9H**.
Example: 1930311**9H**

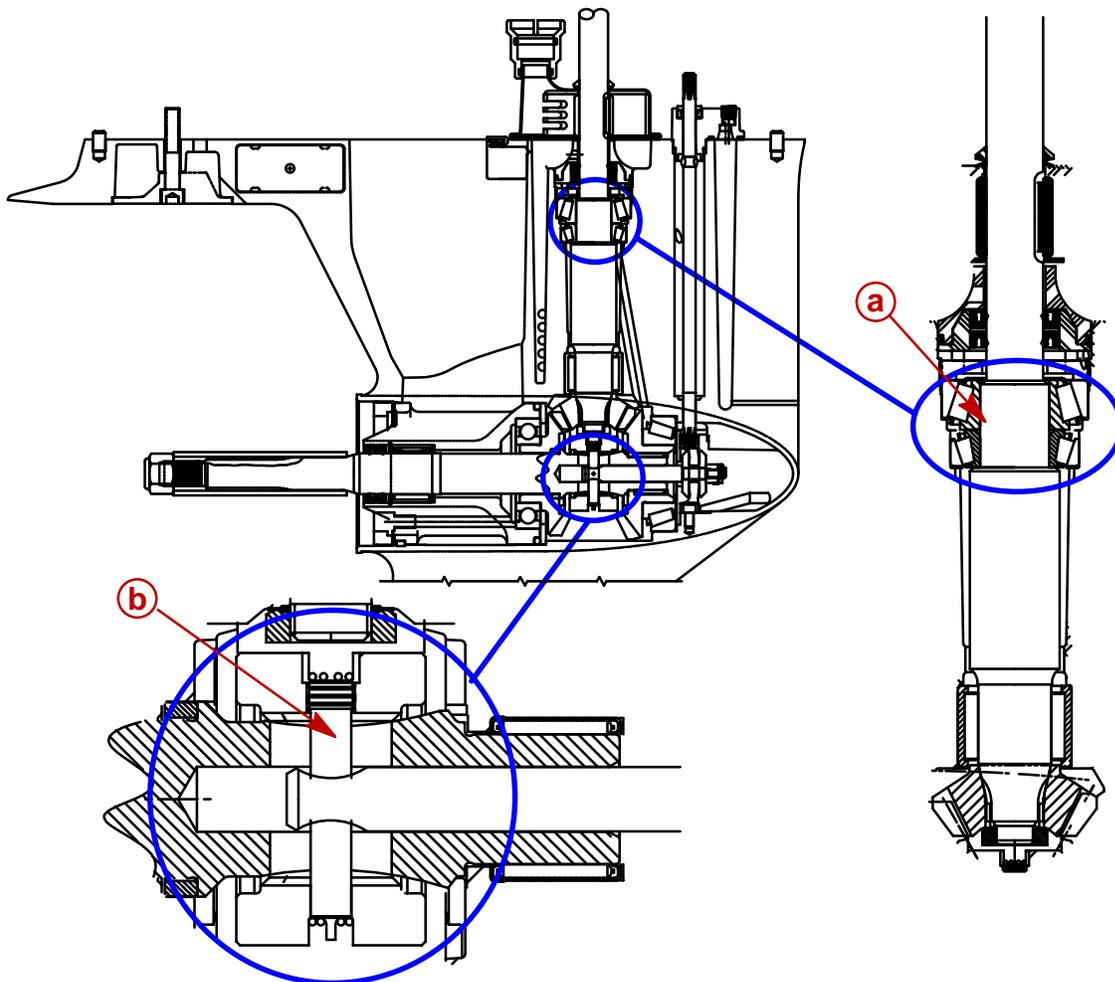
1. Double upper driveshaft bearings (gear housing is also modified to accept double bearing)
2. Screw-in style clutch pin

- a** - Double Upper Driveshaft Bearings
b - Screw-In Style Clutch Pin

The single bearing driveshaft gear housing can be superceded by the double bearing drive-shaft gear housing.

Sliding clutches are interchangeable between single and double style bearing gear cases.

Single bearing drive shafts can be used as is in double bearing gear cases.

Double bearing drive shafts can not be used in single bearing gear housings, however single bearing drive shafts will remain available as a service part.

Use the service repair procedures in the 300 Pro Max/Super Magnum Service Manual P/N 90-849372, Section 6A (Torque Master Gear Housing).
