## Shift Link 3.0 Litre

MERCURY RACING 3.0L OUTBOARDS

1999/2000 Model Year

Mercury Marine  
Mercury Racing Service Bulletin 2000-7  
W6250-9A Pioneer Road  
Fond du Lac, WI 54935

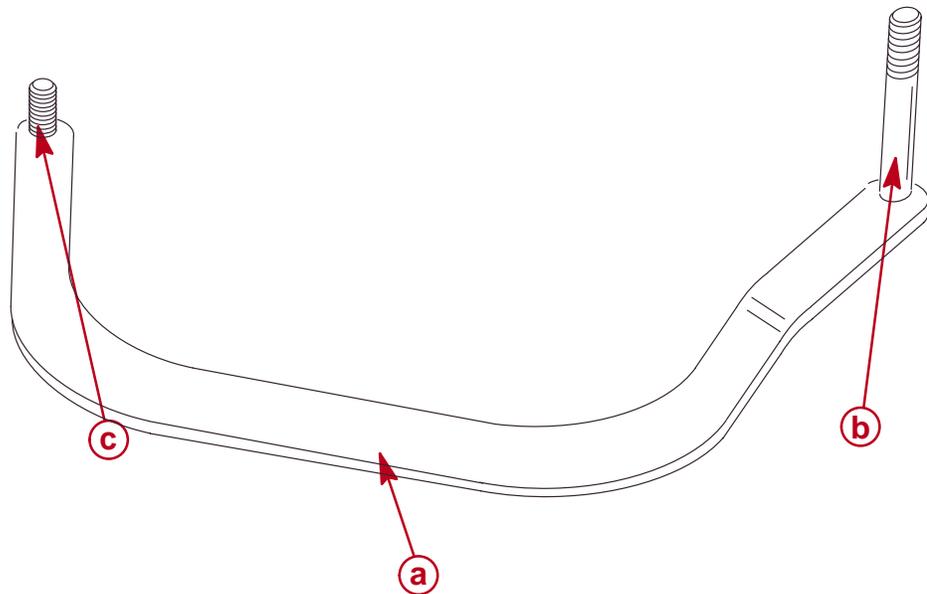
Some shift links may have insufficient weld penetration between the bracket and shift cable attaching stud. This could result in possible attaching stud breakage and loss of shift control.

- a** - Shift Link Bracket
- b** - Control Cable Attaching Stud
- c** - Shift Link to Upper Shift Shaft Attaching Stud

**If engine is within the above serial number range, replace the shift link using the following steps.**

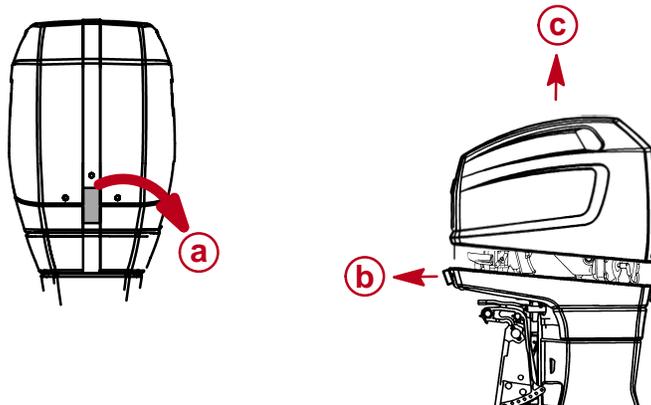
- a** - Rotate rear latching handle clockwise.
- b** - Pull out on front latching handle and at the same time lift front of cowl.
- c** - Lift cowl from engine

- Remove upper cowl.

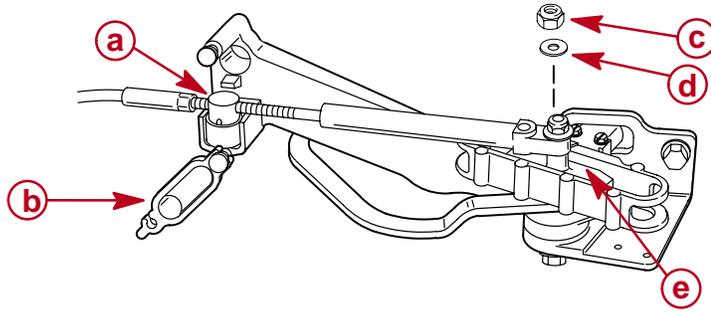
- a** - Cable Barrel
- b** - Shift Cable Retainer
- c** - Locknut
- d** - Washer
- e** - Shift Slide

- Remove the nut, washer, shift cable, and shift roller from the rear shift link attaching stud.

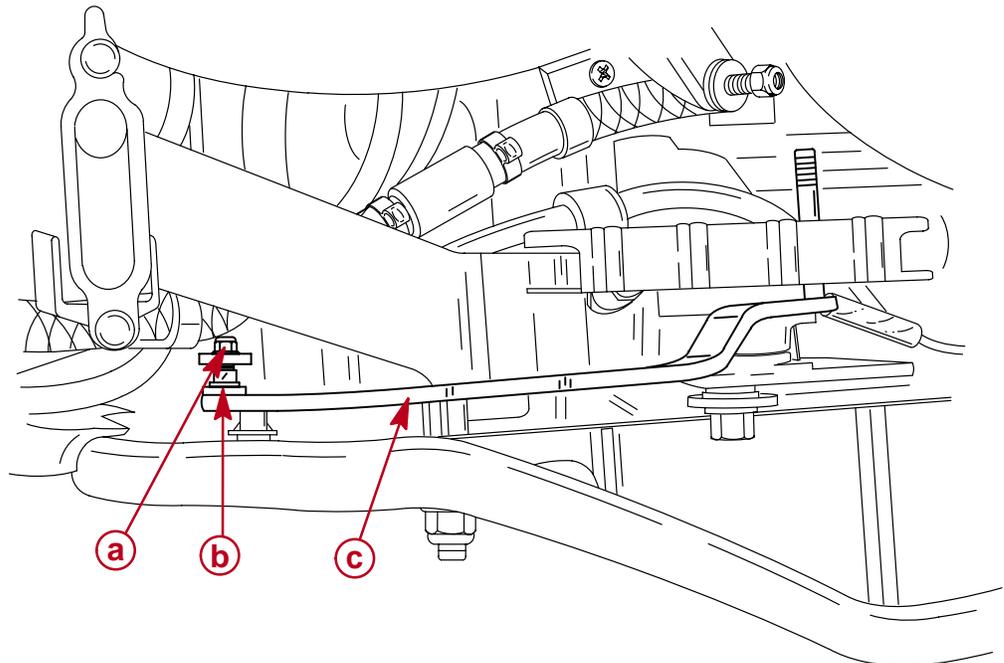
**NOTE:** The view below is shown with the front Nylock retainer nut loose and plastic bushing **NOT** engaged into the upper shift shaft.

- a** - Nylock Nut - Shift Link To Upper Shift Shaft
- b** - Plastic Bushing
- c** - Shift Link Assemble

- Remove the nylock nut that attaches the shift link to the upper shift shaft, retain nylock nut and plastic bushing to be reused on the replacement shift link.

- Install shift link into upper shift shaft, taking care that plastic bushing enters the shift shaft correctly. Install the nylock nut and drive tight.
- Reinstall shift roller, shift cable, washer, and nylock nut.
- Reinstall top cowl.
