SERVICE INFORMATION

Correct Spark Plug Gap for 300X Pro Max

All 2001 Model Year 300X Pro Max Engines

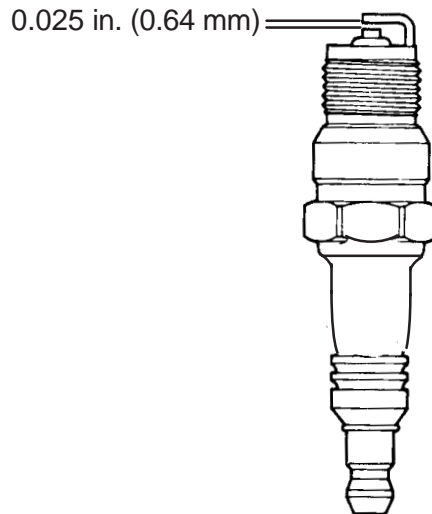
The spark plug gap specification is incorrect on the emissions sticker attached to the engine and in the Operation, Maintenance and Warranty Manual. The incorrect gap is 0.035 in. (0.89 mm), which is too wide.

The correct spark plug gap for the 300 X Pro Max is 0.025 in. (0.64 mm). When checking or installing spark plugs, set the gap at 0.025 in. (0.64 mm).
