Mercury 4000 Series Panel Mount Control - Pistol Grip

Models Affected

Mercury Marine has identified a potential problem with the manufacturing of the 4000 series pistol grip panel mount remote controls. The amount of force required to move the shift handle out of the "NEUTRAL" detent lock position without depressing the release button, in a very small percentage of these controls, was found to be below specification.

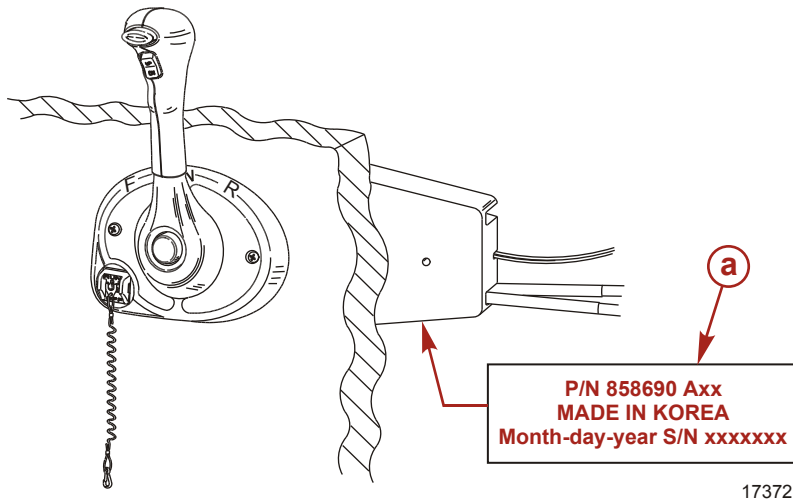
1. Have been installed in boats with the **last four digits** of the Hull Identification Numbers (HIN) between J000 (October, 2000) through F505 (June, 2005) are affected.
2. Have remote controls with dates of manufacture that are on the labels located as shown in the figure below between October, 2000 and May, 2005.

a - Label on bottom side of housing

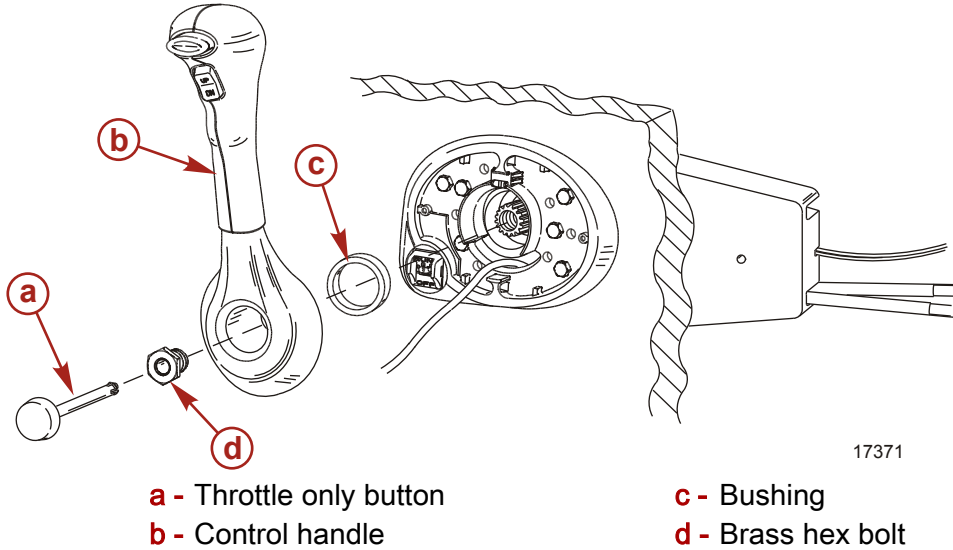
- e. If the handle lock functions properly, no further action is required.
4. If excessive free play is felt, it indicates that either the bolt that secures the handle to the control may not be fully seated or the bushing between the handle and bezel is missing. Either condition may allow the control handle to shift into gear without depressing the neutral release button while using minimal force. The excessive free play condition must be corrected before proceeding with any testing as described previously.

- a. Remove the throttle only button by:
 - Placing the control handle in the "NEUTRAL" position.
 - Push in the throttle only button.
 - Advance the handle forward to the first detent felt.

- Release the throttle only button and carefully pry it out. This exposes the hex head bolt in the bore of the handle.
 - b. Loosen the bolt approximately 1/4 turn. Then retighten the bolt and torque to specification. This should rectify the free play condition.

- c. If the free play still exists, remove the bolt. Remove the handle from the control and check to ensure the handle bushing is installed. If the handle bushing is not installed, purchase a new bushing (23-859016). Install the bushing and reinstall handle.
- d. Verify that the free play condition was rectified. Follow the procedures for the neutral lock test as described in Step 3. If the neutral lock functions properly, submit a warranty claim for **Inspection only**.

Description	Nm	lb. in.	lb. ft.
Hex head bolt	17	150

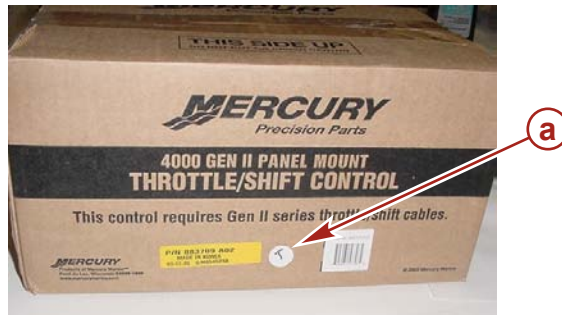
17483

Remote controls in the parts inventory must be checked for the part numbers as listed on the first page of this bulletin. All remote controls in the original unopened carton WITHOUT a white round sticker with a purple colored "T" on the part number label must be returned to Mercury Marine for credit. The purple colored "T" in the white round sticker indicates that the control was inspected and is able to be sold.

a - White dot with purple "T"

All controls that are in opened cartons should be inspected for the purple dot or two white dots on both the control handle and the bezel. If it is determined that they do not have the purple dot or two white dots, the handle and bezel should be replaced.
