Oil Injection Pump Sport Jet

Models Affected

1995 SPORT JET 90 & 120
S/N 0E125390 - 0E141088

1996 SPORT JET 95XR & 120XR
S/N 0E141089 - 0E200011

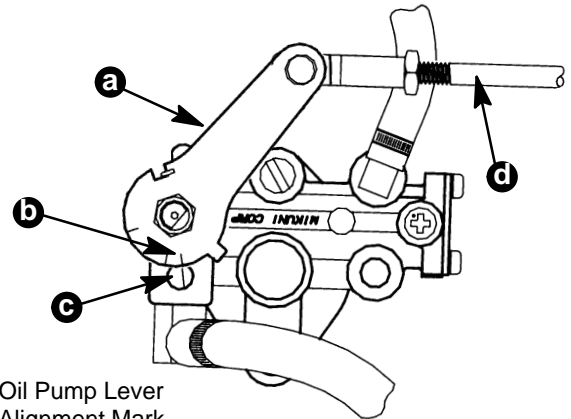
There have been sporadic reports of Sport Jet powerheads scoring pistons during the break-in period. Engineering had found that the oil injection pump has not been consistently adjusted to provide the correct ratio of oil at wide open throttle. Several engines were found where the oil injection pump was metering oil at 70:1 rather than 50:1.

This was caused by a change where the fixed wide open throttle stop was replaced by an adjustable stop. The adjustable stop was necessary to increase the idle timing to achieve the 1000 rpm idle speed with a closed throttle shutter. The closed throttle shutter is a requirement for the Turn Key Start feature.

1. Move towershaft to the Wide Open Throttle position. Inspect oil injection pump alignment mark (c) with the oil pump lever mark (b). This check may require the use of a small mirror.

- a - Oil Pump Lever
- b - Alignment Mark
(At Wide Open Throttle)
- c - Pump Alignment Mark
- d - Link Rod

To correct this potential problem, the procedure for adjusting the oil injection pump has been changed. The oil injection pump is now adjusted at wide open throttle position rather than at idle.

IMPORTANT: The oil pump adjustment must be made after all timing and synchronization operations have been performed.

2. Adjust oil pump link rod (d) to align the marks as necessary.
