## Mid Range Surging and/or Poor Acceleration 70 HP

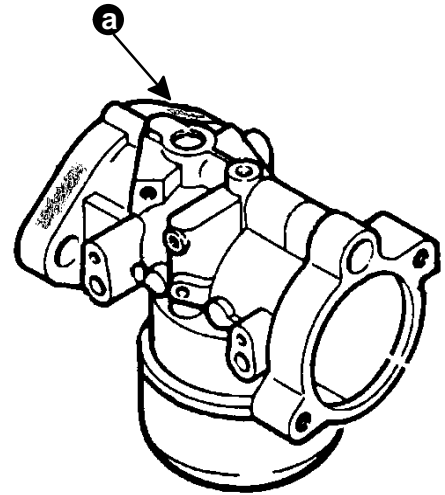
We have received reports on the 70 HP outboards where the engine surges between 3000 RPM and 4000 RPM. The problem was found to be in the machining of the carburetors. Check the part number on the carburetor mounting flange (a). If the part number is 749061 and the engine has this condition, the carburetor should be replaced. The part number for the replacement carburetor is 1300-826369.

If the engine is within the warranty period and this condition exists replace the carburetor and complete a warranty claim.
