Bearing Carrier Nut Low Torque – 90/120

1997 90/120

S/N 0E262167 thru 0E264177

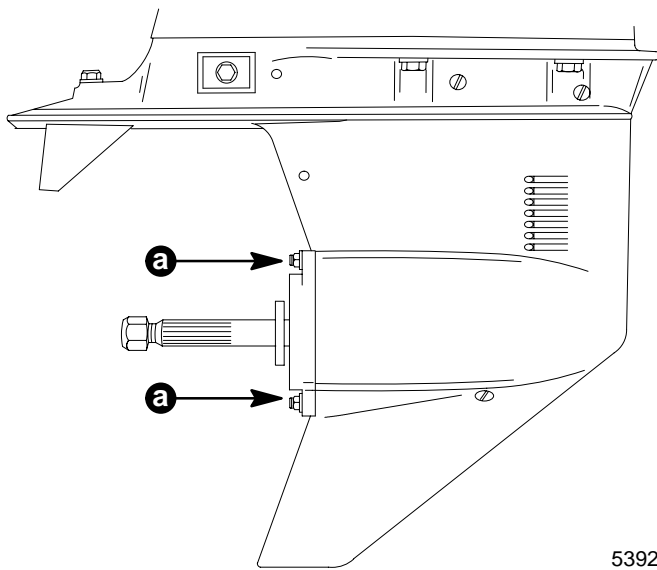
A small quantity of bearing carrier nuts on the models listed were torqued below specification during assembly. On these models, the bearing carrier may become loose and eventually fail the gearcase. It is necessary to retorque the bearing carrier nuts to the specified torque of 25 lb. ft. (33.9 N·m).

a - Nut Torque 25 lb. ft. (33.9 N·m)

Loosen each bearing carrier nut, one quarter turn, and retorque to 25 lb. ft. (33.9 N·m). Paint the end of the stud/nut white for repair identification.
