Reverse Gate Adjustment - Sport Jet 175 XR²

All Sport Jet 175 XR² Models

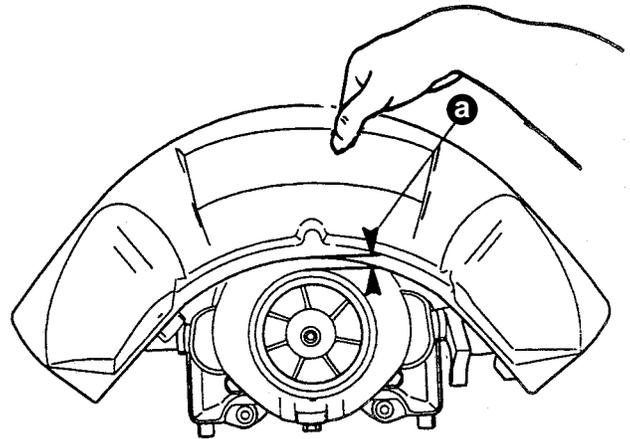
We have received reports from the field of failed reverse gate stops. Review of these failures indicate the cause was due to improper adjustment of the shift cable. If the lower edge of the reverse gate is not 3/8" (9.5 mm) to 1/2" (12.7 mm) above the edge of the steering rudder after removing the shift cable slack in the forward position, damage to the stops and reverse gate may occur.

a - 3/8" (9.5 mm) to 1/2" (12.7 mm)

To check shift cable adjustment, first shift the remote control lever into the forward position. Apply a light downward pressure on the reverse gate until all slack is removed from the shift cable. While maintaining the downward pressure to remove the cable slack, measure the distance between the lower edge of the reverse gate and the upper-most portion of the steering rudder (dimension "a" in figure below). This dimension should be between 3/8" (9.5 mm) to 1/2" (12.7 mm). If the clearance is less than 3/8" (9.5 mm), readjust the shift cable as outlined in the installation manual (P/N 90-10164970) or the service manual (P/N 90-852396).

If the clearance is within the specification, check the reverse gate forward stop adjustment.

If the cable slack is not sufficient to allow the reverse gate to move, adjust the forward stop to allow the specified movement. Refer to the installation or service manual for complete instructions.
