Bulletin No. 2002-07

RF Interference Between MotorGuide Excel Sonar-Ready Motors and Pinpoint Sonar Displays

All 2000-2003 MotorGuide Excel sonar-ready motors (model numbers EX82SP & EX109SP)

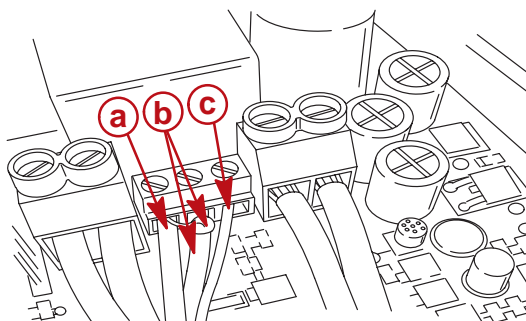
Under certain circumstances, RF interference may occur between the MotorGuide Excel motor and the Pinpoint sonar display.

- a** - 18 AWG PWM wire
- b** - 18 AWG return ground wire with .22 uf 50v capacitor
- c** - 24 AWG transducer ground wire

Should you encounter RF interference between the Excel motor and the Pinpoint sonar display, inspect the 24 AWG (0.8 mm²) white ground wire coming from the transducer to the TB3 green terminal block on the circuit board. There should be one 24 AWG (0.8 mm²) white transducer ground wire on terminal C, an 18 AWG white return ground wire on terminal B and an 18 AWG blue pulse-width modulation (PWM) wire connected to terminal A. Also inspect for the presence of the blue .22 uf 50v capacitor connected to terminal B with the white return ground wire and to terminal A with the blue PWM gate lead. The 24 AWG (0.8 mm²) white transducer ground wire must be connected to terminal C and the capacitor must be present. If the capacitor is damaged or missing it must be replaced. If the ground wire is missing, replace the magnet housing.
