No. 94-7

HOLLEY CARBURETOR IDLE IMPROVEMENT

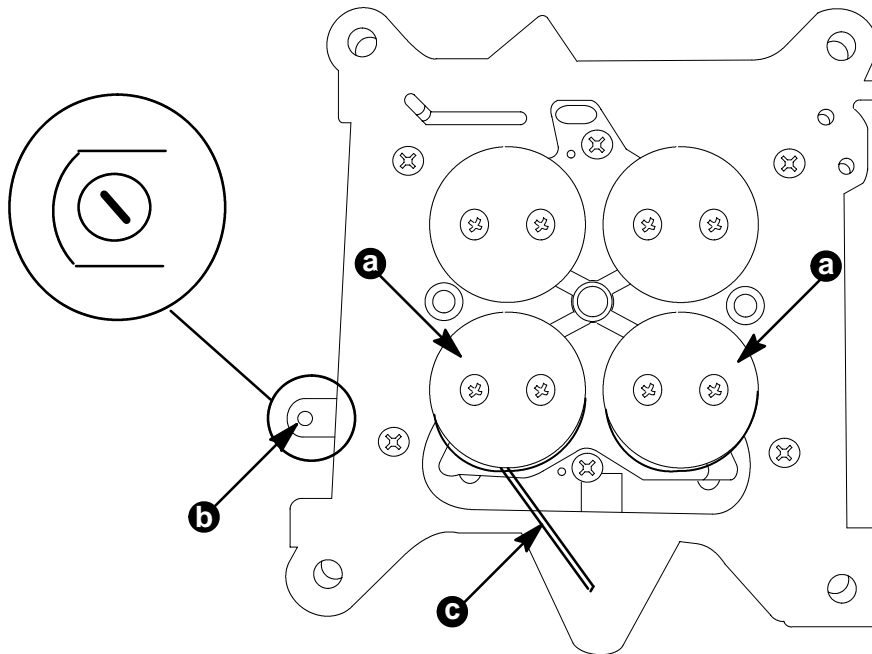
Periodically Mercury Hi-Performance receives complaints of rich running at idle. In many cases, re-adjusting the secondary throttle plates will improve this condition.

- S Remove carburetor from engine
- S Carefully drain fuel from float bowls into a proper container
- S Turn carburetor over and remove gasket if necessary
- S Insert a piece of wire .015" to .018" (.38mm to .46mm) thick between secondary throttle plate and secondary throttle bore

NOTE: The wire removed from a tie wrap measures about .017" (.43mm).

- S Turn adjusting screw until wire can be removed with a slight drag
- S Re-install carburetor with new gasket
- S Start engine and check for fuel leaks

- a - Secondary Throttle Plates
- b - Secondary Throttle Plate Adjusting Screw
- c - Wire-.015" to .018" (.38mm to .46mm) Gauge
