Ignition Module Overheat Condition

Models Affected;

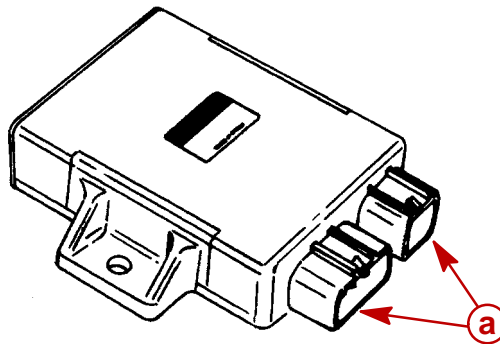
a - Thunderbolt V Module - Two Separate Connectors

Excessive internal ignition module heat may result in module failure.

Installation of an IGNITION MODULE HEAT SINK PLATE KIT 841868A1 which fits against the ignition module to help draw excessive heat away from the module.
