Service Bulletin

OEM No. 04-06

Sterndrive No. 2004-07

Correction to Installation Manuals

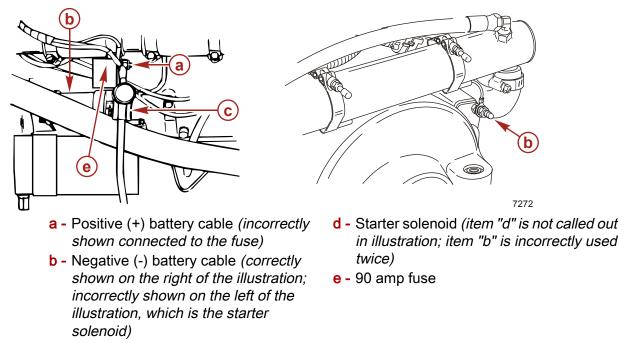
INCORRECT ILLUSTRATION

The following illustration used in the installation manuals for the above listed products, is incorrect. The positive battery cable connection to the engine's starter is incorrectly shown connected to the 90 amp starter fuse. Callout item "b", which is the negative (-) battery cable connection, is pointing to two places. On the right, it is pointing to the proper location. On the left, it is pointing to the starter solenoid. This is incorrect. Callout item "d" is not shown in the illustration.

c - Rubber boot - slide over (+) terminal
