Crankshaft Sensor Lead Chafing

Models Covered	Serial Number Or Year
1550 and 1650	0M973231 and up

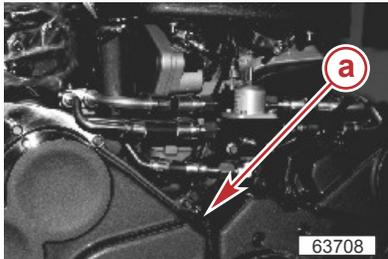
a - Crankshaft lead wire

The front carbon fiber cover on the engine is rubbing against the crankshaft sensor lead and wearing through the protective cover.

- If the crankshaft lead protective cover is worn through but the lead wire insulation is not, follow the instructions to repair the protective cover with shrink wrap and modify the front cover.
- If the crankshaft lead wire insulation is worn through and exposing the copper wire, replace the engine harness.
