service bulletin

Driveshaft Replacement 30/40 and 50 (4-Stroke)

MARINER AND MERCURY

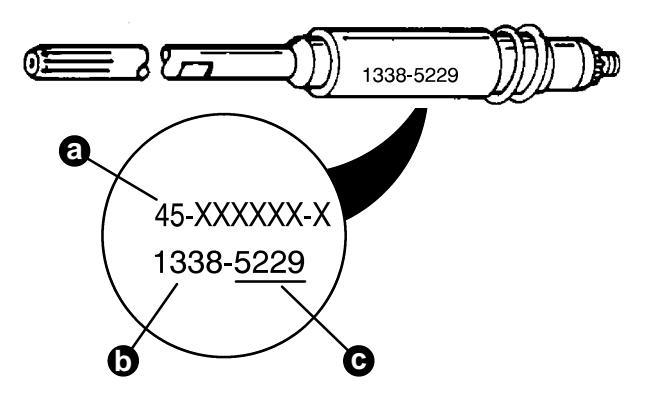
Figure 1. Driveshaft Date Code

The outboards listed may have driveshafts with defective welds. Endurance testing has discovered a small possibility of voids in the weld that joins the stainless steel upper section to the carbon steel lower section of the driveshaft. Operation of the outboard may result in early driveshaft failure.

- a Driveshaft Part Number
- b Manufacturing Number
- c Date Code

- 1. Remove gear housing and the driveshaft as outlined in the Outboard Service Manual.
- 2. Check the date code on the driveshaft per Figure 1.
- 3. Driveshaft MUST BE replaced if the date code is 5190 thru 5233.
- 4. Order Parts Kit p/n 809796A1 and driveshaft (if required) per this bulletin for reassembly.
- 5. Reassemble and install the gear housing as outlined in the Outboard Service Manual.
- 6. Fill the gear housing with Quicksilver gear lube, install the propeller, and check for proper operation of the outboard.

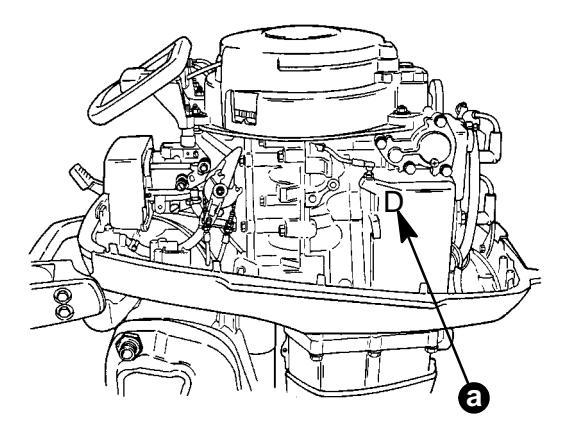
a - Yellow Paint Dot Figure 2. 30/40 Rework Marking

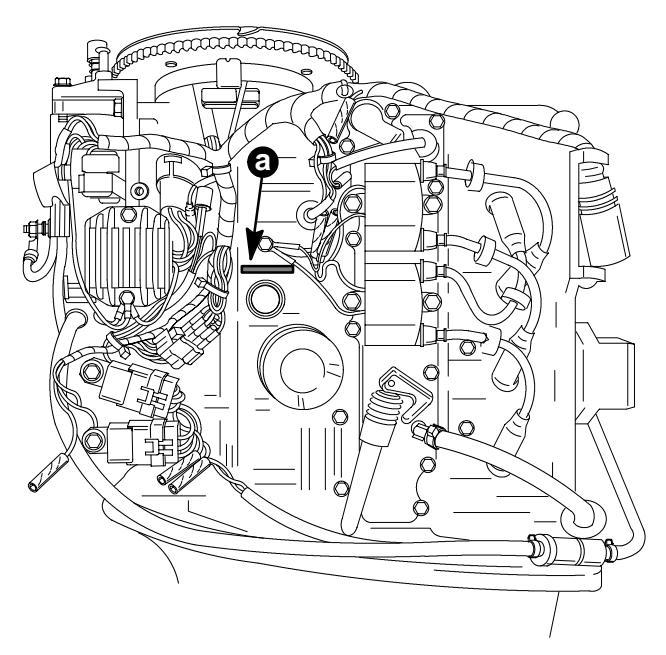
Figure 3. 50 4-Stroke Rework Marking

a - Yellow Paint Marking
