## Oil Injection Crankcase Pressure Valve – 135 thru 275

### Mariner and Mercury

135-200 S/N OD067952 and above

275 S/N OD070440 XL and above  
S/N OD078274 CXL and above  
S/N OD078285 XXL and above

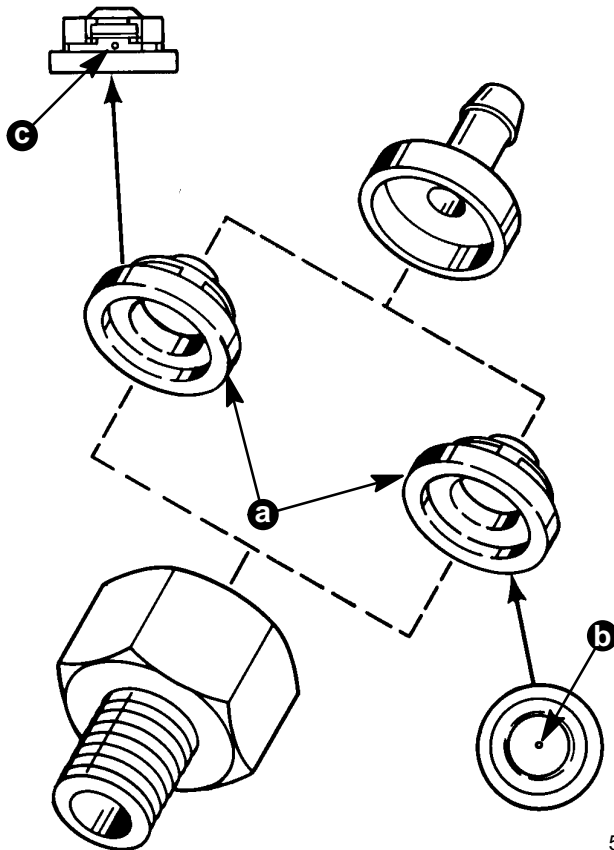
51379

There has been a product improvement to the crankcase pressure valve P/N 21-43278. The valves used before the serial number listed above had 0.0135 in. (0.34mm) pressure relief hole in the center of disc in the inner check valve. The new valve will have the hole moved to the side of the inner check valve to lessen the possibility of blockage and ease of manufacturing.

- a - Inner Check Valve
- b - Previous Pressure Relief Hole
- c - New Pressure Relief Hole

When inspecting the previous style check valve, the pressure relief hole can be seen from either end. The new valve does not have an external hole that can be seen. To determine that the pressure relief hole is open on the new valve, slowly loosen the filler cap on remote oil tank one minute after engine shut down. There should not be any pressure released.
