- A. Power Steering Control Valve and Cylinder Assembly Check and Adjustments (MerCruiser 888-215E-215H-225II-TR and 255II-TR)
- B. New Engine Coupling Torque Wrench Adaptor (MerCruiser 888)
- C. Remote Mounted Seawater Pump (MerCruiser 888)

**A. POWER STEERING CONTROL VALVE and CYLINDER ASSEMBLY CHECK and ADJUSTMENTS (MerCruiser 888-215E-215H-225II-TR and 255II-TR)**

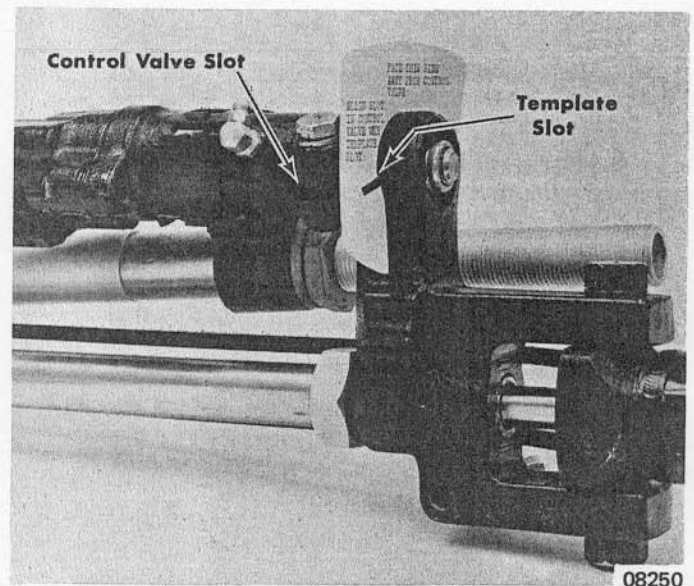
**Figure 1. Template Location for Position Check**

- a. Carefully cut out template (attached) and place template on control valve mounting bracket. (Figure 1)
- b. Reposition control valve by loosening mounting nut and 4 hydraulic tube fittings. (Figure 2)
- c. Rotate control valve to align slot in control valve with slot in template and tighten mounting nut. Torque nut to 25-35 ft. lbs. (3.46 to 4.84mkg).
- d. Retighten hydraulic tube fittings securely.

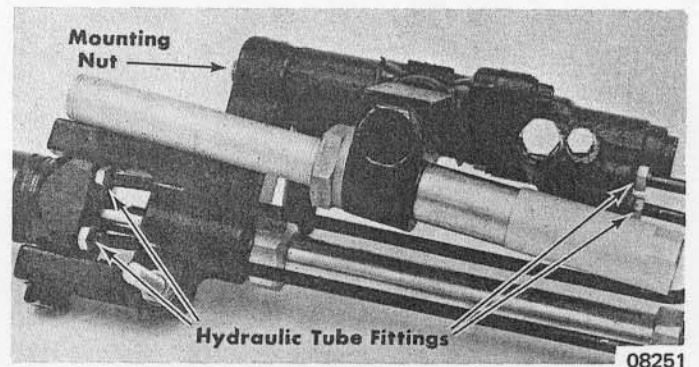
**Figure 2. Valve Alignment Adjustment**

**NOTE:** Perform valve alignment, preceding, when replacing control valve.

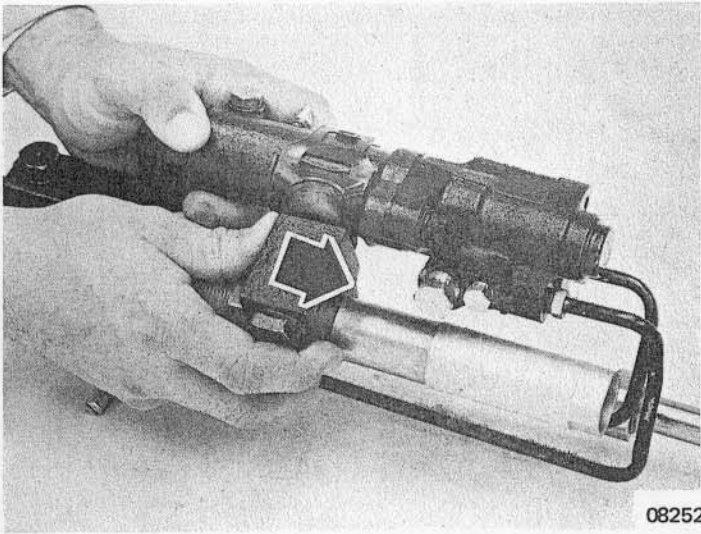
08252

Figure 3. Control Valve Movement

- a. Grasp Power Steering assembly and move control valve in a parallel direction as shown in Figures 3 and 4. The valve must move between 1/16" (1.6mm) and 3/32" (2.4mm) in both directions, and return to center freely. About 10 lbs. (4.5kg) of force is required to move valve.
- b. If valve moves freely and returns to center without binding or sticking, lubricate valve with Multipurpose Lubricant (C-92-49588 or C-92-63250) until lubricant flows from under boot. (Figure 5) A 90° grease fitting (C-22-67305) can be installed for future periodic lubrication.
- c. If valve sticks, binds or does not move as described above, replace control valve.

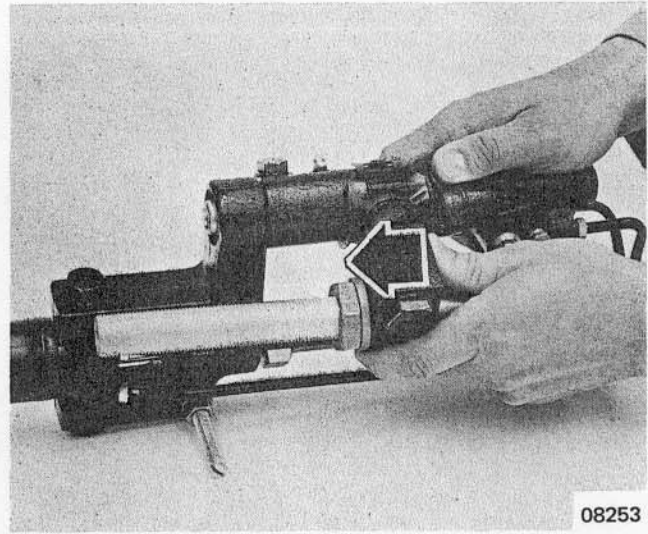
08253

Figure 4. Control Valve Movement

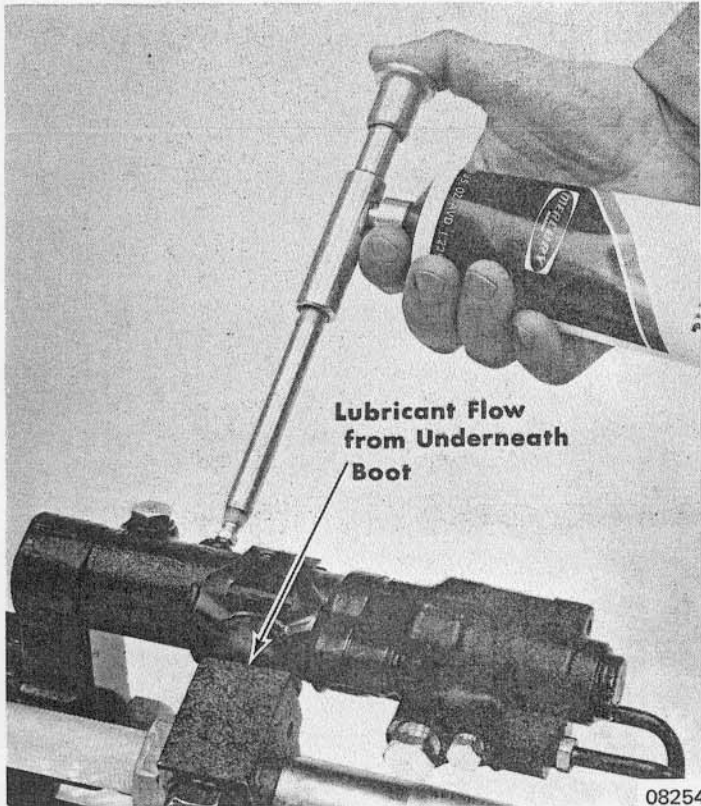
08254

Figure 5. Control Valve Lubrication

1. Lubricate shaft and mounting tube with Multipurpose Lubricant (C-92-49588 or C-92-63250) during installation. If binding is found, replace damaged parts. Refer to MerCruiser Accessories Parts List for replacement parts.
2. Check Ride-Guide cable mounting tube. Pre-adjusted dimension should be  $5\frac{1}{2}''$  (14cm)+ $\frac{1}{8}''$  (3.2mm). (Figure 6)
3. Reset dimension if incorrect. Replace Ride-Guide tube or adjusting sleeves if necessary.

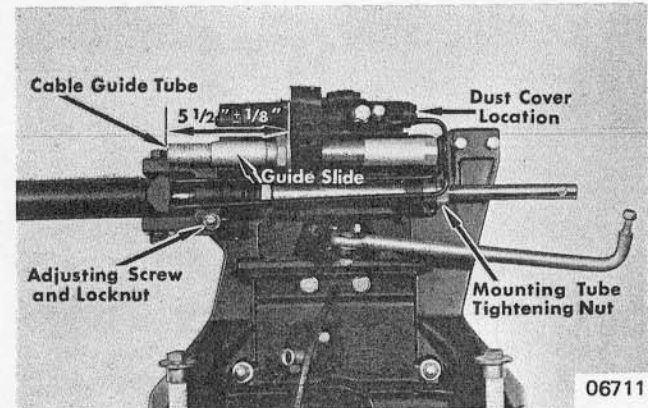
06711

Figure 6. Pre-adjusted Dimension
