No. 86-7

- A. TR/TRS Exhaust Tube Missing on Gimbal Housing Assembly.
- B. TR/TRS Power Steering Control Valve Grease Fitting

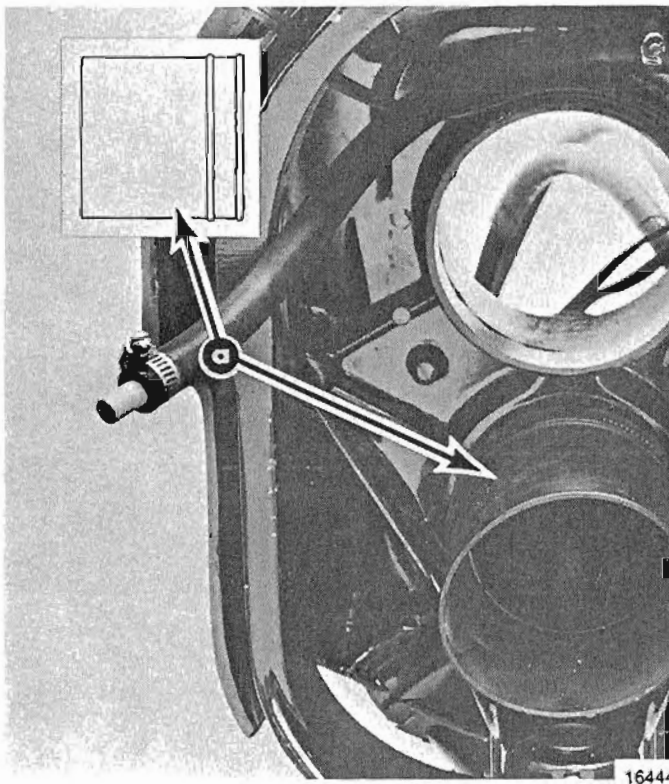
A. TR/TRS EXHAUST TUBE MISSING on the GIMBAL HOUSING ASSEMBLY

On some TR/TRS gimbal housing assemblies, the exhaust tube (a) was not put on the gimbal housing in production. If the exhaust tube is missing, you would detect a louder exhaust noise at idle with the drive unit fully down. The following serial group is affected A587717 thru A610971.

Order part number 78632A1 tube and clamp 54-38889 and install. Submit warranty claim to your regional service center.

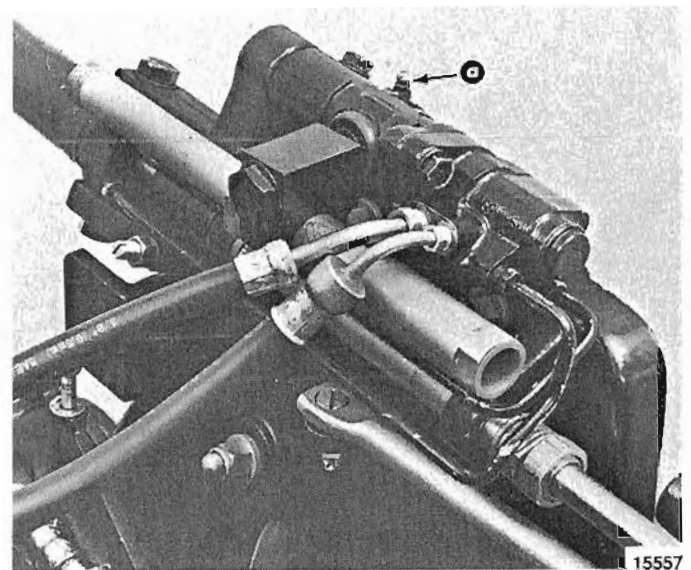
B. TR/TRS POWER STEERING CONTROL VALVE GREASE FITTING

The grease fitting (a) on the control valves were turned down for a period of time during production. The fitting must be turned up to allow the valve to be greased. The following serial number group is affected.

A543321 thru A588562
