OFFICIAL NOTIFICATION
Under the U.S. Federal Boat Safety Act

NUMBER: 83-28

TR, TRS, 215E and 215H GIMBAL RING FIX

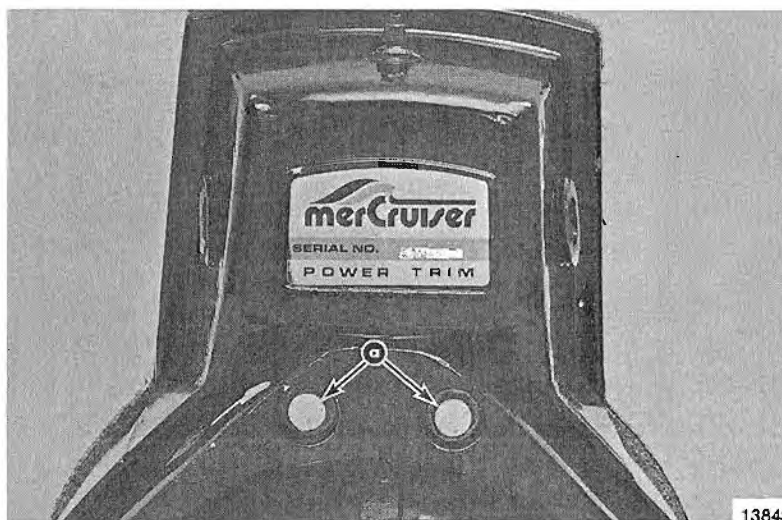
It has come to our attention that the gimbal ring on some MerCruiser TR, TRS, 215E and 215H Stern Drives could crack where it connects to the swivel shaft. If this should occur, it could cause loss of steering control.

The potential problem is isolated to stern drives equipped with "square swivel shaft" type gimbal rings. (Figure 1) These gimbal rings were used as original equipment on newer TR and TRS models (with transom assembly Serial No. 6037486 and above). The gimbal ring also was included in Swivel Shaft Kit (93305A1), which was designated for use on 215E, 215H and older TR and TRS models.

Figure 1. "Square Swivel Shaft" Type Gimbal Ring

A Clamp Bracket Kit (41456A1) is to be installed on all units equipped with the "square swivel shaft" type gimbal ring. (Figure 2)

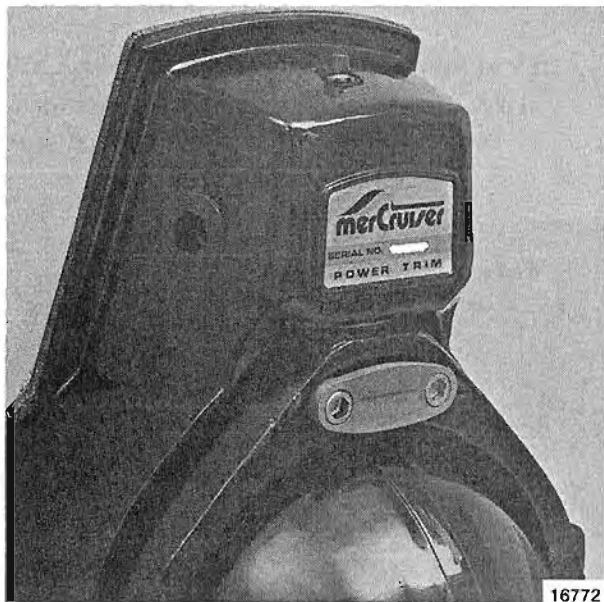
Figure 2. Clamp Bracket Kit (41456A1) Installed

Install Clamp Bracket Kit in accordance with instructions accompanying it. Submit a warranty claim for kit installation, being sure to include the engine serial number and, if so equipped, the transom assembly serial number. Several kit installations can be included on one warranty claim to save time. Warranty labor allowance is 0.5 hours for each kit.

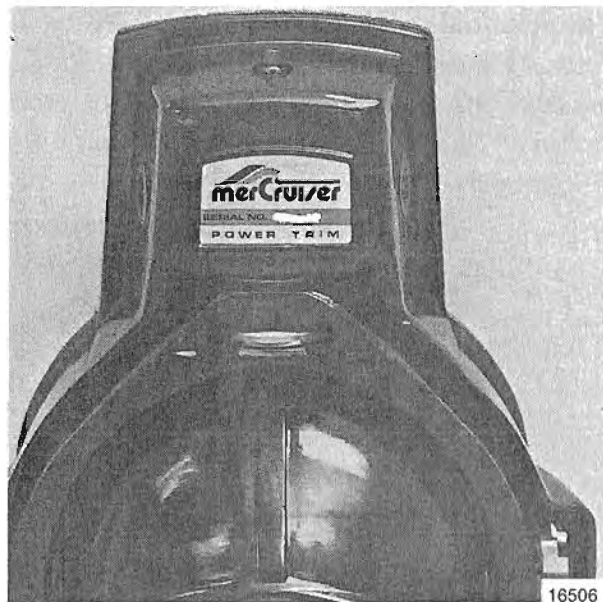
Future TR/TRS transom assemblies will be equipped with a gimbal ring utilizing a U-bolt at the top connection. (Figure 3) This gimbal ring also will be used in Swivel Shaft Kit (42385A3) and Gimbal Ring Assembly (42385A1).

Figure 3. U-Bolt Style Gimbal Ring

If you should find a unit with a cracked gimbal ring, a Swivel Shaft Kit (42385A3) should be installed. Installation instructions are provided with the kit. Return the failed gimbal ring with the completed warranty claim.
