91-27

OFFICIAL NOTIFICATION UNDER THE U.S. FEDERAL BOAT SAFETY ACT

A. Required Water Separating Fuel Filter Replacement

MCM 7.4L Stern Drive Engines

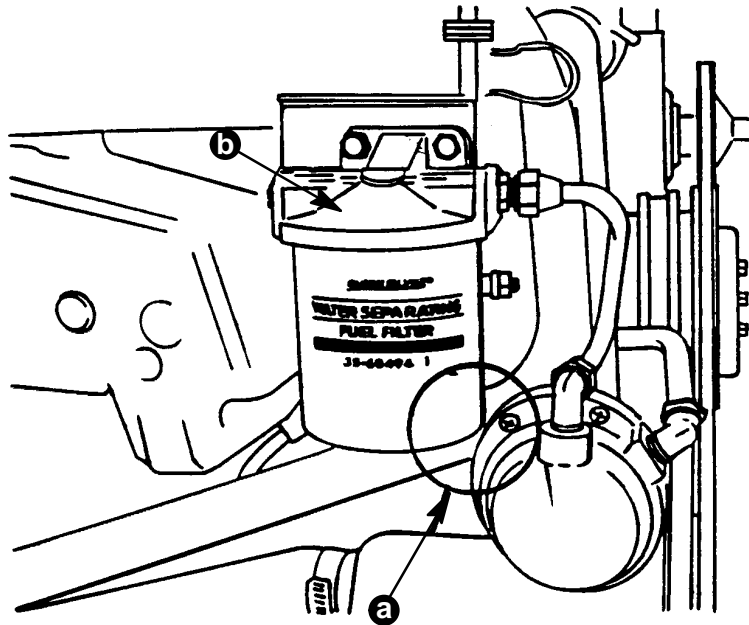
71229

The fuel filter (Part Number 35-60494--1) may be touching the fuel pump. This situation was caused during the assembly of the engine. After a period of time, a hole will be worn into the bottom of the filter which in turn will allow fuel (gasoline) to leak into the bilge of the boat.

- a - Filter may wear through in this area
- b - Place Warning Decal Here

Look at part number on fuel filter. If the number (on filter) is 35-60494--1, the filter must be changed.

Change the filter on any engine that you have in stock. Install warning decal at location (b). If the boat has been sold, please contact your customer and perform this service on his engine(s). When an engine is registered at Mercury Marine, our computer will check to see if filter has been changed. If our records do not show that the filter has been changed, the customer will be contacted by letter with a campaign card enclosed. Please change filter and install warning decal. Use the campaign card to file for warranty.

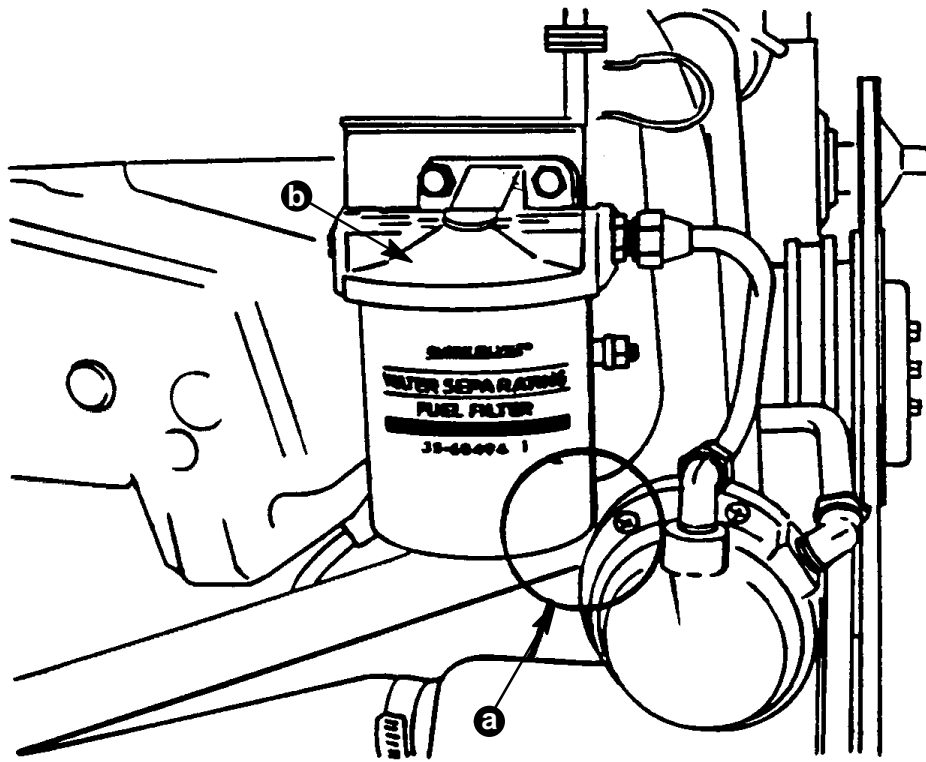
71229

Mercury Marine has discovered that there may be insufficient clearance between the fuel pump and water separating fuel filter on your engine. Insufficient clearance can allow the filter to rub on the fuel pump. If it does, a hole could be worn through the filter and result in a fuel leak. A leak would create the potential for a fire or explosion if an ignition source is present. Mercury Marine has developed this recall program to eliminate any such risk or concern.

- a - Filter may wear through in this area
- b - Dealer to place warning decal here

Enclosed with this letter is a recall campaign card and a warning decal. Your local MerCruiser dealer can install the decal and a new, shorter fuel filter designed to provide greater clearance and eliminate the possibility of a fuel leak. Please have your dealer refer to Service Bulletin 91-27. To accomplish the replacement, please take the following steps:

Installation of the decal and replacement fuel filter can normally be done in one half hour or less, but it is important that the filter be dealer installed since improper installation could result in fuel leaks. Until the new filter is installed, use the drawing included with this letter and check your fuel filter for signs of wear. Always make sure to run your bilge blowers before starting the boat.
