Required Replacement of the Coolant Recovery Reservoir Cap

Models Covered	Serial Numbers
Vazer	All

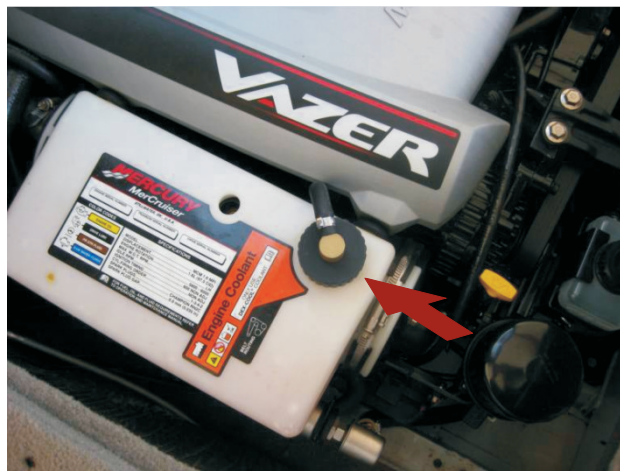
46050

The coolant recovery reservoir cap on Vazer engines may crack, causing an unexpected high pressure discharge of hot coolant.

Coolant recovery reservoir cap

Replace the existing cap with the new cap and discharge hose assembly. Position the discharge hose between the coolant recovery reservoir and the silver engine cover as shown.
