Water Circulation Pump Impeller Cracking

Revised May 2013. This bulletin supersedes the previous bulletin number 2013-05 April 2013.

Models Covered	Serial Number
4.3 Liter Models	1A645142-2A036214
5.0, 5.7 and 6.2 Liter Models	1A645061-2A036260

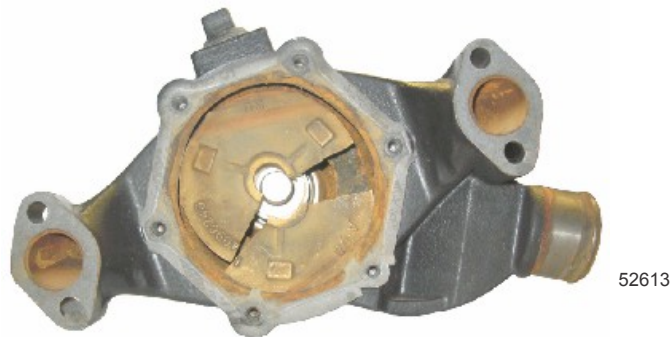
Mercury MerCruiser has observed water circulation pump impellers cracking, which can cause the engine to run below normal operating temperatures or cause an engine overheat. These impeller failures sometimes may be difficult to diagnose. Below are some specific symptoms and actions to help diagnose the potential problem.

Replace any failed water circulation pumps. Refer to Service Manual for removal and replacement procedures.
