Hi-Performance MerCruiser Tailpipe Change

1999 Model Year Hi-Performance 500 C and 500 Bulldog Engine Packages.

Exhaust Tailpipe Change

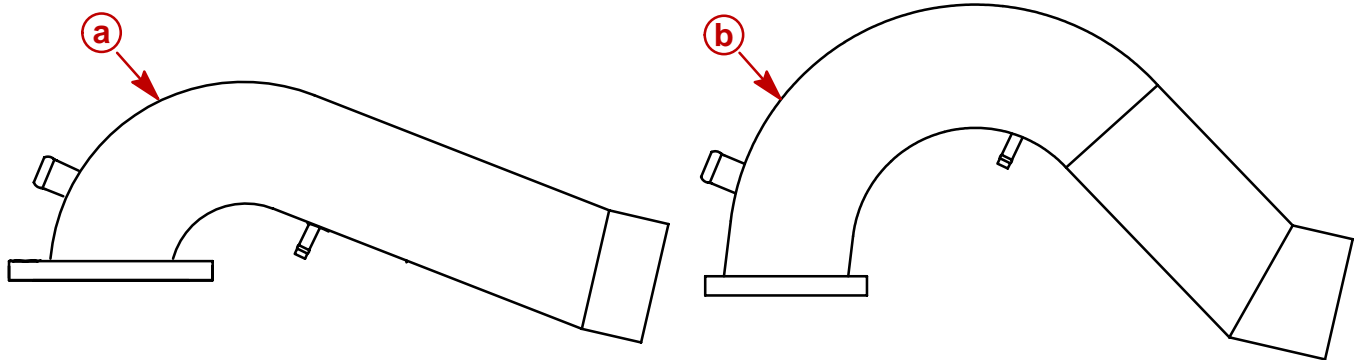
Tailpipes on models listed above will have a higher rise built into the pipe but will exit the transom in the same location as previous tailpipes on Gil/MerCruiser exhausts. Hatch clearance should not be a problem since the top of the pipes do not extend above the flame arrester.

- a** - Standard Exhaust Pipe, 1998 & Below
- b** - Standard Exhaust Pipe 1999 & Above

Although the extra pipe rise should help prevent water ingestion/reversion on installations that are marginal in water line to tailpipe height, it is still the responsibility of the installer to test for water ingestion problems. Internal exhaust shutters and external flappers are also required on all Hi-Performance exhaust installations.
