SPORT JET 90 INFORMATION UPDATE

1993-1994 Sport Jet 90

S/N 0E009675 thru 0E095087

The following represents the most common customer and/or dealer problems and solutions on 1993-1994 Sport Jets.

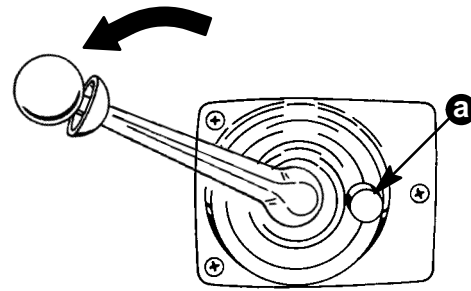
a - Knob

1. Run blower per Operation & Maintenance Manual.
2. Connect lanyard.
3. Pull knob (a) out for "throttle only" detent.

4. Advance throttle lever in Neutral until it stops.

5. Push key in to actuate the choke and continue to hold the key in while cranking.
6. Once engine starts, release the key. If engine begins to audibly lose RPM, quickly engage and disengage the choke. This will provide necessary fuel to sustain the engine thru the warm-up period.

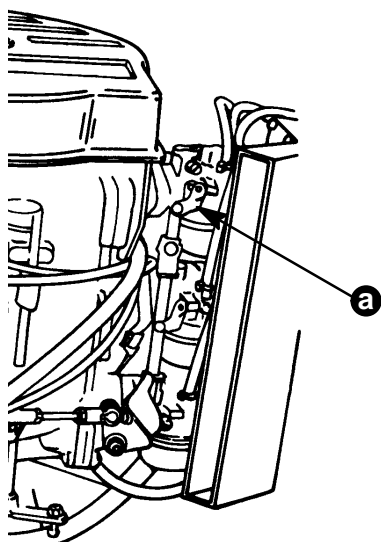
a - Throttle Arm, Top Carburetor

4. Lift engine hatch.
5. Hold throttle arm of top carburetor at W.O.T. position.

6. Crank engine – DO NOT PUSH IN KEY TO ACTUATE CHOKE.
7. As soon as engine starts, immediately release throttle arm of top carburetor.
