# MERCUISER SERVICE BULLETIN

Section: XII (Bulletins)  
Number: 68-15-10  
Date : 5/29/68

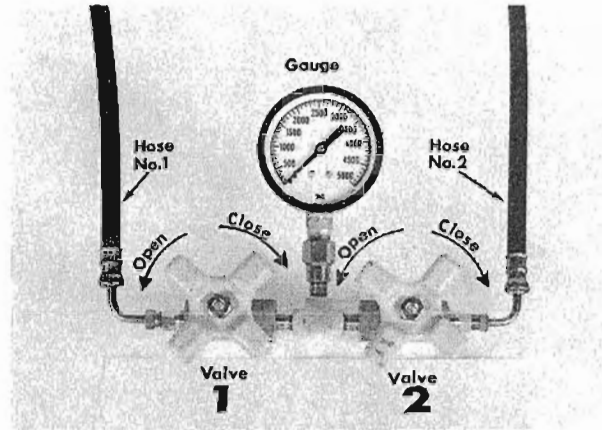
Figure 1. Test Gauge and Valve Assembly

Use Test Gauge Assembly C-91-52915A2 for field testing hydraulic pumps. The test procedures (included in the assembly) will enable you to test the condition of the pump or control valve to determine which of the parts, if any, are defective. It specifies hydraulic pump pressures and amperage requirements for MerCruiser Power Tilt and Trim pumps and for Mercury Outboard Power Trim pump.
