- A. New MerCathode System for MerCruiser 120-thru-260 R & MR Models
- B. Improved Corrosion Resistance On New Trim Cylinders
- C. Stern Drive Continuity Test
- D. Stainless Steel Propellers Corroding
- E. Anti-Fouling Paint Usage On MerCruiser Stern Drives
- F. Inactive Sacrificial Zinc Anodes
- G. MerCathode Monitor Operation and Testing
- H. Corrosion Protection Testing and Troubleshooting
- I. MerCathode System and Monitor Wiring Diagrams

A. NEW MERCATHODE SYSTEM FOR MERCUISER 120-thru-260 R & MR MODELS

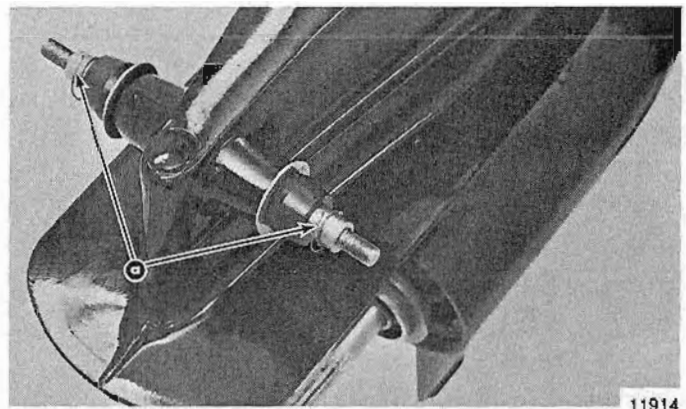
**Figure 4. Trim Cylinder
Spiral Grounding Springs**

The new trim cylinders do not require the use of spiral springs (Figure 4) as was required on the trim cylinders in the past.

a - Spiral Grounding Springs

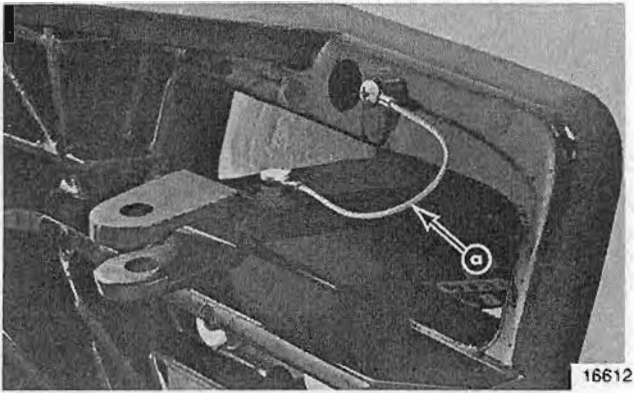
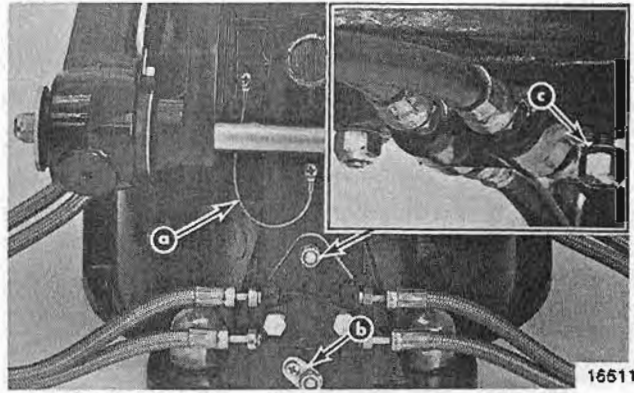
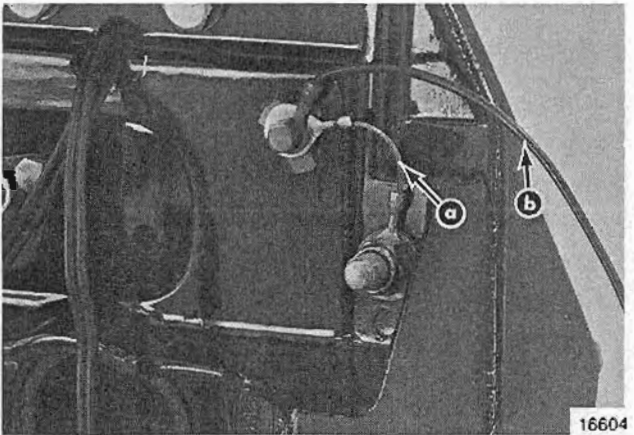
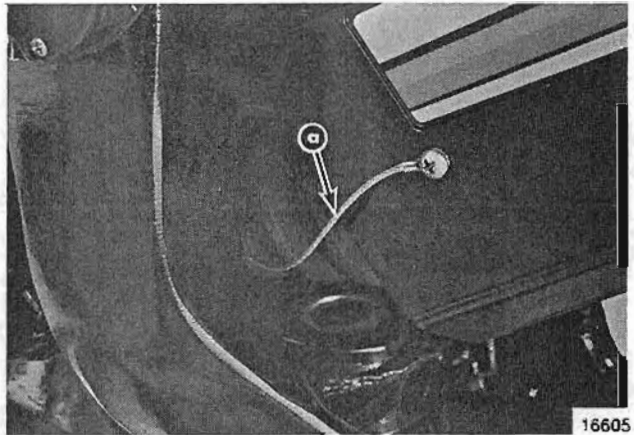
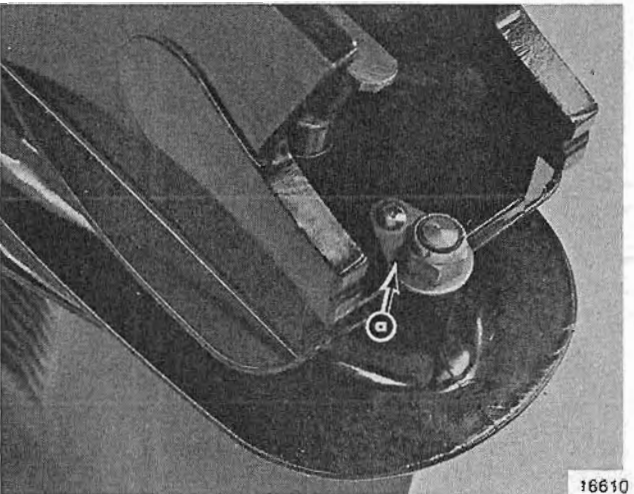
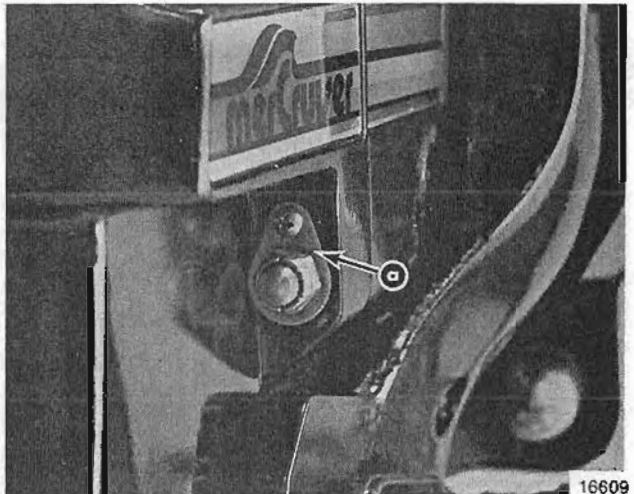
Figure 5. MerCruiser 120-thru-260 R & MR Continuity Circuit

To help ensure proper grounding of underwater components, current production MerCruiser 120-thru-260 R & MR and TR/TRS models are now equipped with a continuity circuit. (Figures 5 and 6) A Continuity Circuit Kit (99940A1) also is available to retrofit older MC I, TR and TRS models with this system. Continuity circuit should be inspected periodically to ensure that there are no loose connections or damaged wires. Isolated corrosion on only one or two components on the stern drive could indicate improper grounding.

a - Steering Lever Ground Wire

a - Gimbal Ring Ground Wire c - Star Washer
b - Hydraulic Connector Ground Plate

*NOTE: Ground Plate Has Been Replaced With Star Washers
(Under Each Nut) On Later Production Models.*

a - Inner Transom Plate Ground Wire
b - Engine Ground Wire

a - Bell Housing Ground Wire

a - Gear Housing to Drive Shaft Housing Ground Plate

a - Drive Shaft Housing to Bell Housing Ground Plate

The following test can be used to check if the stern drive is properly grounded.

1. Boat must be in the water when performing this test.
2. Set D.C. voltmeter on 0-2 volt (0-2000 millivolt) scale.
3. Connect negative (black) meter lead to negative (-) battery terminal.
4. Suspend end of positive (red) meter lead in the water within 6" (15cm) of drive unit. Do not allow it to contact drive unit. Reading should be above 3 millivolts.
5. Connect end of positive meter lead to each metallic component on stern drive. Reading should drop below 2 millivolts.
6. A reading higher than specified indicates improper grounding.

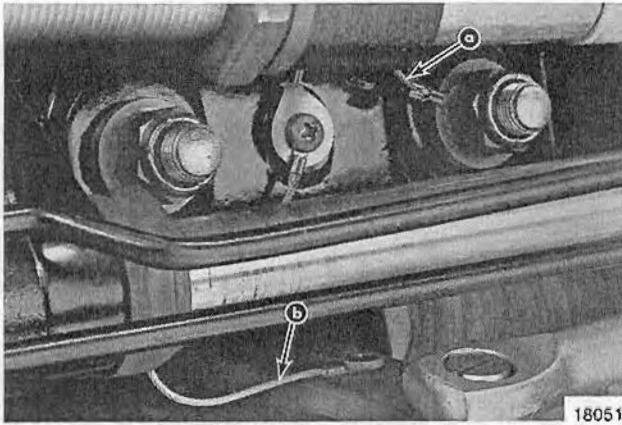
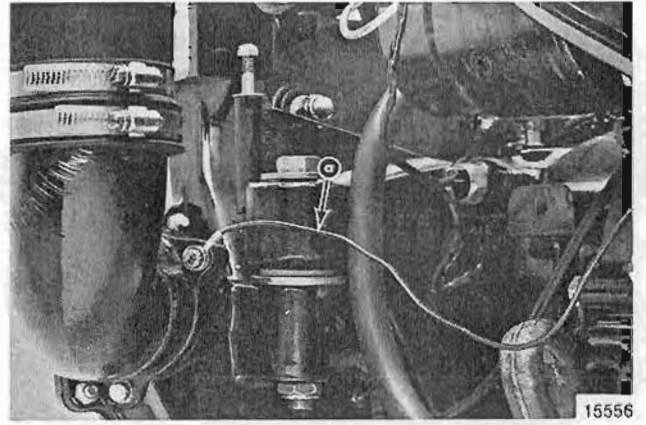
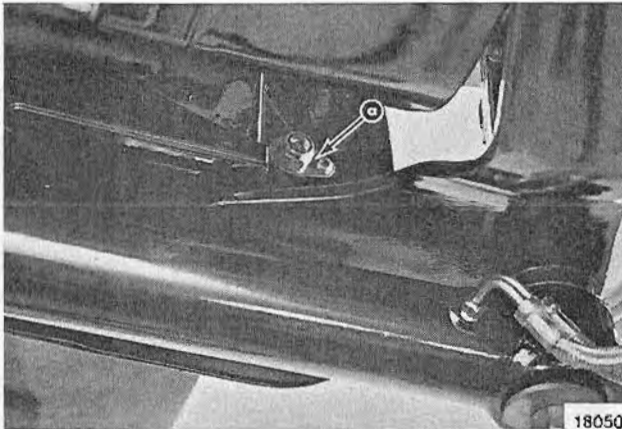
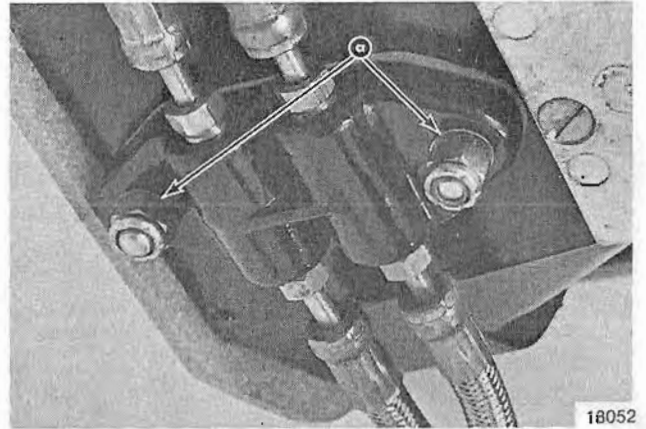
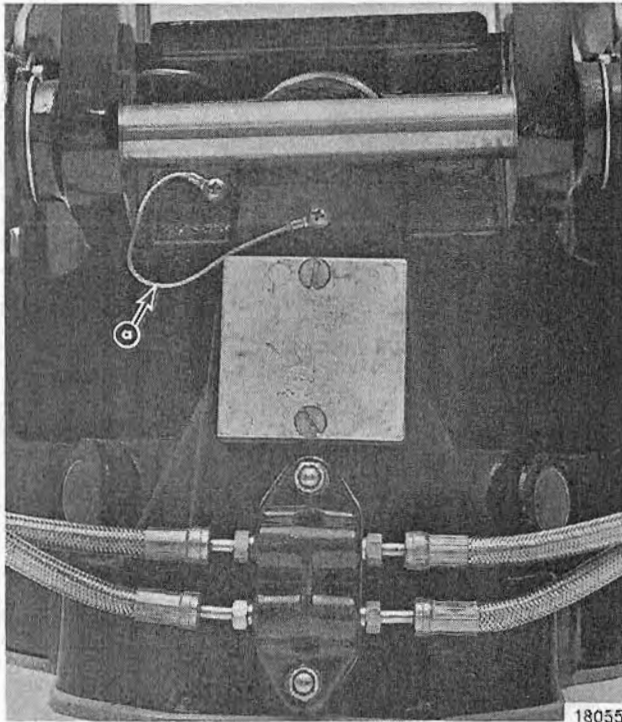
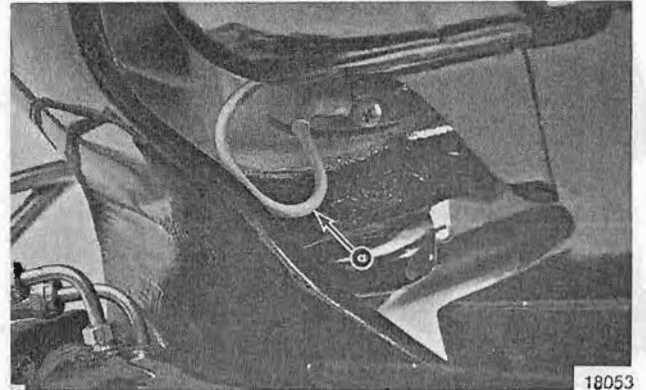
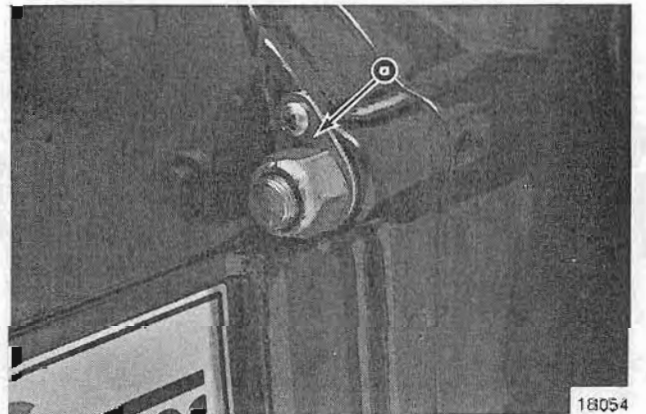
Figure 6. MerCruiser TR and TRS Continuity Circuit

a - Inner Transom Plate Ground Wire
b - Steering Lever Ground Wire

a - Engine to Inner Transom Plate Ground Wire

a - Drive Shaft Housing to Gear Housing Ground Plate

a - Hydraulic Connector Continuity Washer

a - Gimbal Ring Ground Wire

a - Bell Housing Ground Wire

Drive Shaft Housing to Bell Housing Ground Plate
