## service bulletin

**NUMBER: 84-10**

A. Mando Alternator Regulator

C. MCM 165 Engine Oil Pan Attachment Changes

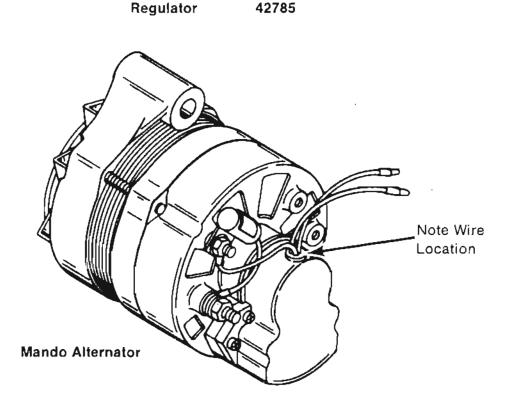
Many complete Mando alternators that were returned to Mercury Marine for warranty had regulator failures. The two most common failures are: no charging or over-charging.

If regulator is at fault, replace regulator only, NOT complete alternator. The replacement of a complete alternator is not covered under warranty unless they are 75% or more damaged. Order:
