Service Bulletin

Bulletin No. 2014-68 OEM No. 2014-66
Circulate to:	Sales Manager	Accounting	Service Manager	Technician	Parts Manager

Official Recall Notification United States Federal Boat Safety Act —Mercury Diesel 3.0L Tier III Turbocharger Oil Supply Line Update

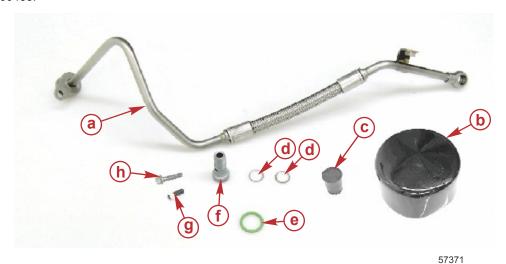
8M0100488 Oil line kit

1. Order 8M0100488.

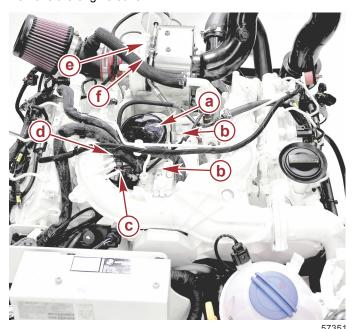
Component locations

- a Oil filter, shown capped (refer to following steps)
- **b** Turbocharger oil line
- **c** Fuel metering valve connector
- d Oil line retainer flange and retaining screw (not visible, but located beneath fuel lines)
- e Turbocharger oil line banjo bolt
- Antirotation screw

3. Remove the engine cover.

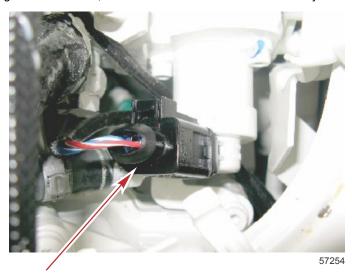
Fuel metering valve connector

5. Disconnect the fuel metering valve connector, and secure the connector out of the way.

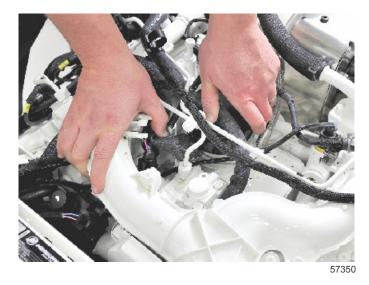
Spread the fuel lines apart to gain access to the oil supply line

9. Remove the fuel line and return fuel line from the fuel line retainer, and spread the lines apart.
