Service Bulletin

Bulletin No. 2015-06
OEM No. 2015-05

Official Recall Notification U.S. Federal Boat Safety Act: #6 Fuel Injector and Water-Separating Fuel Filter Require Inspections

4.5L Sterndrive Engines

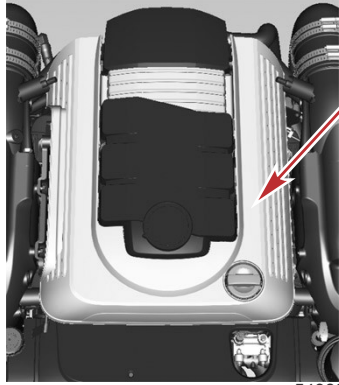
Outside engine cover

Inspect the PCV hose for a blue paint dot. If the dot is present, then the inspection has been completed. If the dot is not present, inspect the PCV hose as follows:

2. Inspect the PCV hose for kinks that restrict proper ventilation.

3. If a kink is found, remove the hose from the PCV valve, and reduce the length such that it reaches the valve but does not kink.
4. Reinstall the hose.
5. Install the outside engine cover.
