MERCUISER SERVICE BULLETIN

Section XIII (Service
Number 1 Bulletins)
Date 10/10/62

62-1

- A. Special Fuel Tanks - Cautions
- B. MerCruiser I & II Stern Drive Repair Stands
- C. Exhaust Tube Replacement
- D. MerCruiser Carburetor Altitude Kits

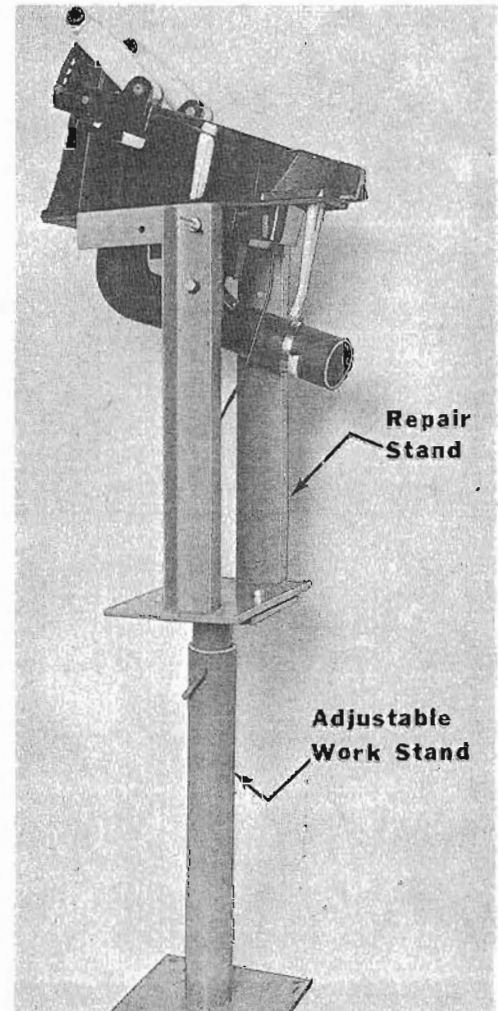
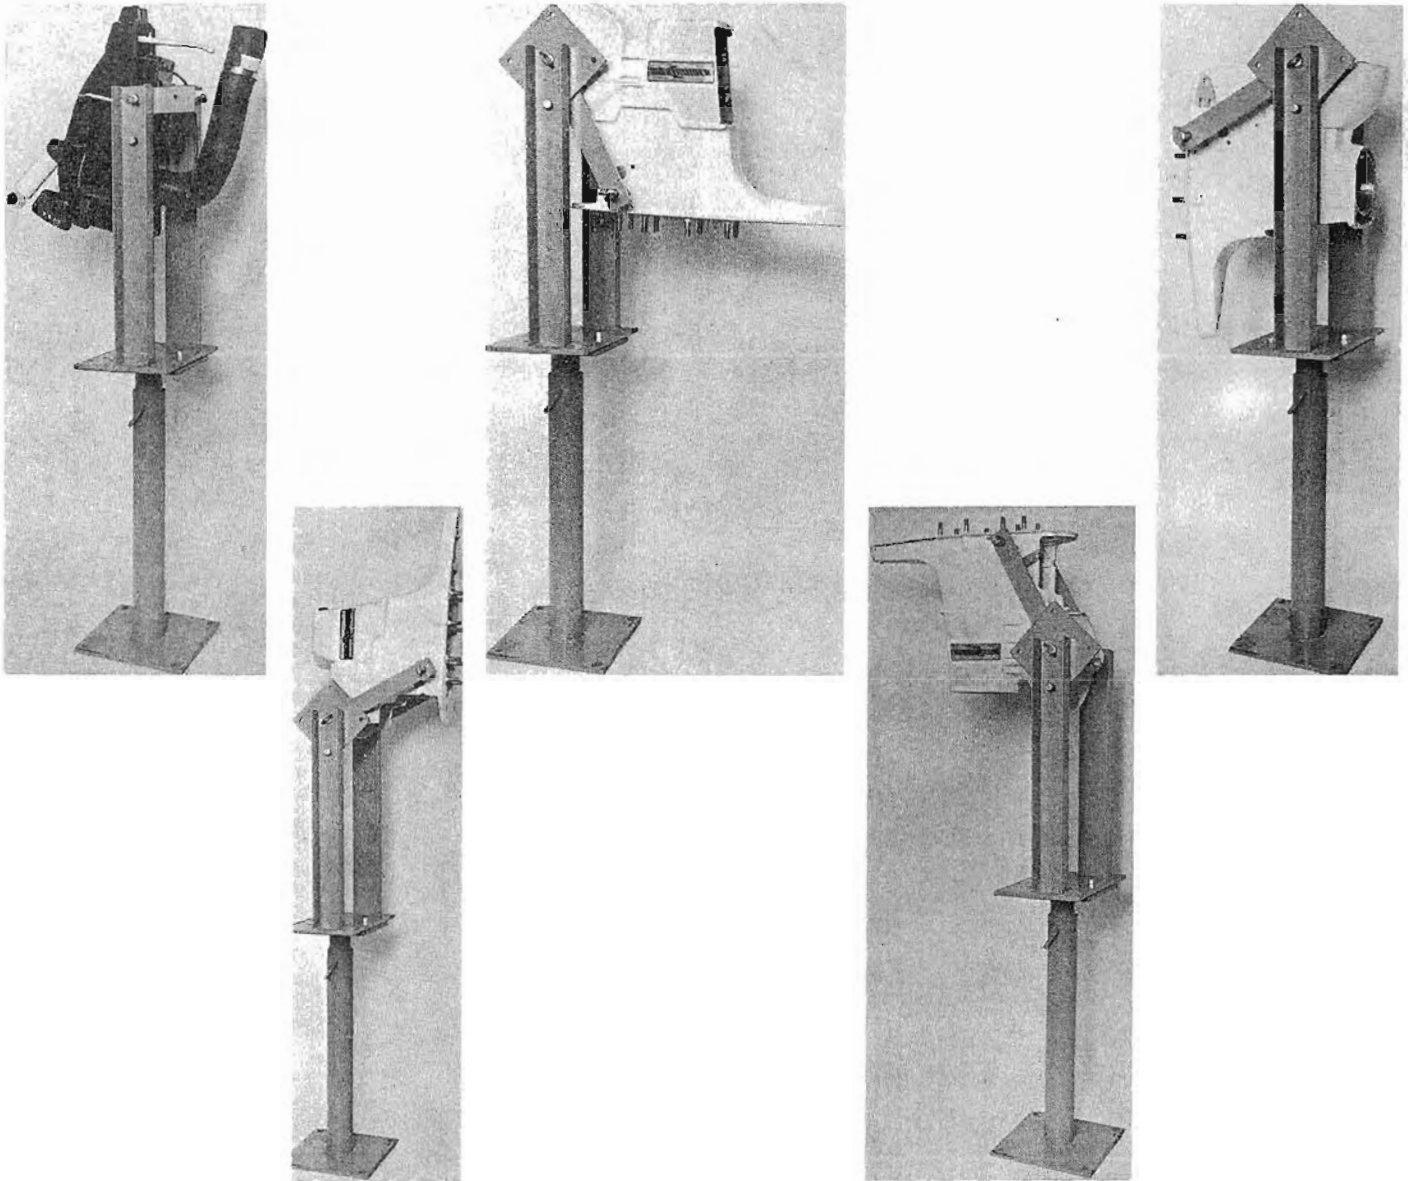
The Adjustable Work Stand, when used in conjunction with the Repair Stand or a vise, provides easy access at various work heights, as shown in the illustrations on the right and over.

The MerCruiser Repair Stand (91-33750) and Adjustable Work Stand (91-33686) are new pieces of equipment which provide easy handling of both MerCruiser Stern Drive Units for quick, easy and efficient service.
