service bulletin

No. 90-3

Reed Block Gasket – Mariner/Mercury 100/115

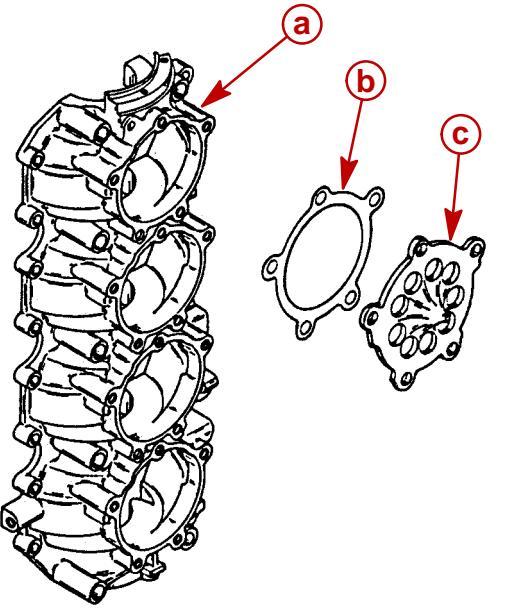
Figure 1.

Outboards listed may have more than one gasket installed between the reed block and crankcase. (Figure 1) Due to production changes, we have returned to installing only one gasket.

- a Crankcase
- b Reed Block Gasket
- c Reed Block

When servicing these outboards, install only one gasket P/N 27-13937--2, --4 or --6 between all reed blocks and the crankcase.
