# MERCUISER SERVICE BULLETIN

Section: XII (Service  
Bulletins)  
Number: 15  
Date : 4/29/64

### E. FUEL RETURN LINE FOR MERCUISER "110" AND "120" ENGINES

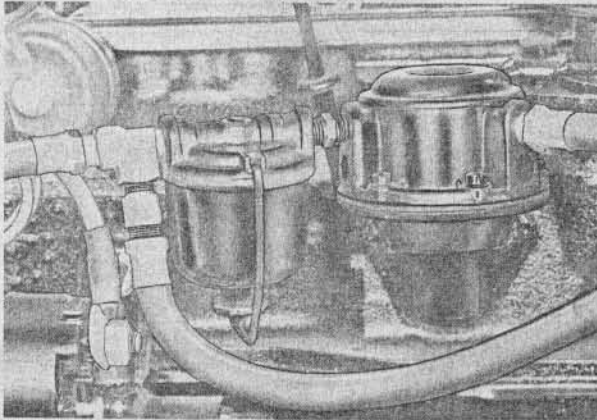
Figure 7. "T" Facing Down (Incorrect)

To aid in servicing the fuel filter on MerCruiser "110" and "120" Marine Engines, the fuel return line "T", previously installed with the "T" facing down (Figure 7), should be installed with the "T" facing up. (Figure 8)

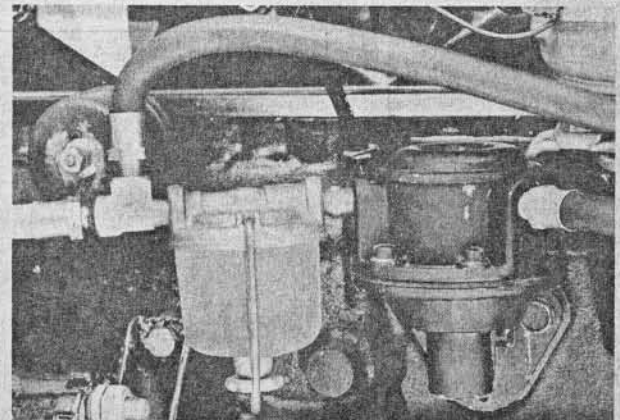
Figure 8. "T" Facing Up (Correct)

Check and change on the MerCruiser Marine Engines which you service.
