No. 89-4

MR and Alpha One Shift Cable Adjustment Inspection and Readjustment

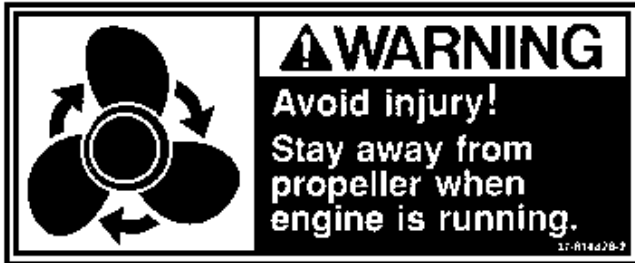
Figure 1.

Two "WARNING" decals (Figure 1) were sent with the letter to the registered owner. One decal is to be put on the dash so it is visible to the operator of the boat. The second decal is to be placed on the transom in a location that is visible to anyone in the vicinity of the propeller.

SAFE BOATING PRACTICES REQUIRE THAT THE ENGINE BE TURNED OFF WHEN ANYONE IS NEAR THE PROPELLER. We urge you to do this and instruct other operators of your boat to do so as well. As a reminder of this safe boating practice, enclosed are two decals for your boat; the small one, part number 37-814828-1, for placing in sight at the operator's station and the larger one, part number 37-814828-2, on the transom visible to people in the area of the propeller.

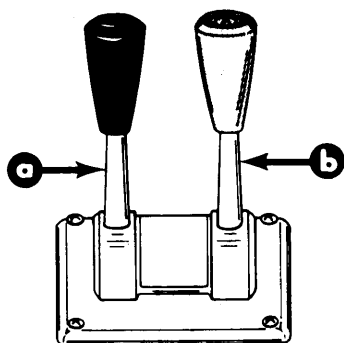
IMPORTANT: If boat is equipped with A REMOTE CONTROL THAT HAS SEPARATE SHIFT AND THROTTLE LEVERS, this shift assist assembly should NOT be used. The use of the shift assist assembly with this type of remote control can cause the shift lever to move out of gear unexpectedly.

a - Shift Lever
b - Throttle Lever

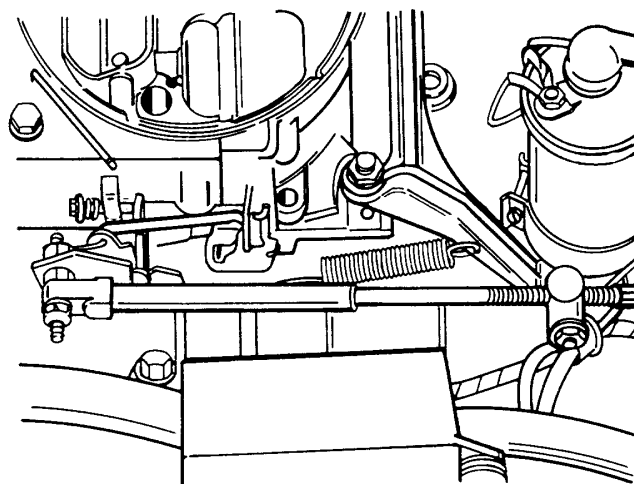
22062

1. Start engine and let it warm up (Refer to operating procedures in Operation and Maintenance Manual).
2. Disconnect throttle cable(s) from carburetor(s).

a - Throttle Cable End Guide
b - Carburetor Throttle Lever

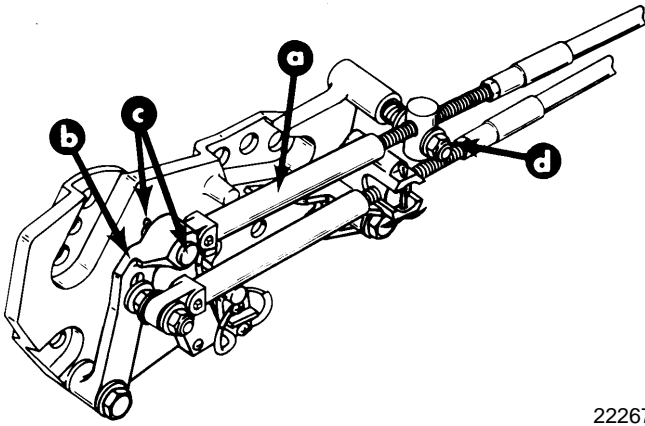
22267

3. Disconnect remote control shift cable.

- a - Remote Control Shift Cable
- b - Plastic Shift Lever
- c - Clevis Pin and Cotter Pin
- d - Locknut and Washer

Later Models (With Plastic Shift Lever)

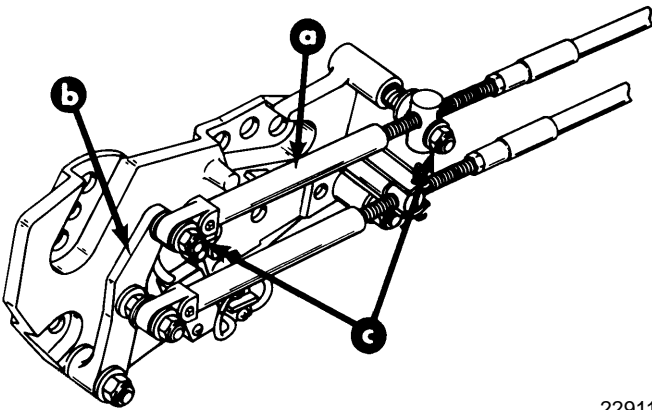
22911

- a - Remote Control Shaft Cable
- b - Metal Shift Lever
- c - Locknuts and Washers

Earlier Models (With Metal Shift Lever)

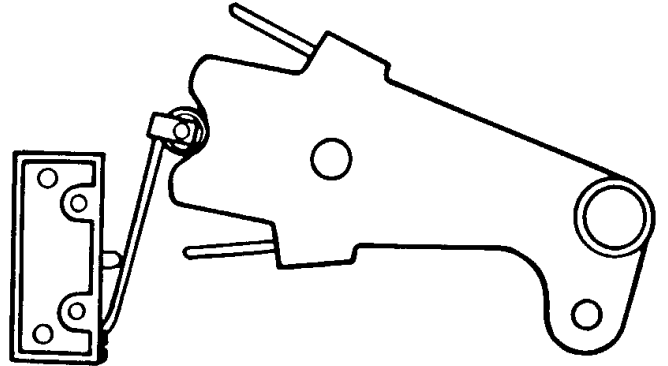
22911

IMPORTANT: When pushing or pulling on drive unit shift cable, in the following steps, apply just enough pressure so that shift cutout switch roller just starts to move off center of notch; then, ease up slightly. Use a fine tip marking device to mark threaded tube to obtain an accurate measurement.

4. Check for excessive play in drive unit shift system as follows:
 - a. Push in on drive unit shift cable to shift into forward gear position.
 - b. Place a mark on shift cable threaded tube, against cable end guide.

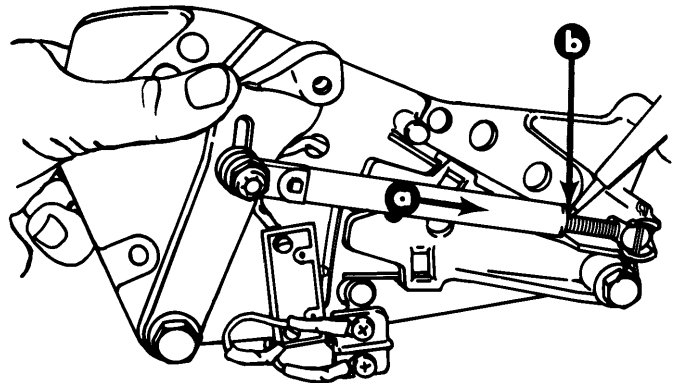
50499

- a - Drive Unit Shaft Cable
- b - Threaded Tube-Mark "Here"

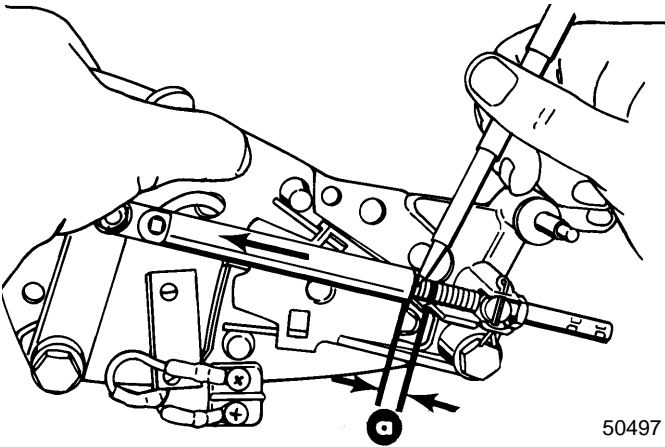
50497

- c. Lightly pull on drive unit shift cable end guide and place another mark on threaded tube.
- d. Measure distance between both marks. Distance should be **9/16 in. (14mm) or less.**

a - 9/16 in. (14mm) or Less

If play is 9/16 in. (14mm) or less: No further attention to drive unit is needed. Proceed with adjustments.

If play is more than 9/16 in. (14mm): Drive unit must be removed to further isolate excessive play.

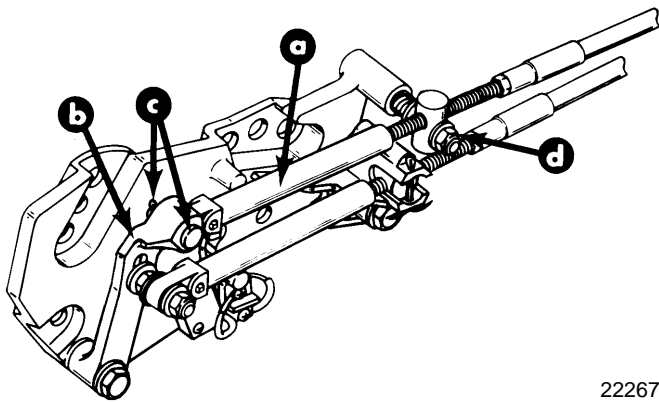
22267

1. Disconnect remote control shift cable.

- a - Remote Control Shift Cable
- b - Plastic Shift Lever
- c - Clevis Pin and Cotter Pin
- d - Locknut and Washer

Later Models (With Plastic Shift Lever)

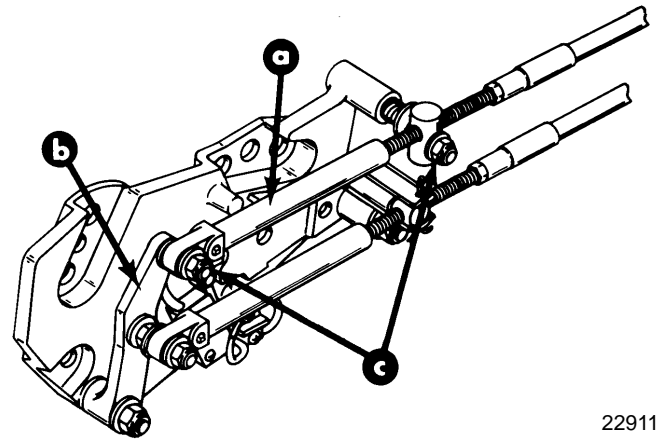
22911

- a - Remote Control Shaft Cable
- b - Metal Shift Lever
- c - Locknuts and Washers

Earlier Models (With Metal Shift Lever)

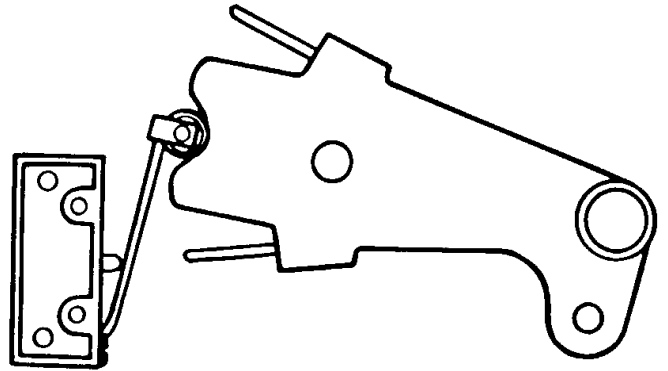
22911

IMPORTANT: When pushing or pulling on drive unit shift cable, in the following steps; apply just enough pressure so that shift cutout switch roller just starts to move off center of notch; then, ease up slightly. Use a fine tip marking device to mark threaded tube to obtain an accurate measurement.

2. Check for excessive play in drive unit shift system as follows:

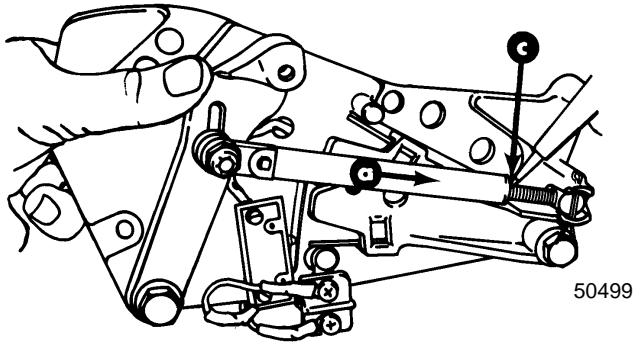
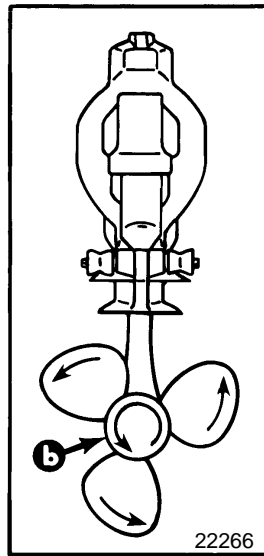
- a. Place drive unit into forward gear by pushing in on drive unit shift cable, while simultaneously rotating propeller shaft counterclockwise until shaft stops, to ensure full clutch engagement.
- b. Place a mark on shift cable threaded tube against edge of end guide.

- a - Drive Unit Shift Cable
- b - Propeller Shaft - Rotate
- c - Threaded Tube - Mark Here

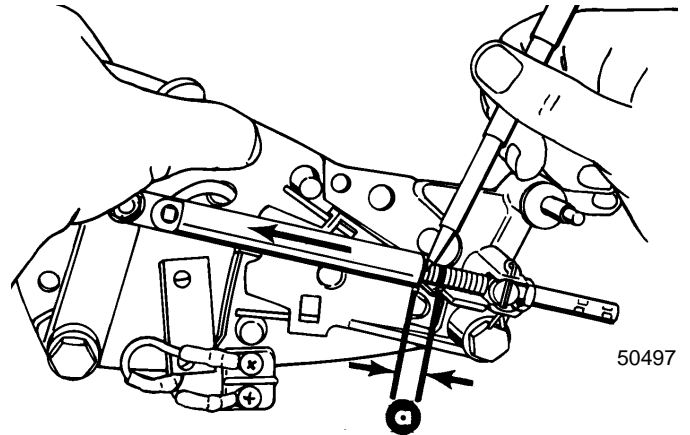
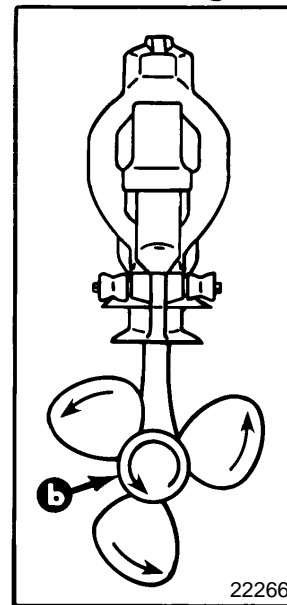
- c. While maintaining pressure on propeller shaft in a counterclockwise direction (to keep clutch locked with forward gear), lightly pull out on drive until shift cable end guide and place another mark on threaded tube.
- d. Measure distance between both marks. Distance should be **9/16 in. (14mm) or less**.

- a - 9/16 in. (14mm) or Less
- b - Propeller Shaft - Maintain Pressure

If play 9/16 in. (14mm) or less: No further attention to drive unit is needed. Proceed with adjustments.

If play is more than 9/16 in. (14mm): Drive unit must be removed to further isolate excessive play.

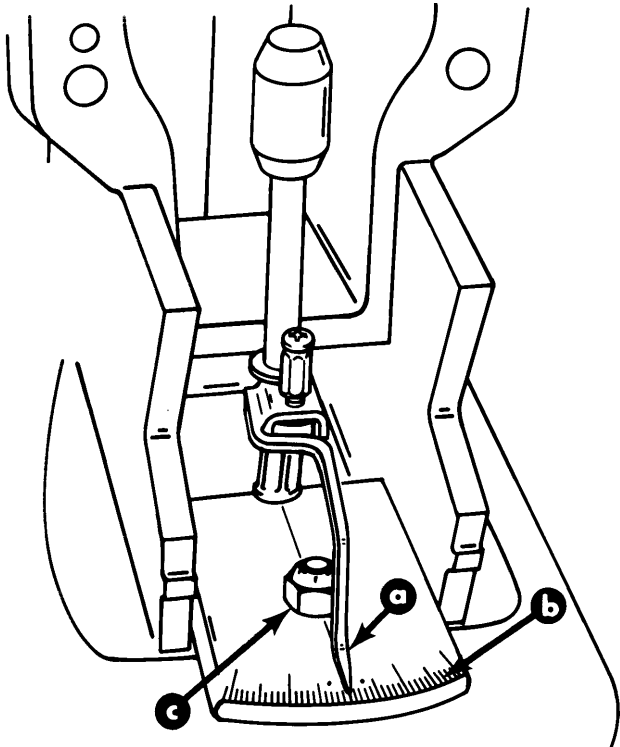
50498

1. To determine shift shaft rotational end play, use a tool such as the one shown, to measure degrees of play in shift shaft, with clutch locked and held in forward gear.

a. Install tool as shown.

- a - Pointer - Installed on Shift Shaft
- b - Scale (1° Increments)
- c - Nut - Hand Tight only

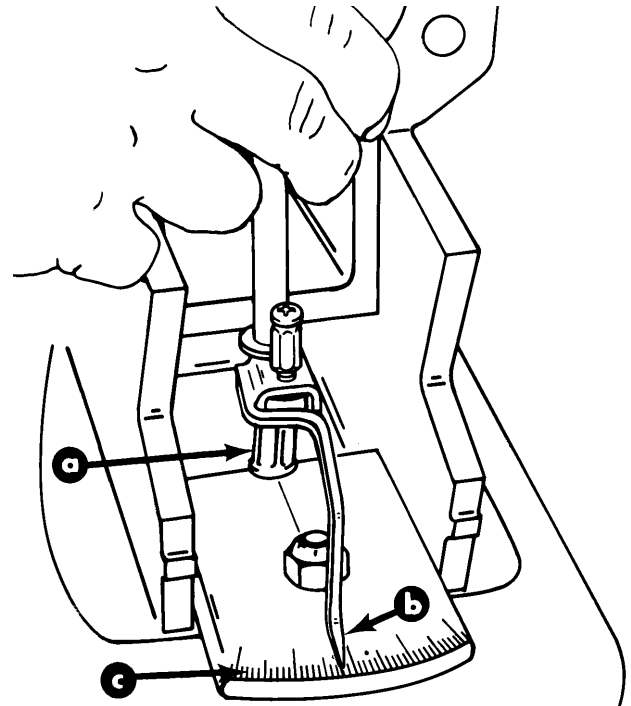
50498

- b. Rotate shift shaft coupler clockwise while simultaneously turning propeller shaft counterclockwise until clutch locks into forward gear. Make note of pointer location on scale.

- a - Shift Shaft Coupler
- b - Pointer
- c - Scale

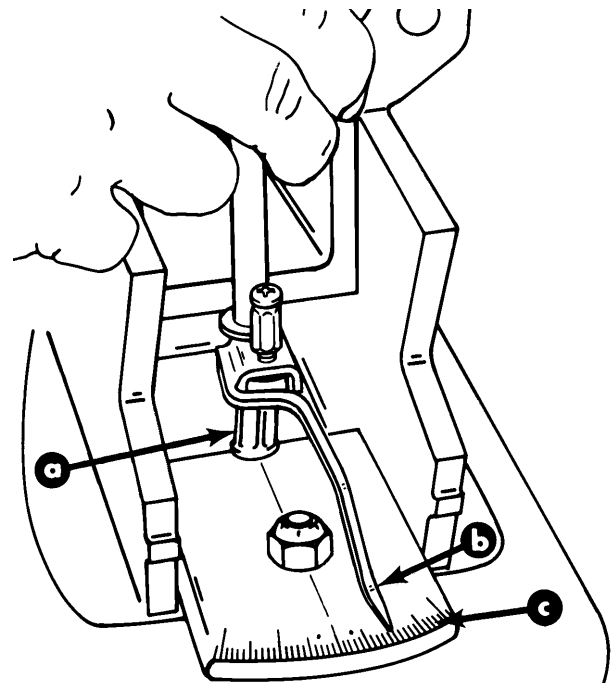
50498

- c. While maintaining pressure on propeller shaft to keep clutch locked with gear, lightly turn shift shaft coupler counterclockwise. Make note of pointer location.

- a - Shift Shaft Coupler
- b - Pointer
- c - Scale

d. Determine total degrees of movement.

If 12° or less: Problem is with the drive unit shift cable, upper shift shaft assembly and lever assembly.

If more than 12°: Problem is with gear case shift spool assembly.

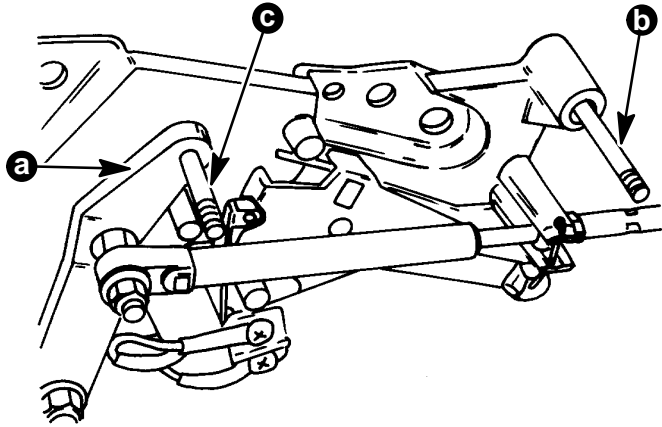
25443

1. Remove short studs from locations shown. Apply Loctite to coarse threads of new longer studs and install as shown. Tighten securely.

- a - Metal Shift Lever
- b - 2-7/8 in. Stud (73mm)
- c - 2-1/8" Stud (54mm)

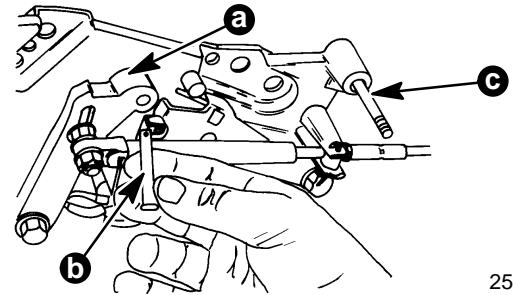
25444

1. Remove and discard short clevis pin. Remove short stud from location shown. Apply Loctite to coarse threads of new longer stud and install as shown. Tighten securely.

- a - Plastic Shift Lever
- b - Longer Clevis Pin
- c - 2-7/8" Stud (73mm)

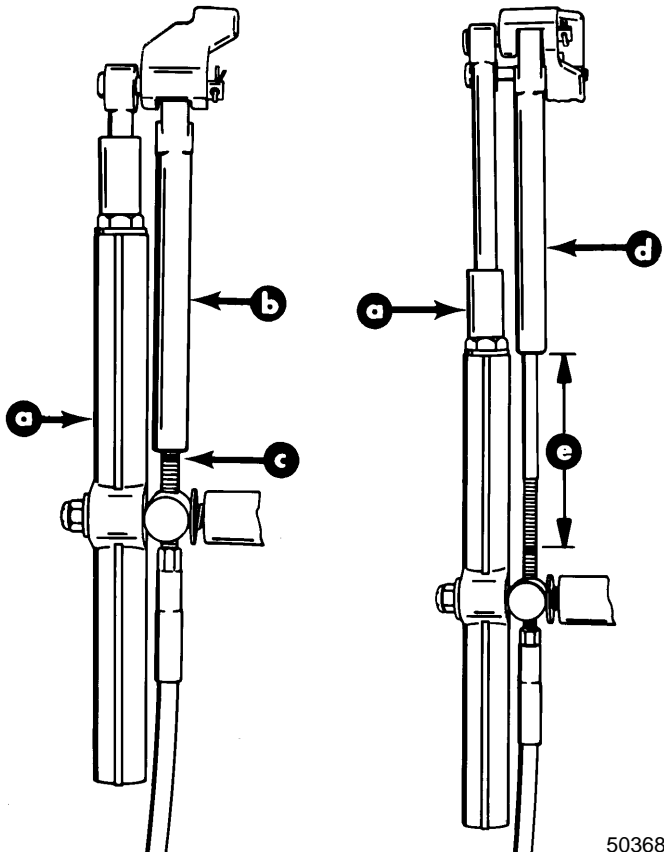
50368

IMPORTANT: Remote control must provide a shift cable travel (at the shift plate end) of 2-7/8 in. (73mm) to 3-1/8 in. (80mm) with a 15 – 20 lb.(6.8 – 9 kg) load applied to the cable end guide. This measurement can be taken by installing the remote control shift cable and using the shift assist assembly (provided) to place the proper load of the shift cable (drive unit shift cable should not be installed).

1. Place remote control in forward gear wide open throttle position. Place a mark on threaded tube against edge of cable end guide.

- Place remote control in reverse gear wide open throttle position. Measure the distance between the edge of shift cable end guide and the mark made in step 1. Total shift cable output is not to be less than 2-7/8 in. (73mm) or more than 3-1/8 (80mm). If output is incorrect, remote control and/or shift cable should be replaced.

- a - Shift Assist Assembly
- b - Remote Control Shift Cable - In Forward Gear Position
- c - Place a Mark on Tube Against Edge of Cable End Guide
- d - Remote Control Shift Cable - In Reverse Gear Position
- e - Measurement Taken from Mark to Edge of Cable End Guide: **2-7/8 in. (73mm) to 3-1/8 in.**

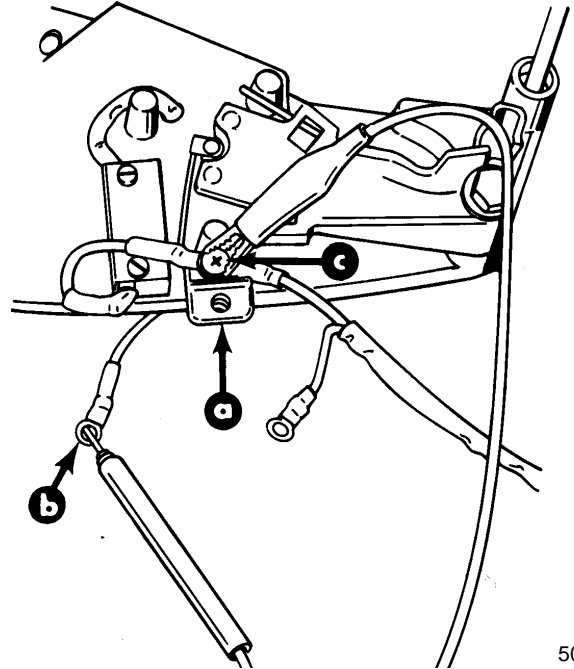
50497

- Disconnect cutout switch white/green wire from terminal block.
- Connect ohmmeter positive (+) lead to cutout switch white/green wire and ohmmeter negative (-) lead to cutout switch black wire at terminal block.
- Set Ohmmeter on RX1 scale.

- a - Terminal Block
- b - Cutout Switch White/Green Wire
- c - Cutout Switch Black Wire

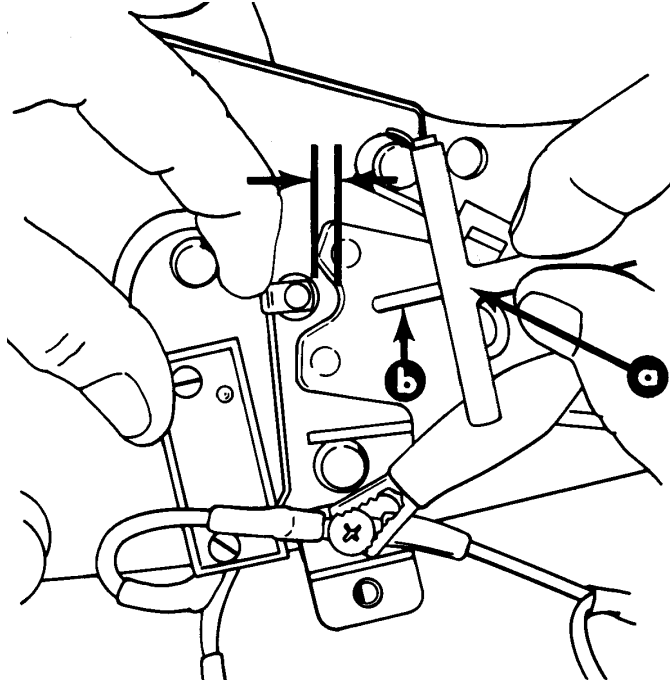
50497

4. Slowly move cutout switch roller off of its seat. Circuit should close (full continuity reading), when roller is moved 1/8 in. (3mm). Use the 1/8 in. rod on the end of special tool to gauge this movement.

- a - Special Tool
- b - 1/8 in. (3mm)

If switch closes too early (less than 1/8 in.): Roller must be bent away from its seat.

If switch closes too late (more than 1/8 in.): Roller must be bent toward its seat.

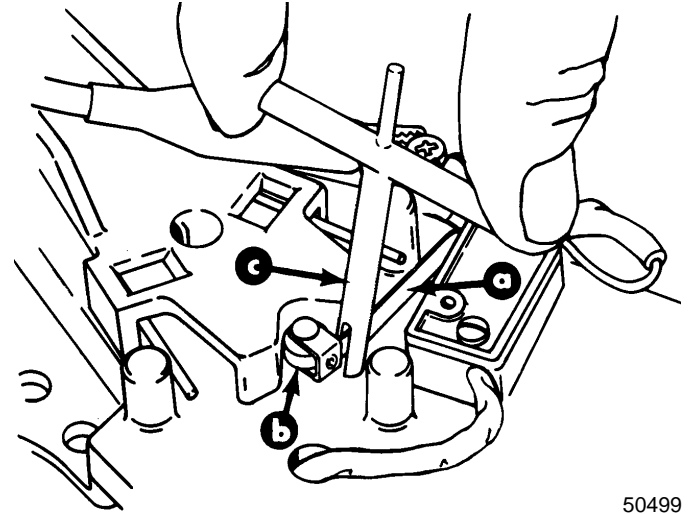
50499

If necessary, use special tool to bend lever as shown.

- a - Lever
- b - Roller
- c - Special Tool

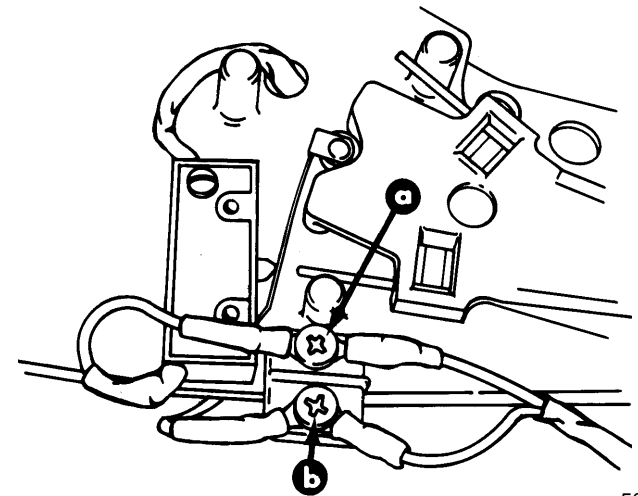
50499

5. Once cutout switch is timed properly, reconnect wires at terminal block and coat terminals with liquid neoprene.

- a - Black Wires
- b - White/Green Wires

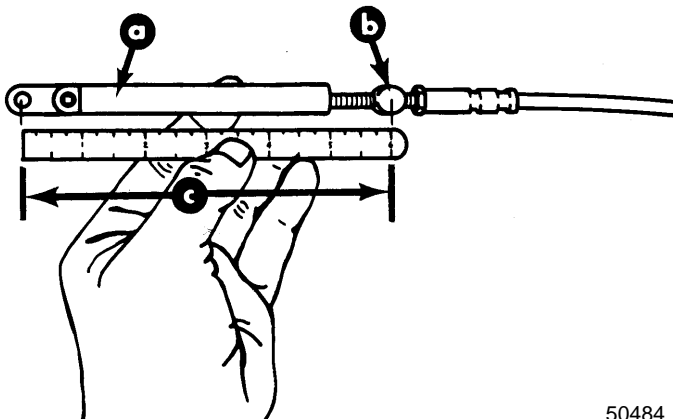
50484

1. Push in on drive unit shift cable while simultaneously turning propeller shaft counterclockwise until shaft stops, to ensure drive unit is completely in forward gear. Maintain pressure on propeller shaft with a suitable device (elastic strap).
2. Measure distance between center of hole in shift cable end guide and center of brass barrel. Measurement should be 6 in. (153mm).

- a - End Guide
- b - Brass Barrel
- c - 6 in. (153mm)

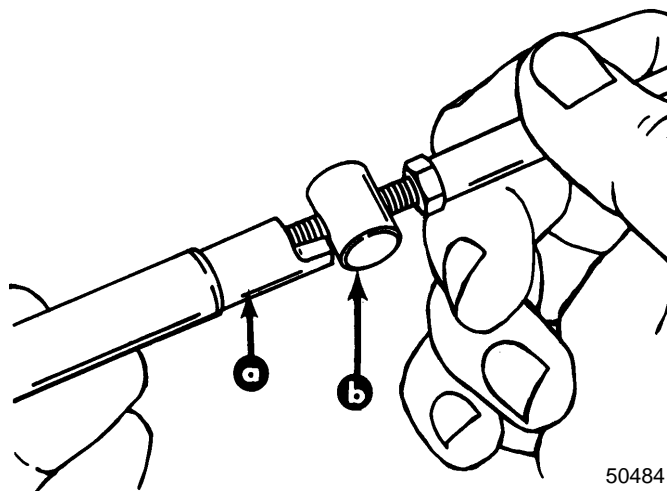
50484

3. Once brass barrel adjustment is correct, install end guide "stop clip" on threaded tube. Position as shown, with tang touching brass barrel.

- a - Stop Clip
- b - Brass Barrel

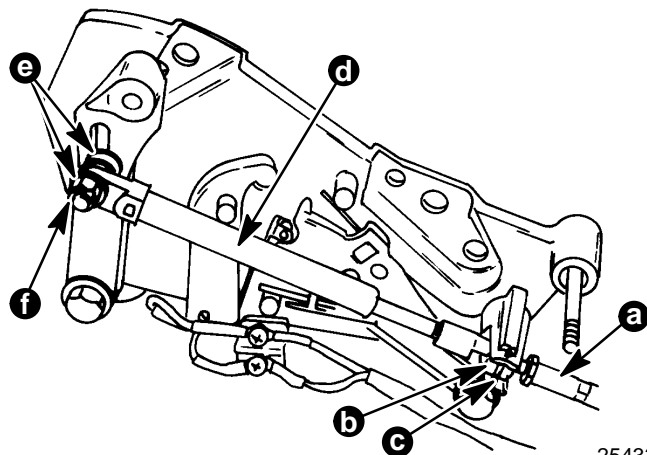
25433

4. Install drive unit shift cable as shown. Secure brass barrel in barrel retainer with cotter pin, spreading both prongs. Secure end guide to shift lever with a washer on each side of end guide and locknut. Tighten locknut until it bottoms, then, back off 1/2 turn.

- a - Drive Unit Shift Cable
- b - Brass Barrel
- c - Cotter Pin
- d - End Guide
- e - Washers
- f - Locknut

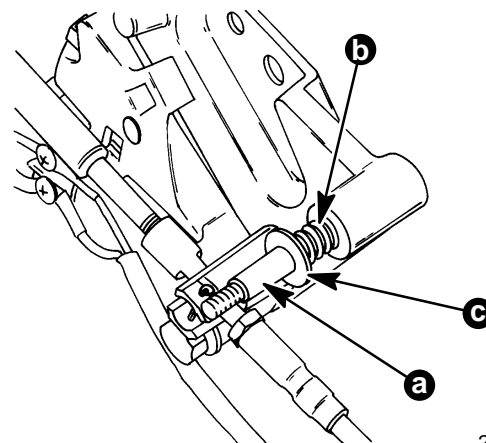
25431

1. Install sleeve, spring and large I.D. washer on stud as shown.

- a - Sleeve
- b - Spring
- c - Large I.D. Washer

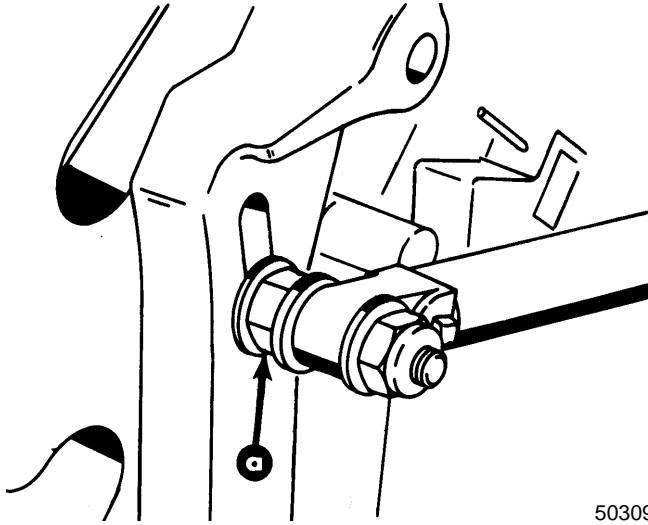
50309

2. Ensure shift lever adjustable stud is at bottom of slot. If necessary, loosen stud and move it to bottom of slot, then retighten stud.

a - Adjustable Stud

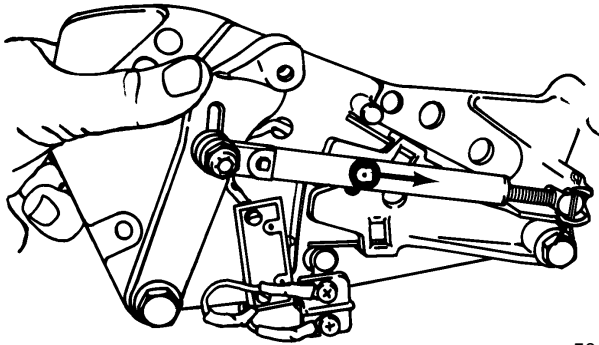
50499

3. Place drive unit into forward gear by pushing in on drive unit shift cable, while simultaneously rotating propeller shaft counterclockwise until shaft stops, to ensure full clutch engagement.

a - Drive Unit Shift Cable - Push In

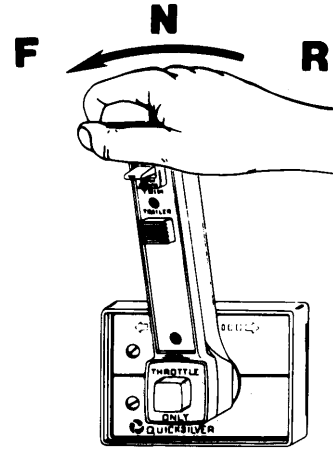
4. Place remote control into forward gear, wide-open-throttle position.

5. Lightly pull on remote control shift cable end guide (to remove slack from remote control and cable) and adjust brass barrel as necessary to align attaching points with shift lever clevis pin hole and stud.

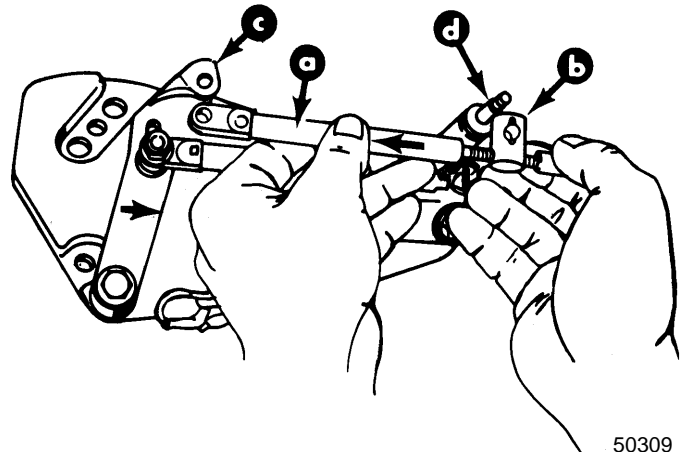
50309

a - End Guide
 b - Brass Barrel
 c - Shift Lever Clevis Pin Hole
 d - Stud

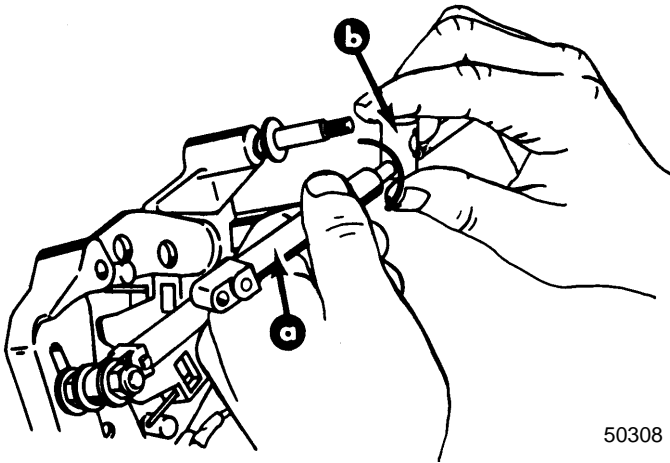
50308

6. After cable has been aligned, turn brass barrel 4 turns **away** from cable end guide.

- a - End Guide
b - Brass Barrel

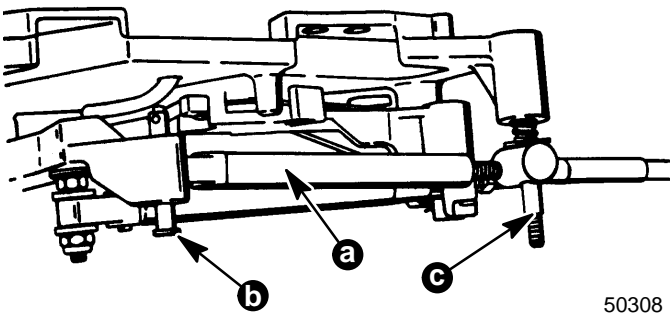
50308

7. Temporarily install remote control shift cable on stud and install clevis pin.

- a - Remote Control Shift Cable
b - Clevis Pin
c - Stud

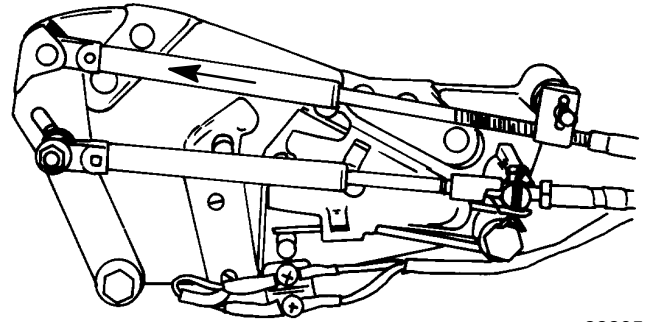
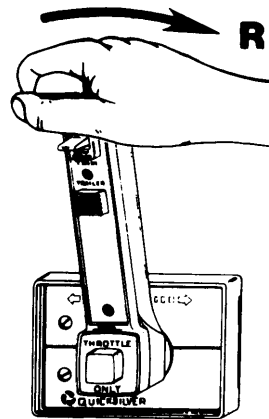
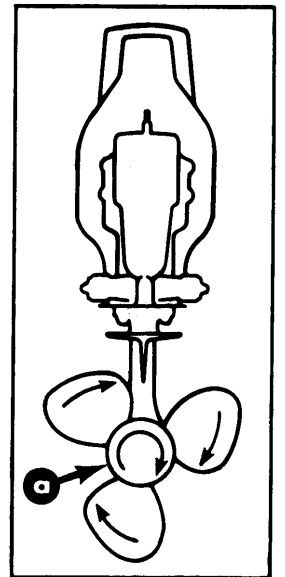
22267

8. Shift remote control into **reverse gear, wide-open-throttle position**, while simultaneously rotating propeller shaft clockwise until shaft stops to ensure full clutch engagement.

- a - Propeller Shaft - Rotate Clockwise

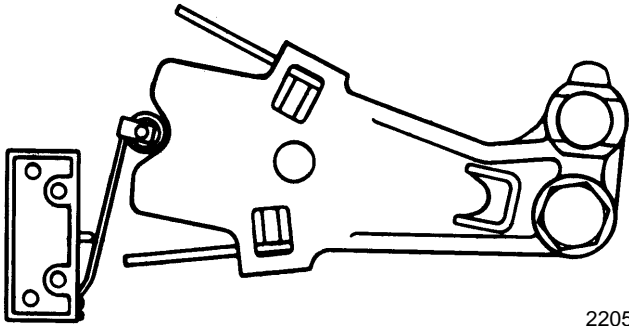
22058

9. Check shift cutout switch lever position. Roller must be centered.

10. If roller is not centered:

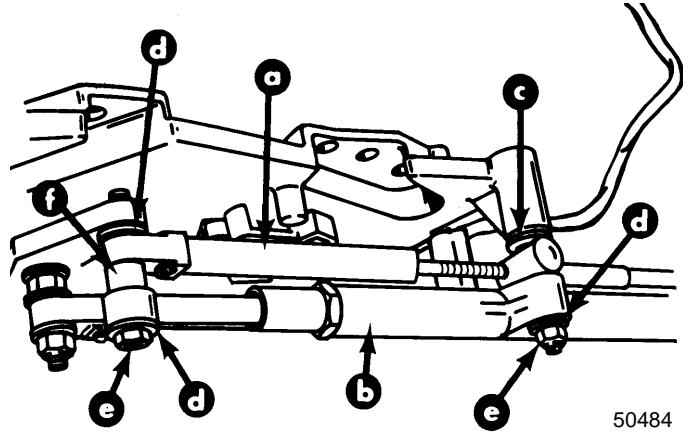
50484

11. After remote control shift plate has been properly adjusted, reinstall cable and shift assist assembly and secure with hardware as shown.

- a - Remote Control Shift Cable
- b - Shift Assist Assembly
- c - Large I.D. Washer
- d - Small I.D. Washer
- e - Locknut - Tighten Until Bottomed then Back off 1/2 Turn
- f - Spacer

Earlier Models (With Metal Shift Lever)

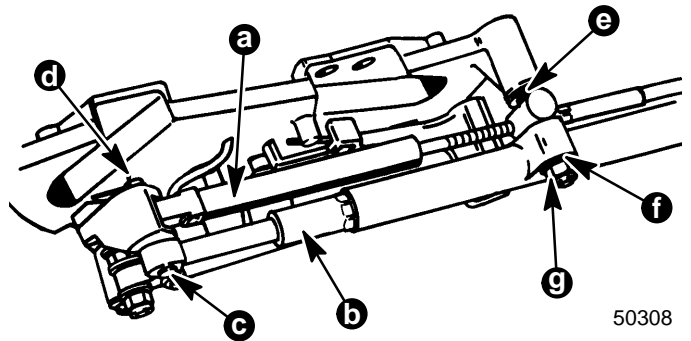
50308

- a - Remote Control Shift Cable
- b - Shift Assist Assembly
- c - Clevis Pin
- d - Cotter Pin - Spread both Prongs
- e - Large I.D. Washer
- f - Small I.D. Washer
- g - Locknut - Tighten Until Bottomed then Back off 1/2 Turn

Later Models (With Plastic Shift Lever)

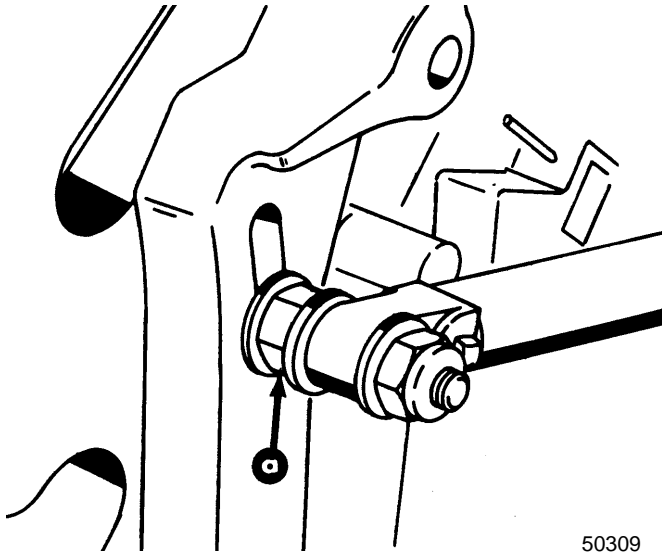
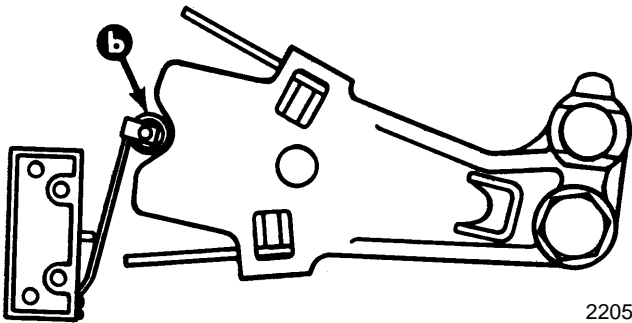
12. Shift remote control into reverse gear, wide open throttle position while simultaneously rotating propeller shaft clockwise. Clutch should engage and cause propeller shaft to lock. If clutch does not engage, loosen adjustable stud on shift lever and move it upward in slot until clutch engages with reverse gear. Retighten stud. Shift remote control several times and stop in reverse to re-check shift cutout switch position. Roller must be centered.

- a - Adjustable Stud
b - Shift Cutout Switch Roller

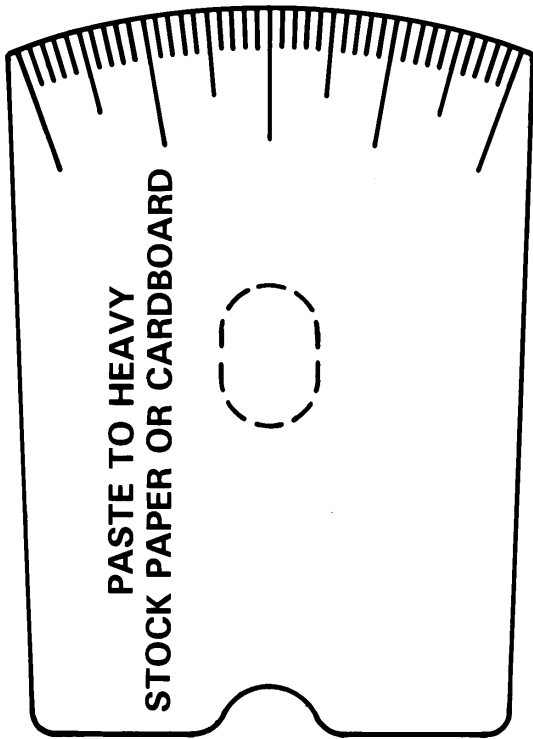
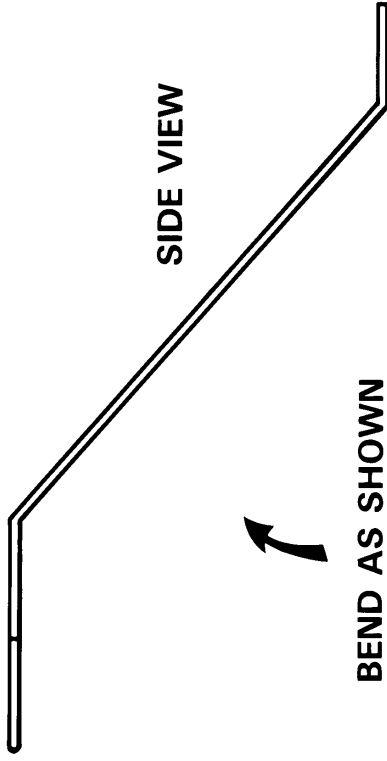
SCALE

POINTER

NOTE: Tools shown will be available thru Quicksilver at a later date. Refer to the end of this instruction booklet for templates and patterns needed to fabricate similar tools.

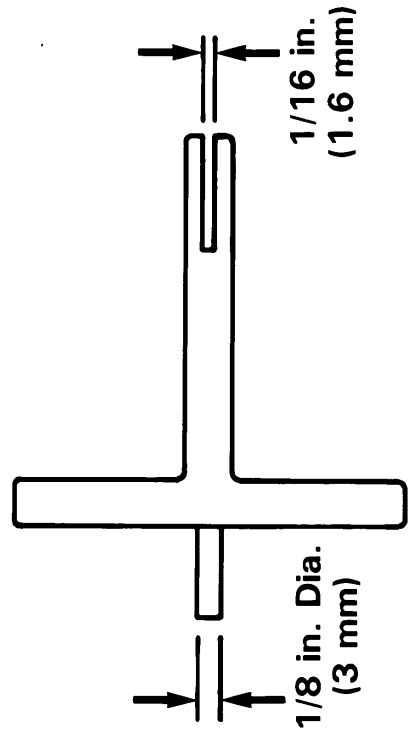
CUTOUT SWITCH
ADJUSTMENT TOOL

1/16 in.
(1.6 mm)

1/8 in. Dia.
(3 mm)

5-1/2 in. (140 mm)

1/16 in. (1.6 mm) Dia. STIFF WIRE

NOTE: Tool shown will be available thru Quicksilver at a later date. Refer to the end of this instruction booklet for the pattern and dimensions needed to fabricate a similar tool.
